Re: Dilapidation Report for Property
No: Pemulwuy Project - Redfern NSW 2016

Job: 170037.0
Date: MAY 2017

SUMMARY

This report serves as a record of the condition of the RailCorp infrastructure assets of the "Metro Illawarra & South Coast" line, which is adjacent to the subject site, prior to the commencement of any works proposed at: Pemulwuy Project - Redfern NSW 2016.

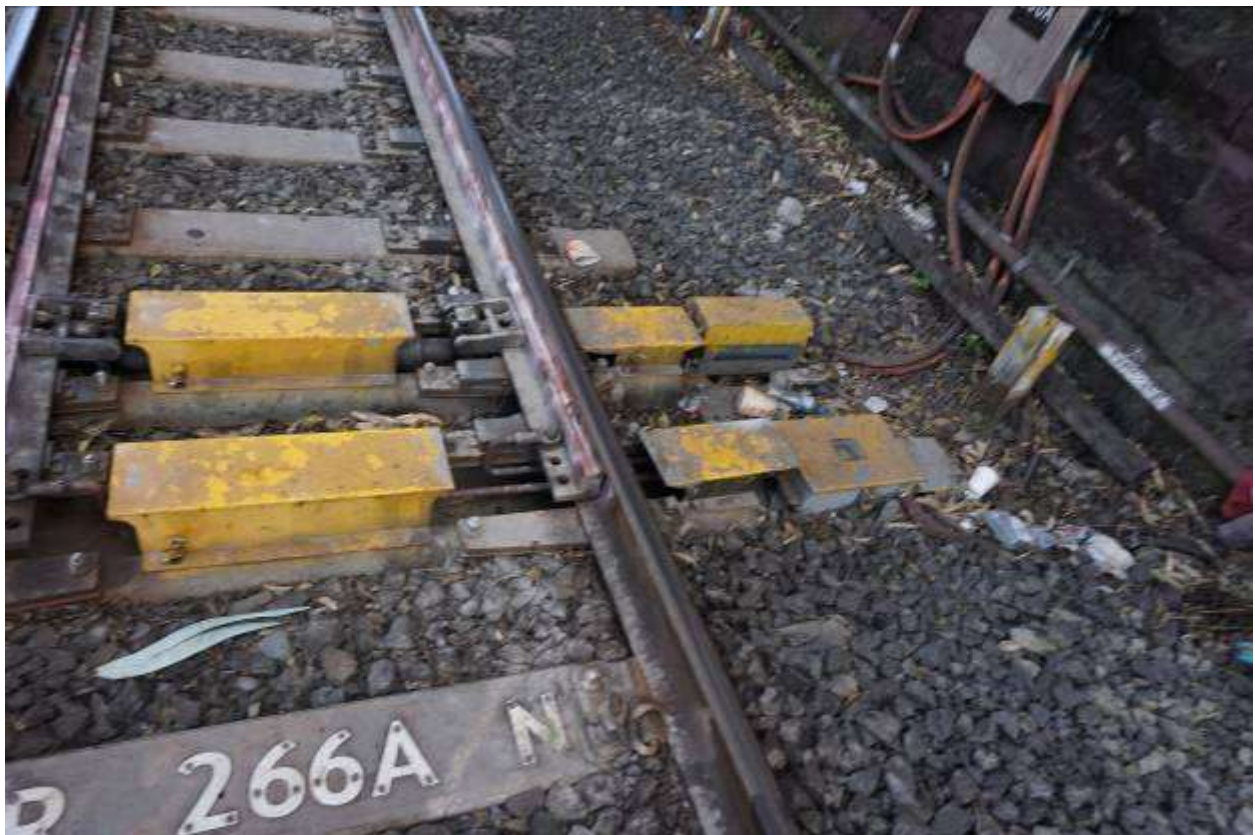
Figure 250 – General condition of RailCorp points rodding observed from Railway Corridor

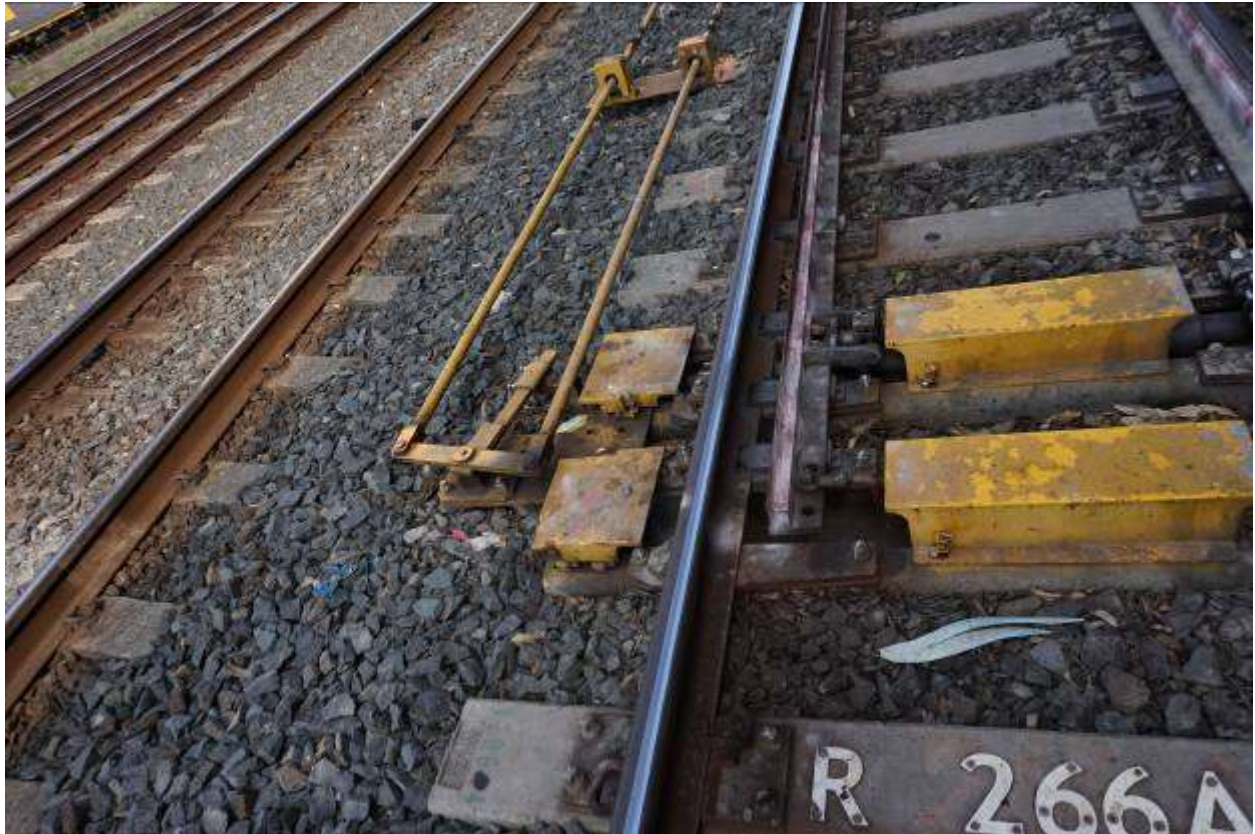
Figure 251 – General condition of RailCorp points rodding observed from Railway Corridor

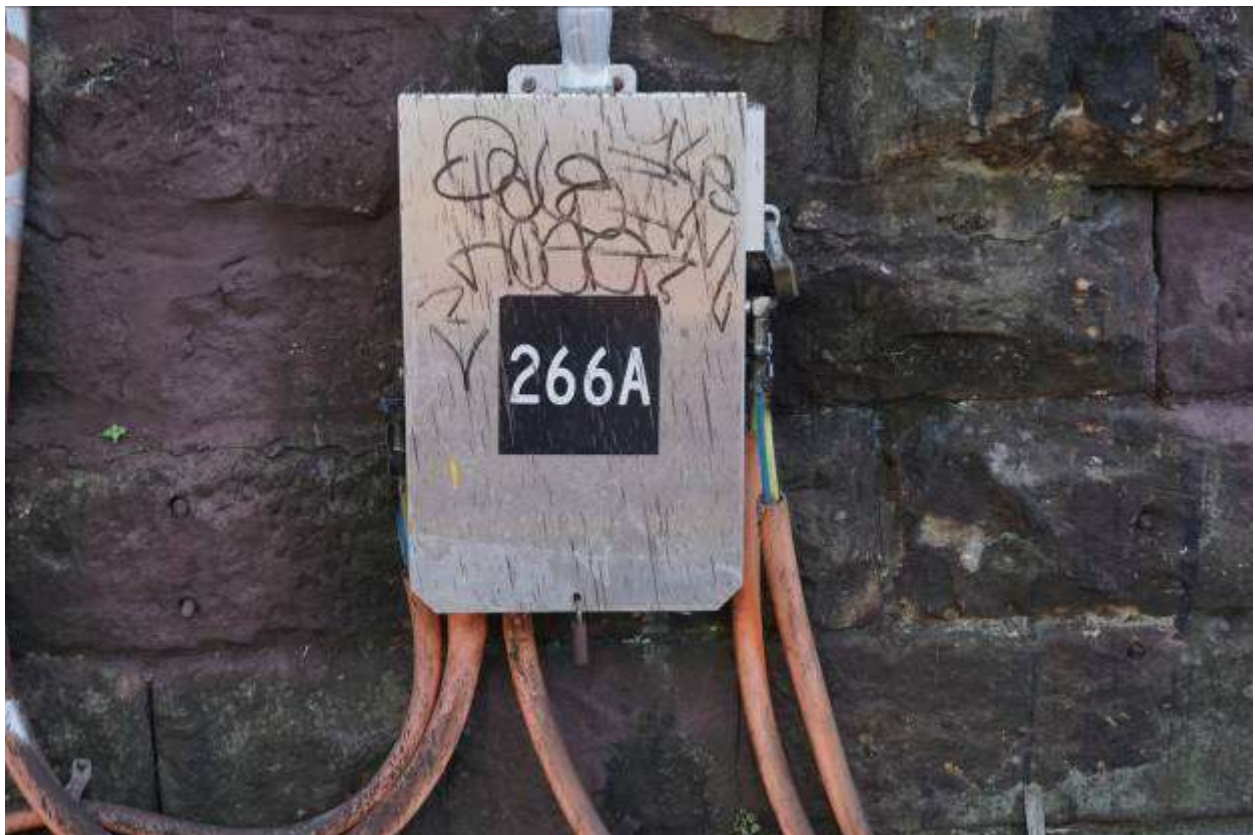
Figure 252 – General condition of RailCorp electricity box observed from Railway Corridor

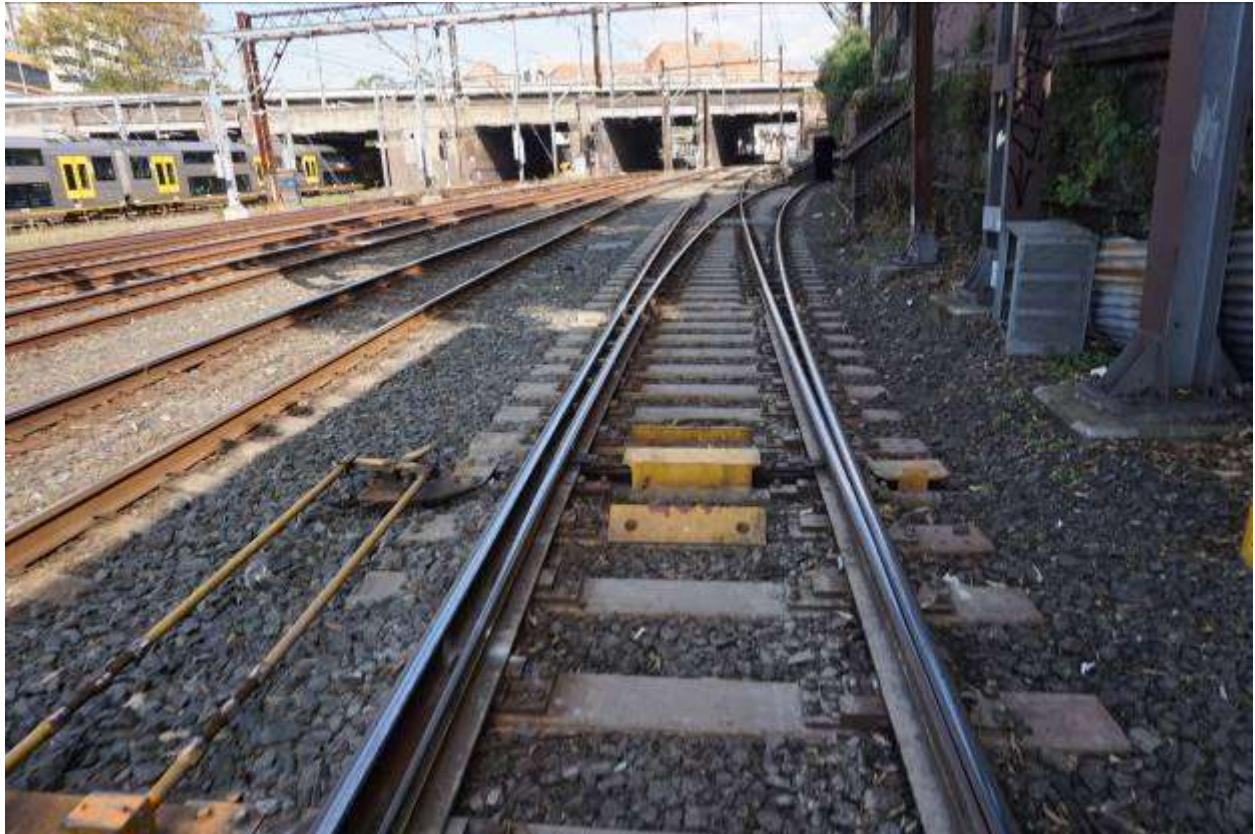
Figure 253 – General condition of RailCorp points rodding observed from Railway Corridor

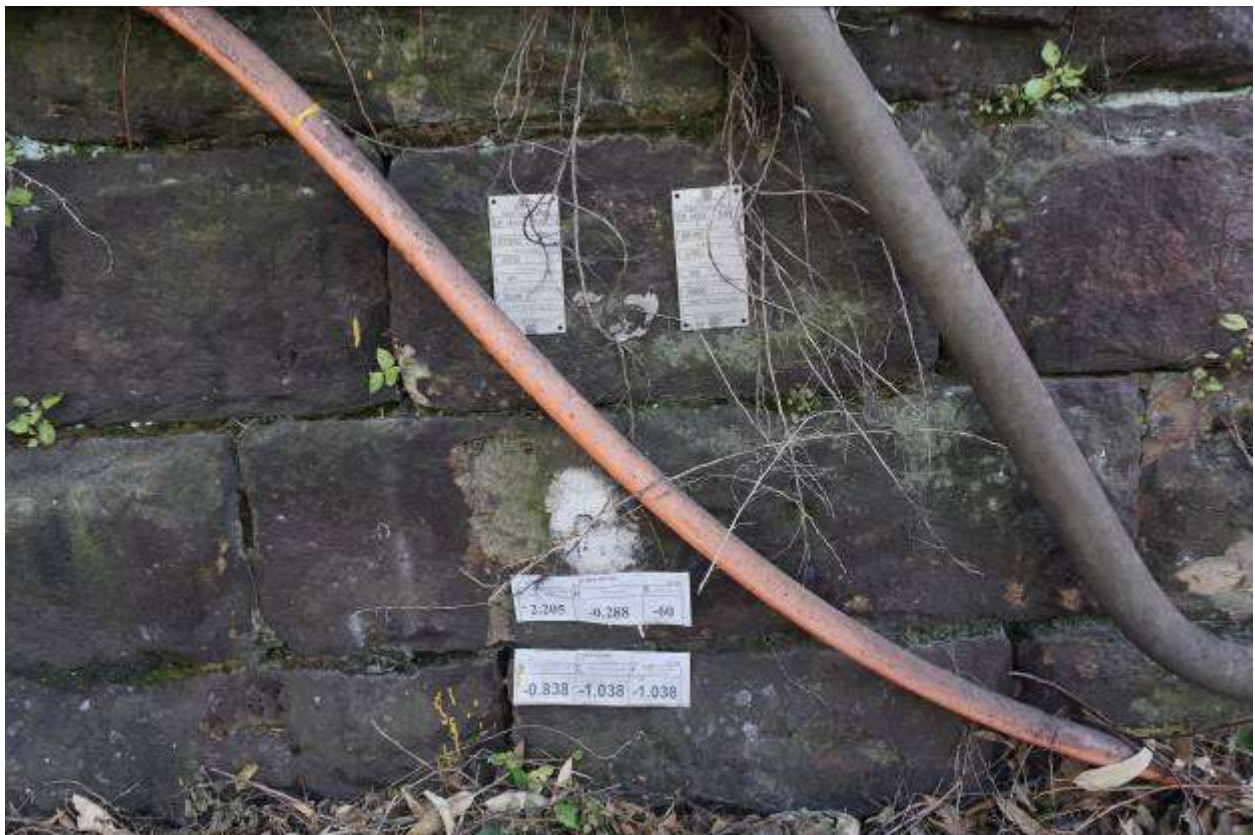
Figure 254 – General condition of Survey Track Control Mark observed from Railway Corridor

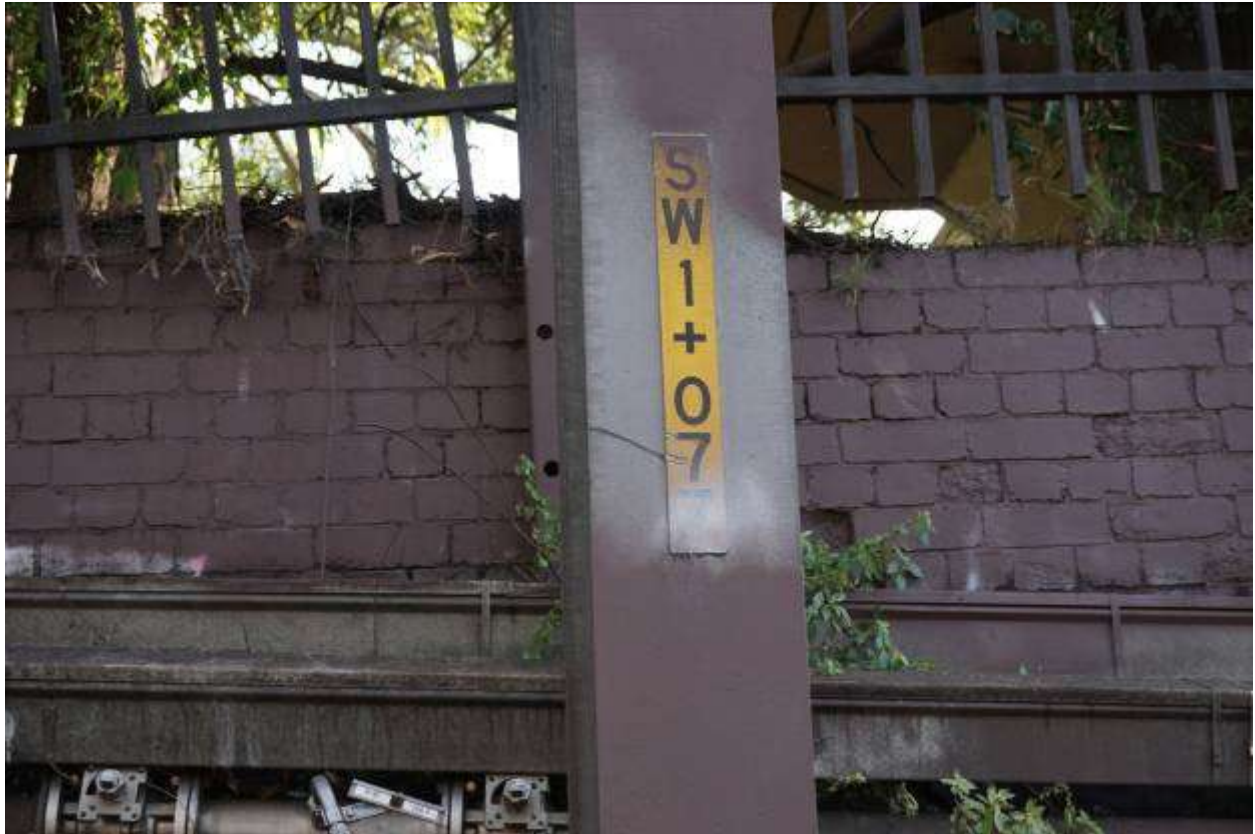
Figure 255 – General condition of steel portal haunch Identification No. SW1+077 observed from Railway Corridor

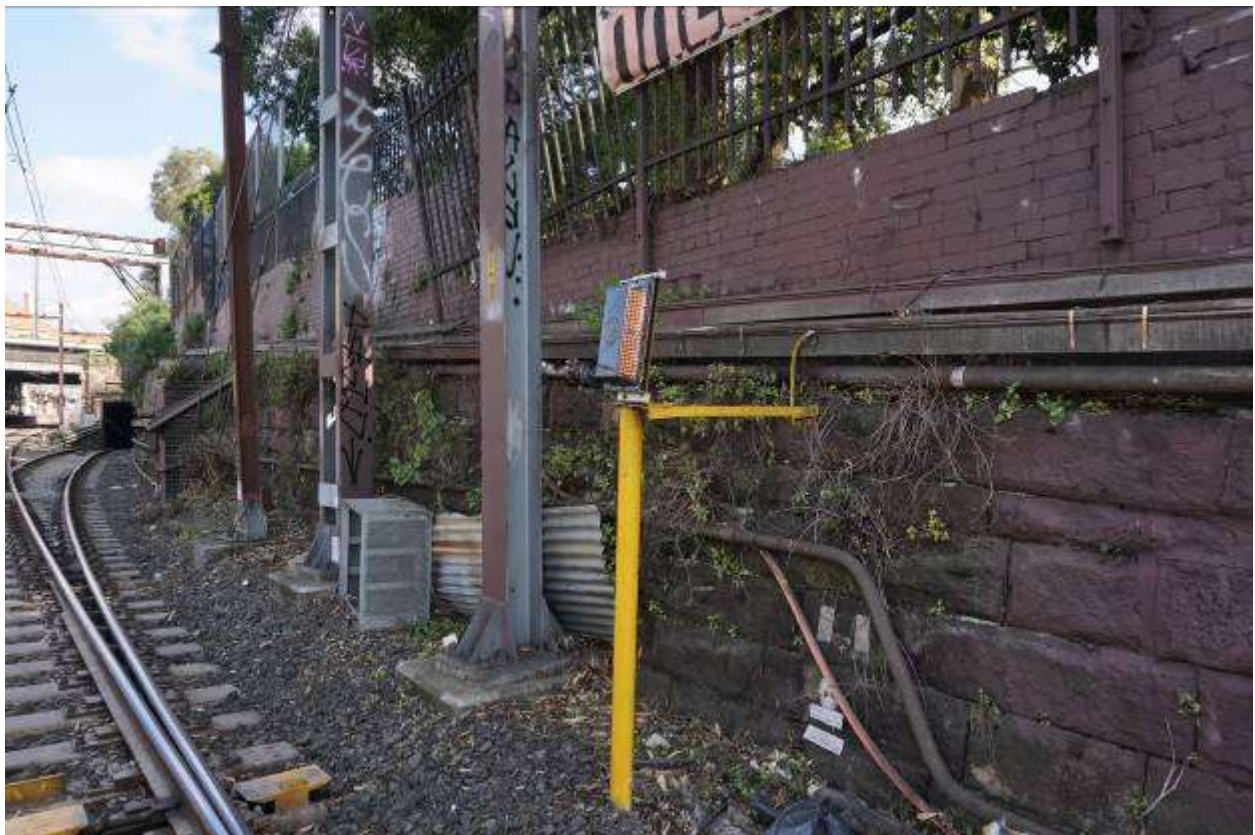
Figure 256 – General condition of steel portal haunch Identification No. SW1+077 observed from Railway Corridor

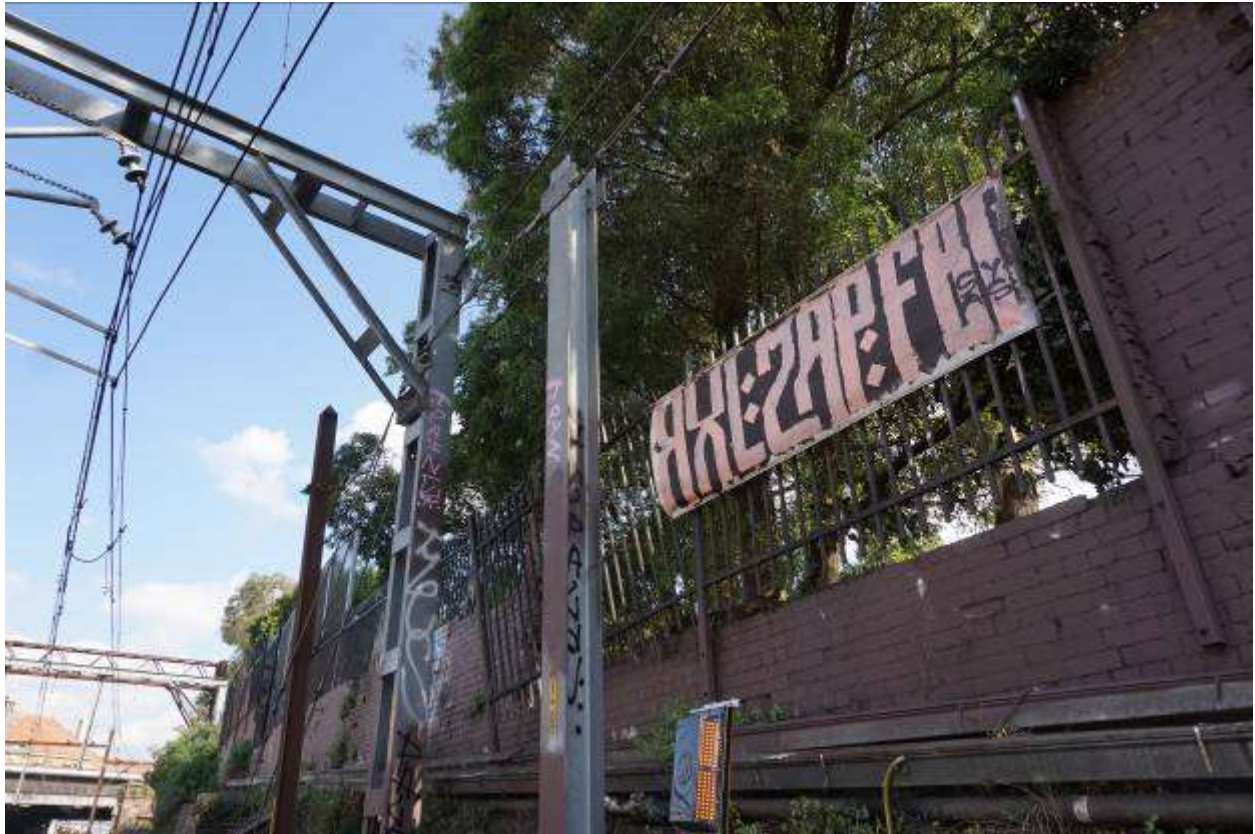
Figure 257 – General condition of steel portal haunch Identification No. SW1+077 observed from Railway Corridor

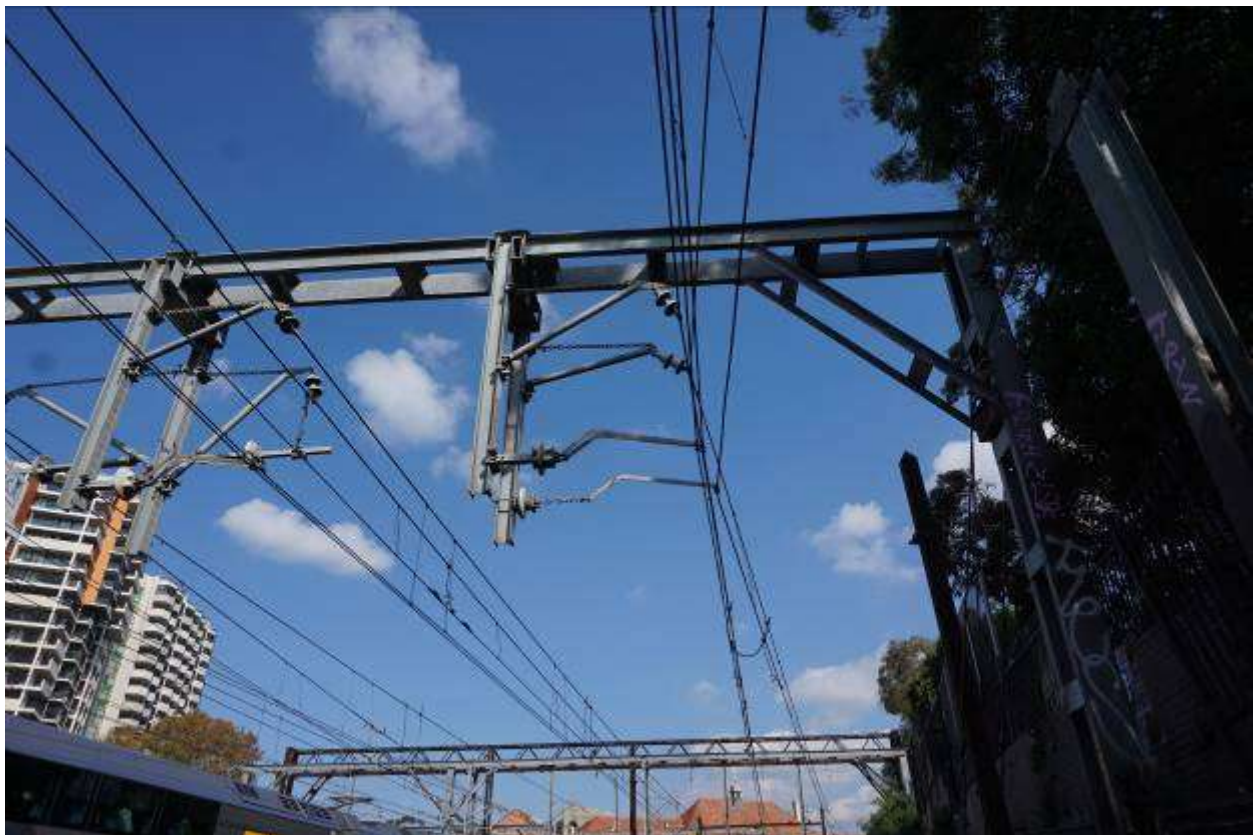
Figure 258 – General condition of steel portal haunch Identification No. SW1+080 and overhead power supply system observed from Railway Corridor

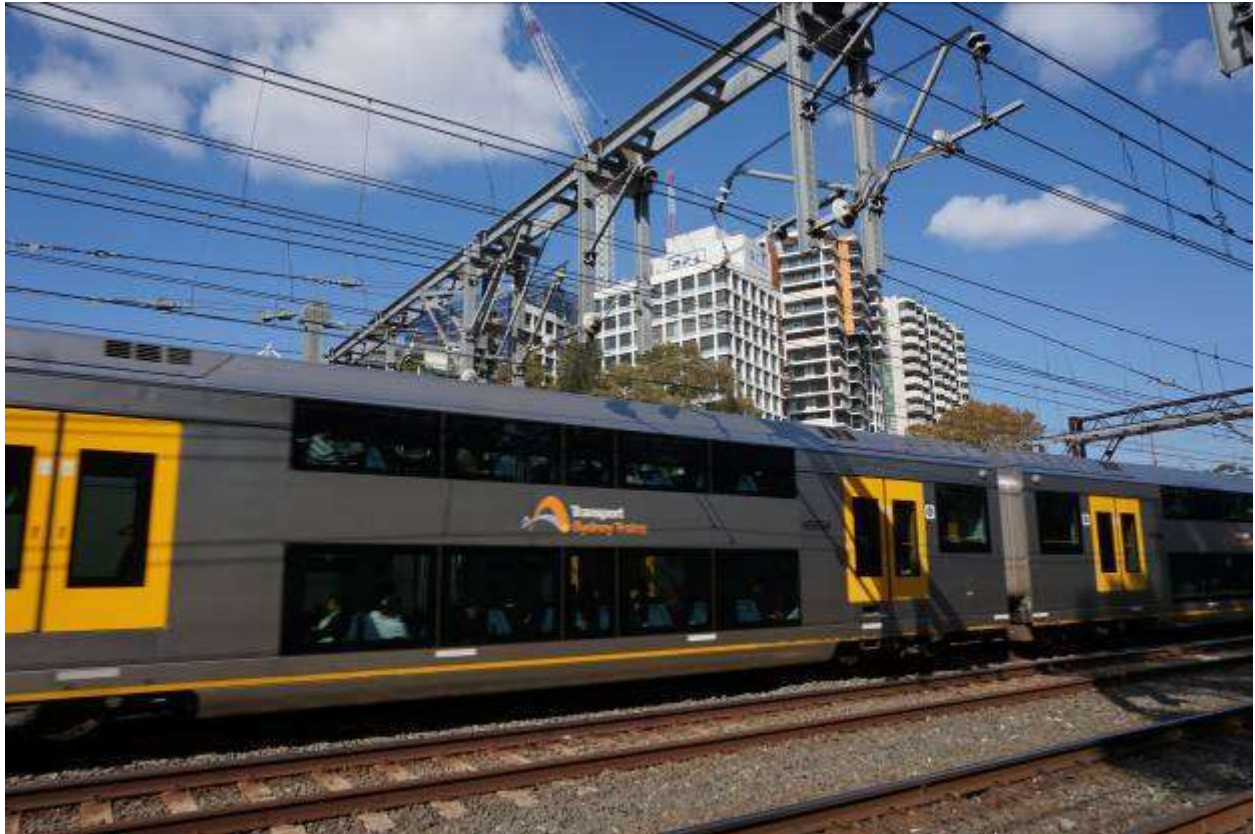
Figure 259 – General condition of steel portal haunch Identification No. SW1+080 and overhead power supply system observed from Railway Corridor

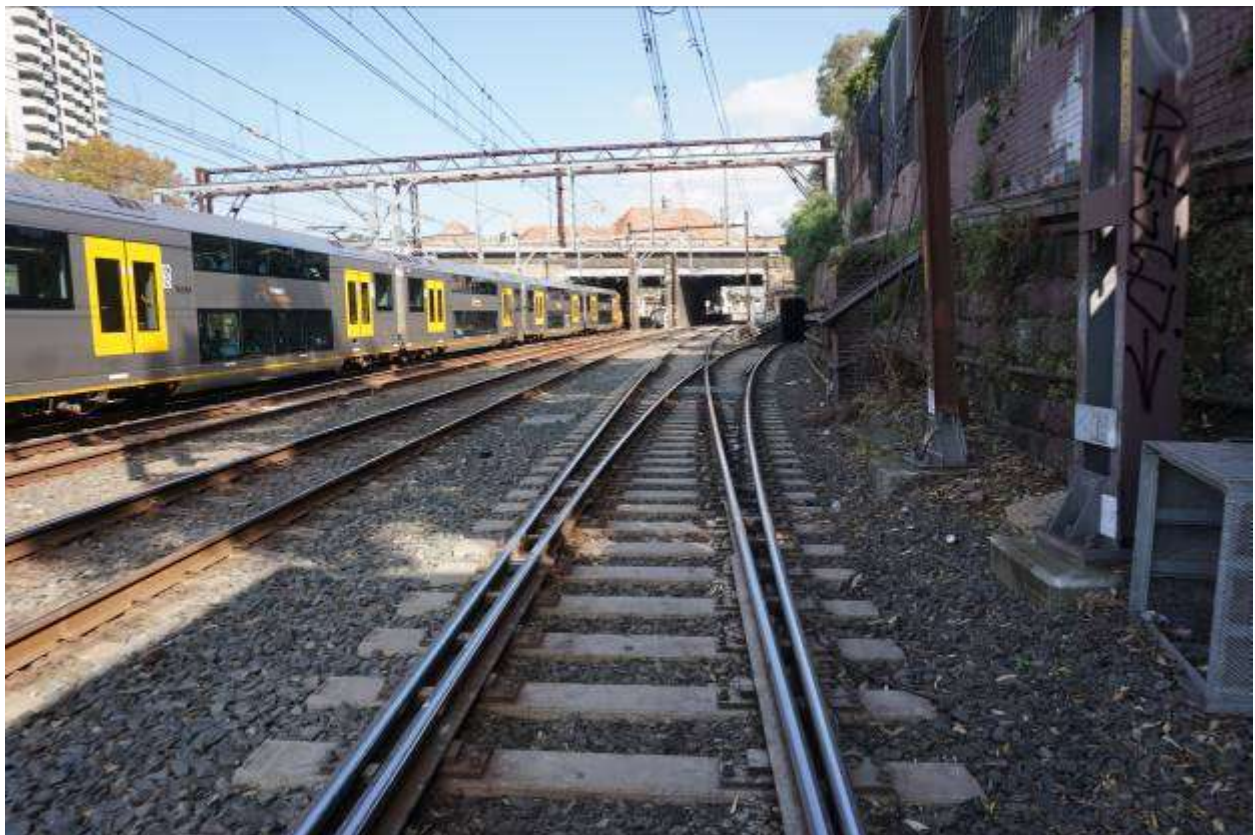
Figure 260 – General condition of railway corridor observed from Railway Corridor

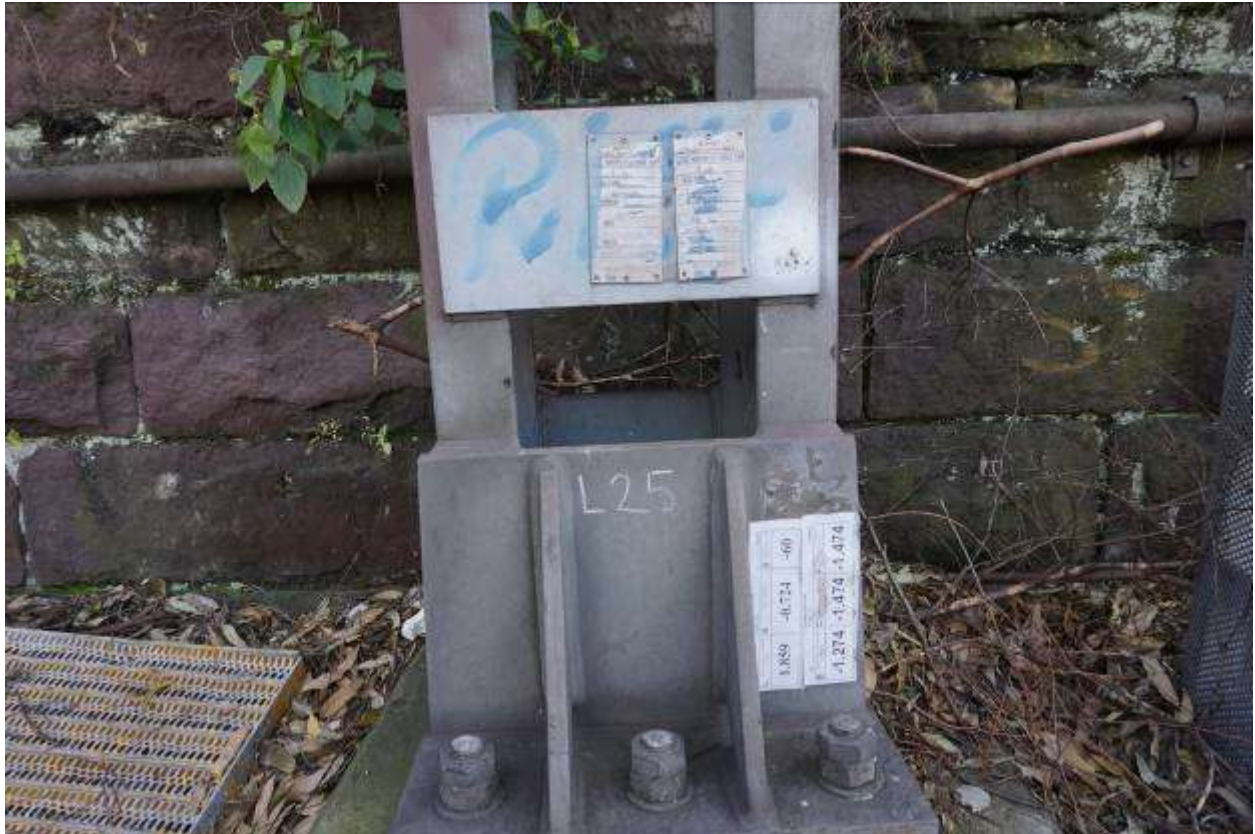
Figure 261 – General condition of Survey Track Control Mark observed from Railway Corridor

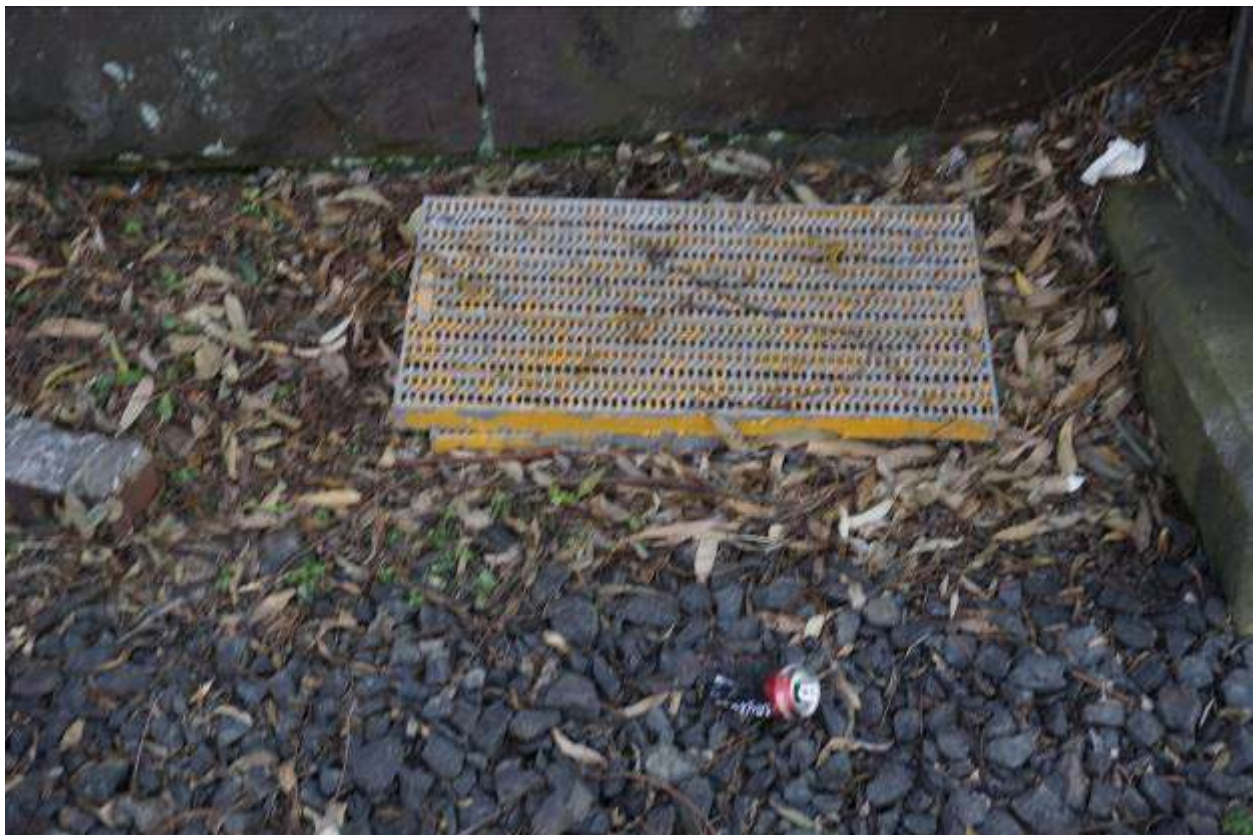
Figure 262 – General condition of railway drainage observed from Railway Corridor

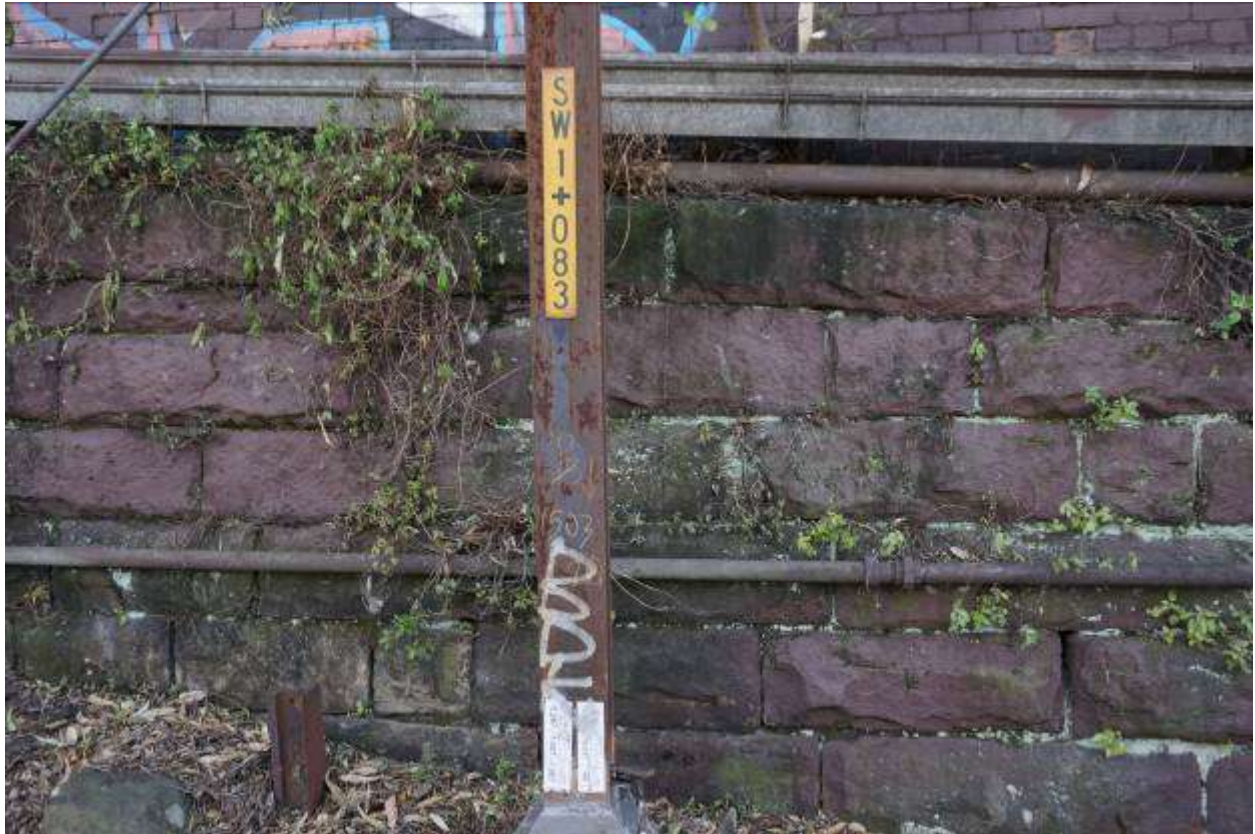
Figure 263 – General condition of steel portal haunch Identification No. SW1+083 observed from Railway Corridor

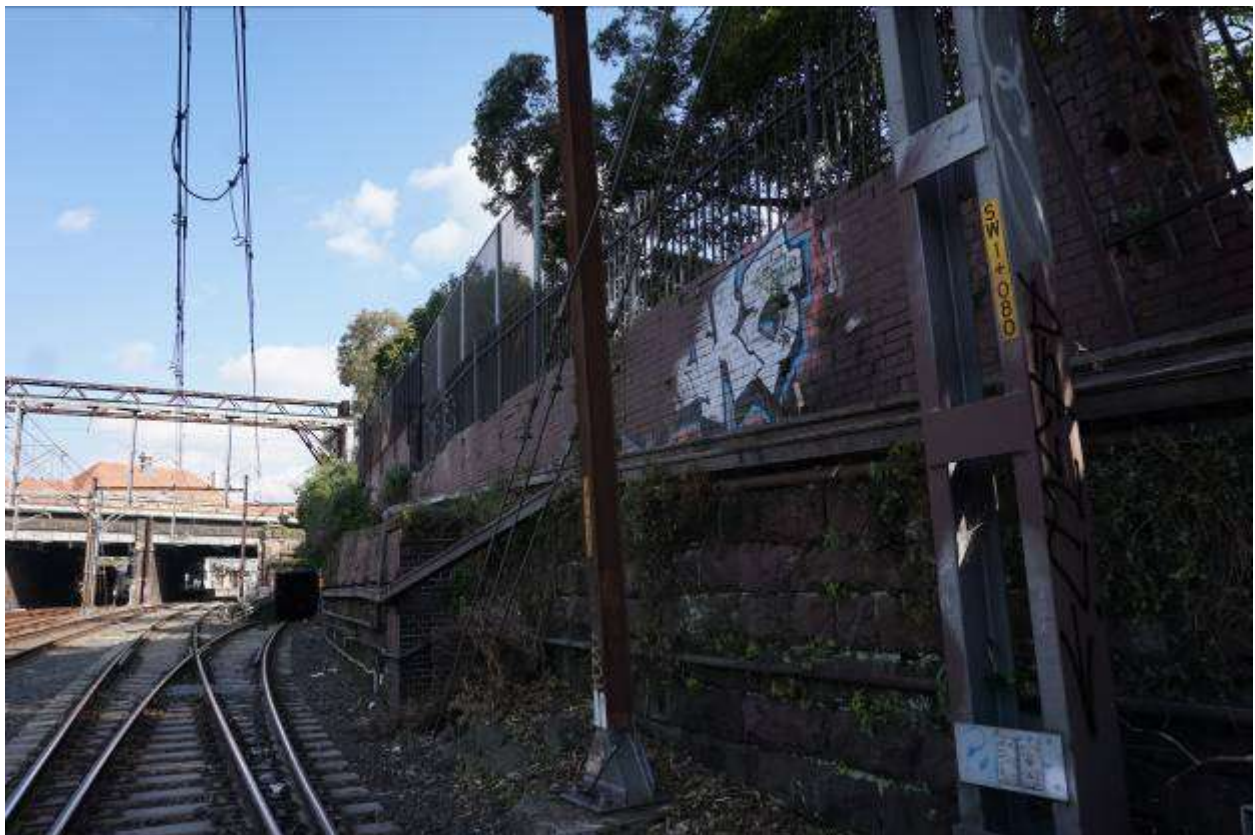
Figure 264 – General condition of steel portal haunch Identification No. SW1+083 observed from Railway Corridor

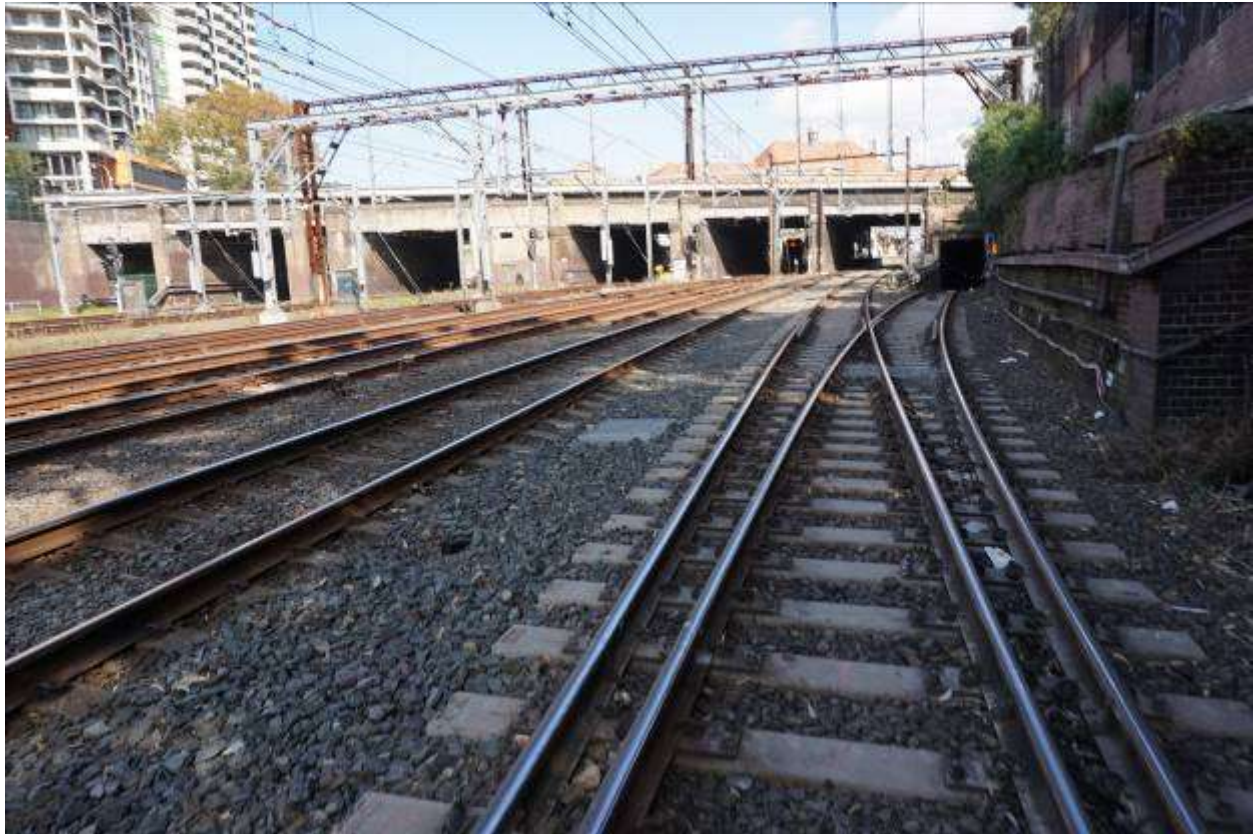
Figure 265 – General condition of railway corridor observed from Railway Corridor

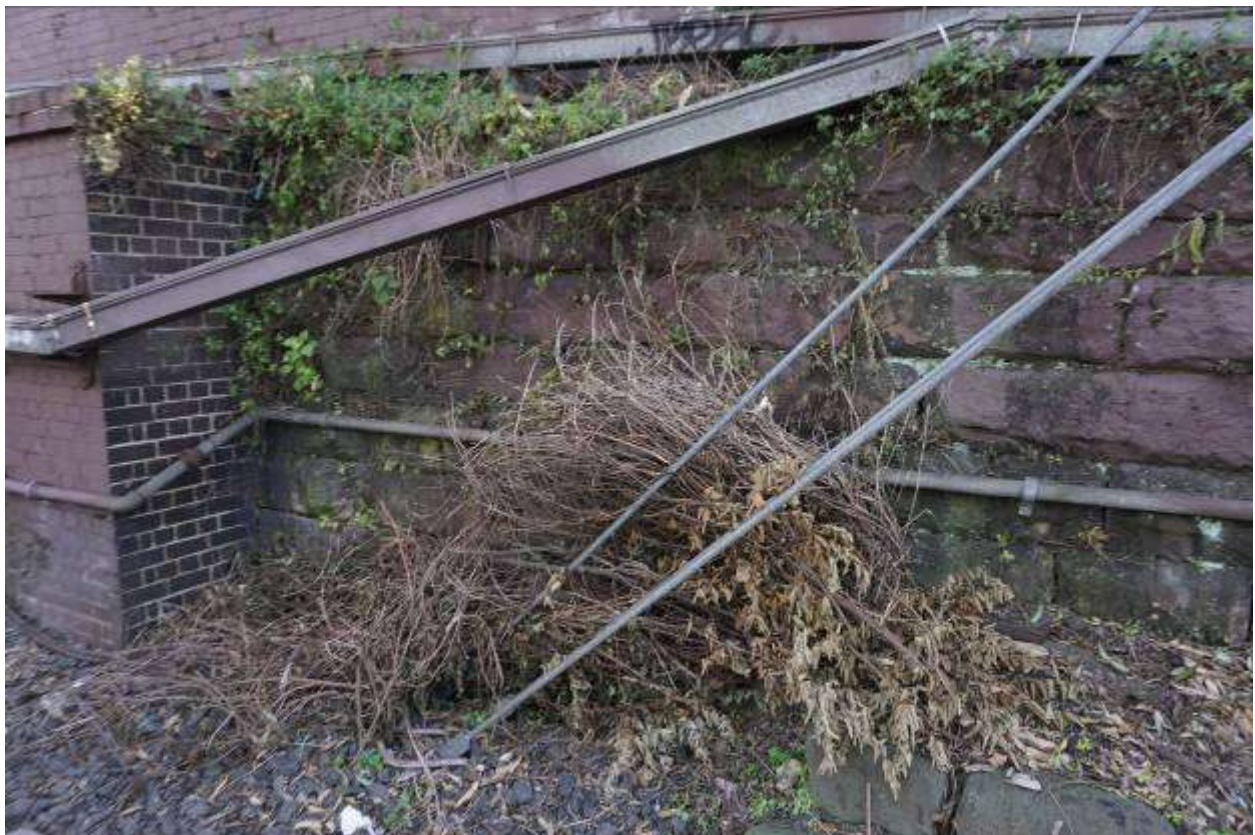
Figure 266 – General condition of RailCorp signal troughing observed from Railway Corridor

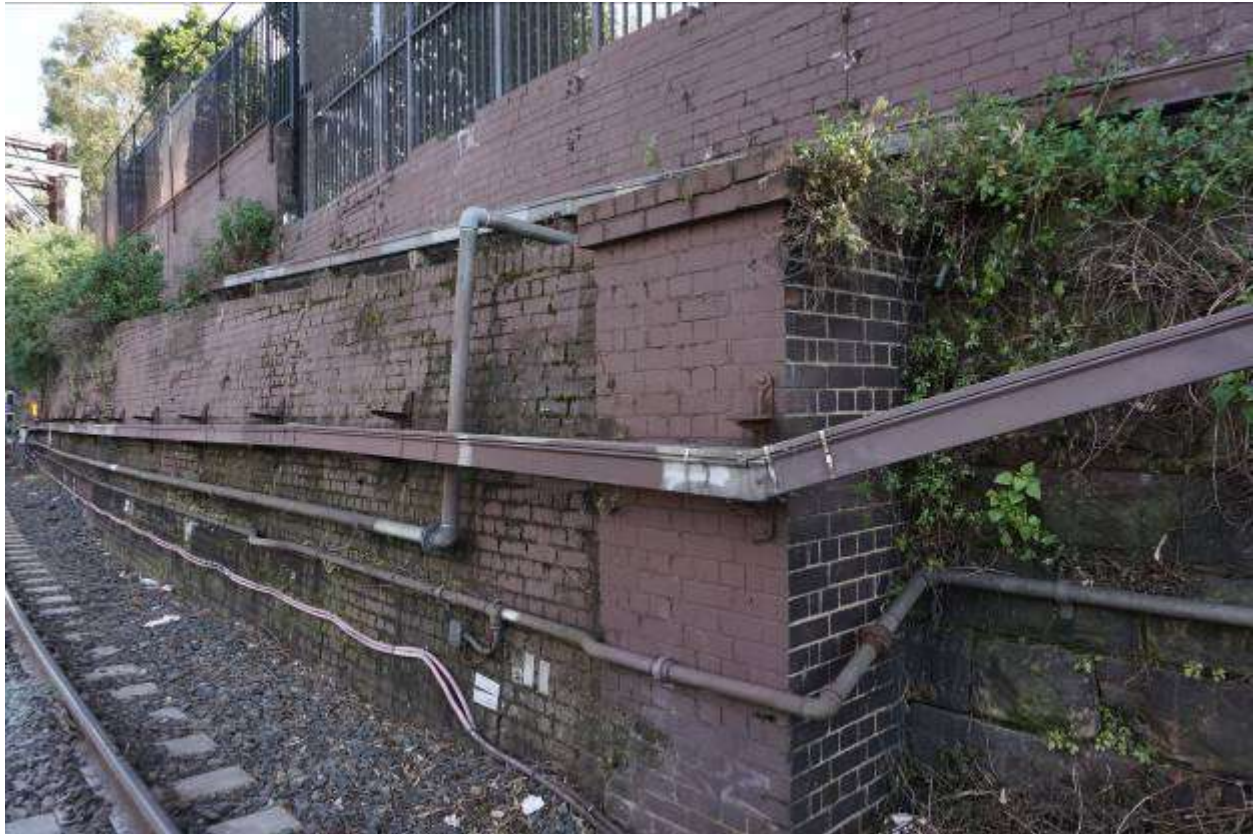
Figure 267 – General condition of RailCorp signal troughing observed from Railway Corridor

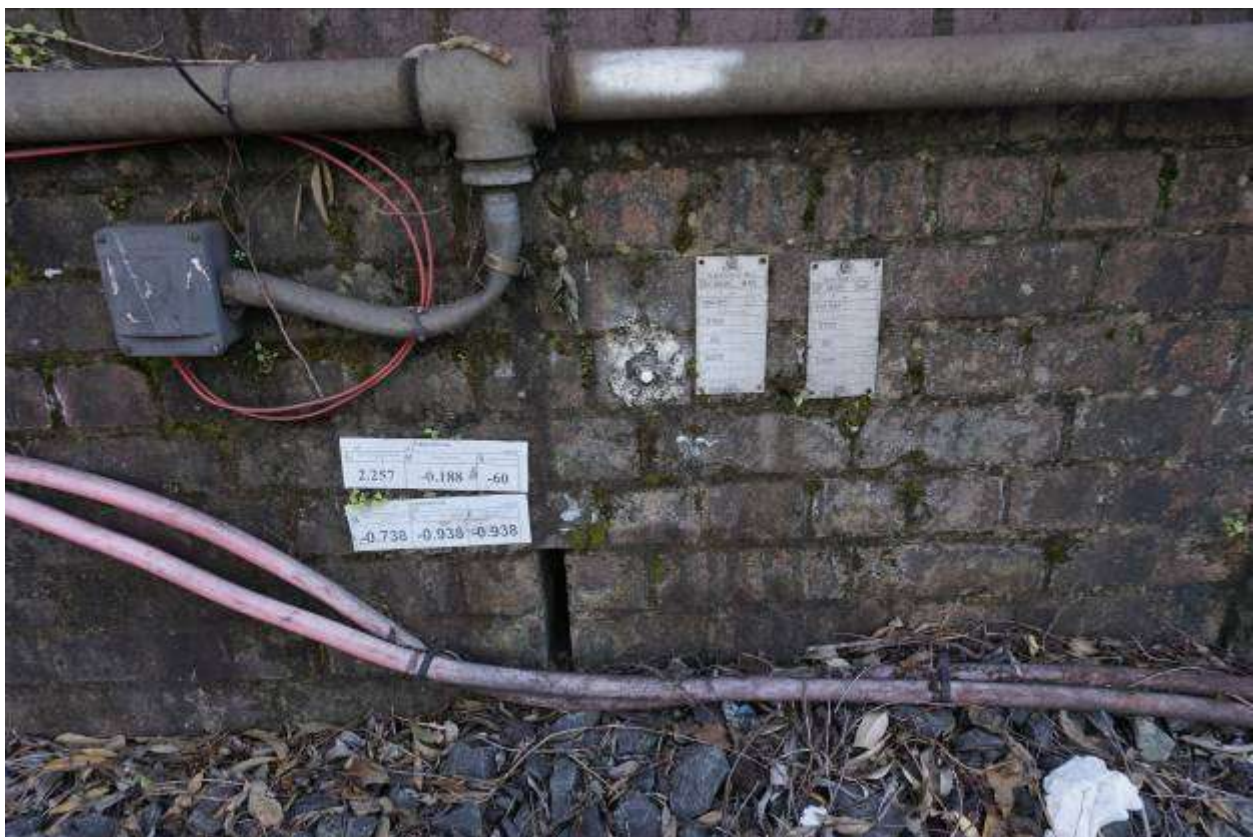
Figure 268 – General condition of Survey Track Control Mark observed from Railway Corridor

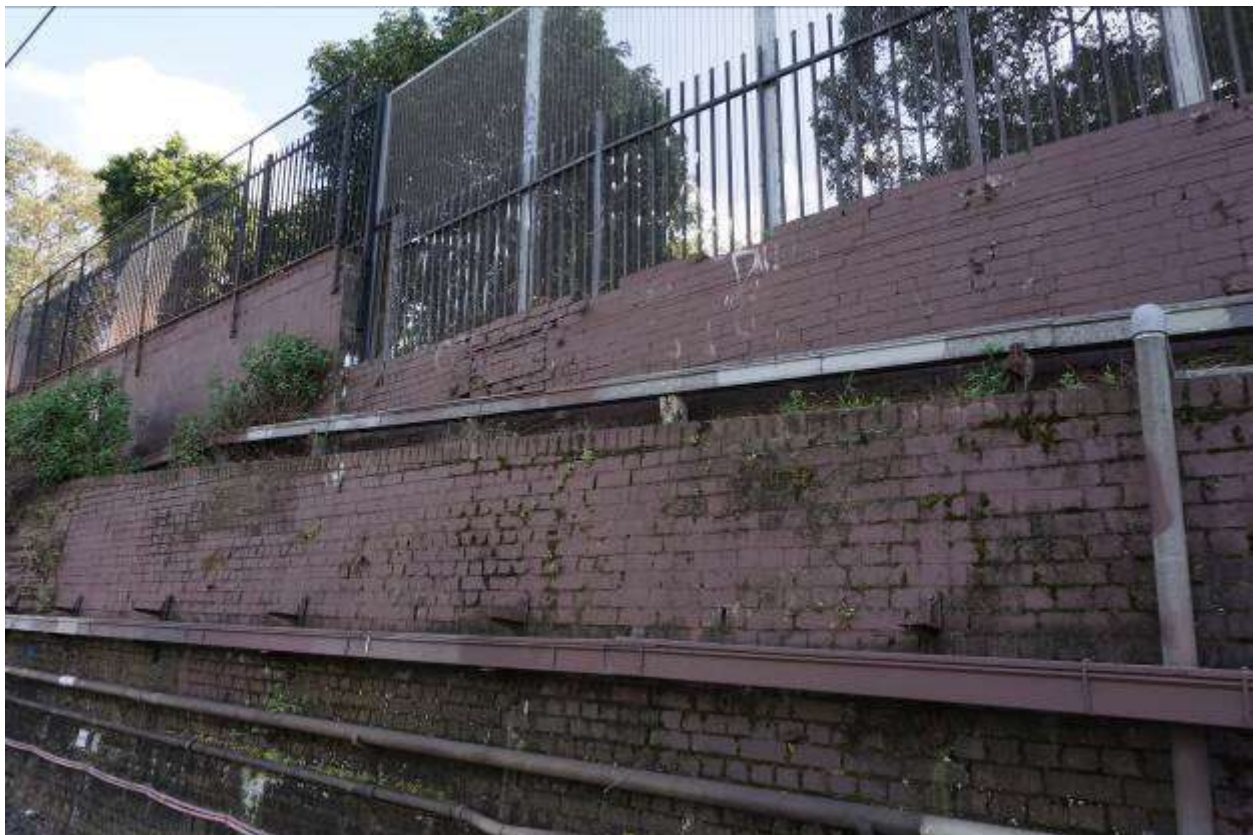
Figure 270 – General condition of RailCorp signal troughing observed from Railway Corridor

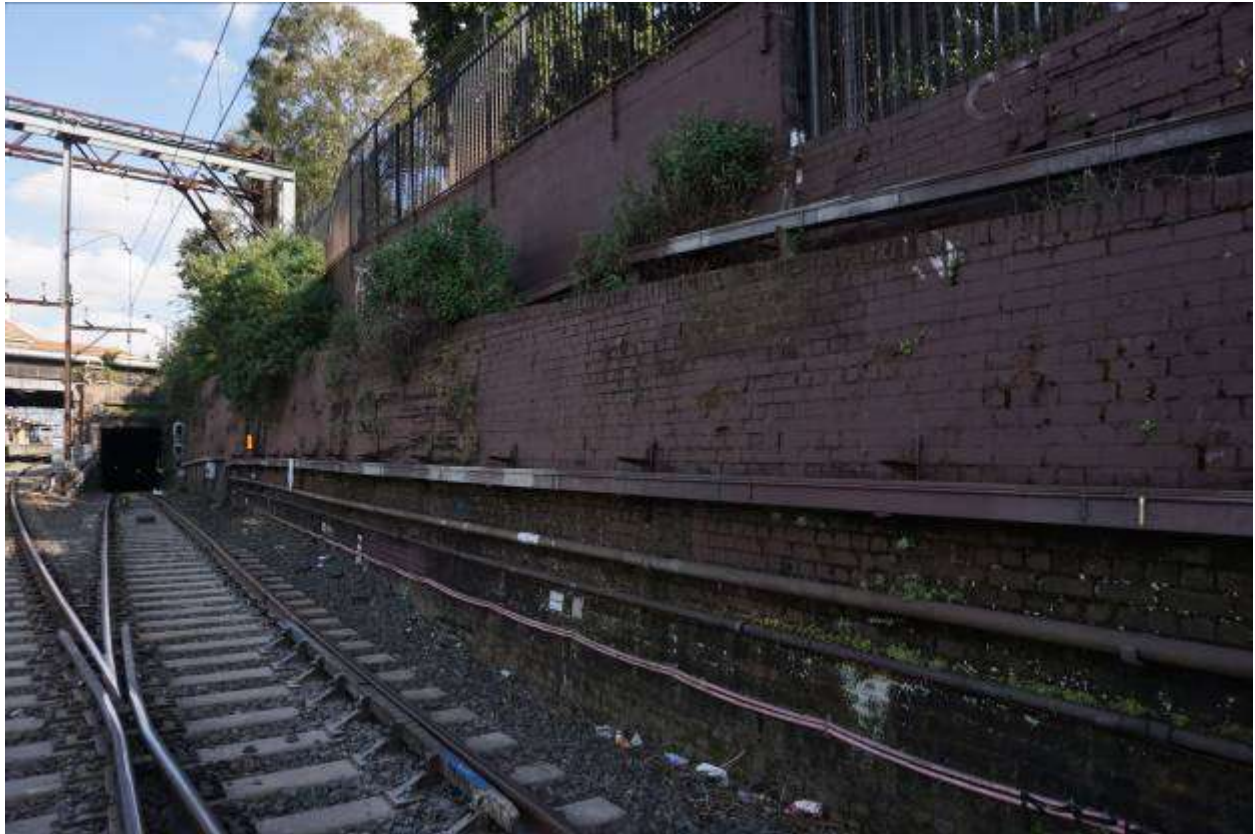
Figure 271 – General condition of RailCorp signal troughing observed from Railway Corridor
