Re: Dilapidation Report for Property
No: Pemulwuy Project - Redfern NSW 2016

Job: 170037.0
Date: MAY 2017

SUMMARY

This report serves as a record of the condition of the RailCorp infrastructure assets of the "Metro Illawarra & South Coast" line, which is adjacent to the subject site, prior to the commencement of any works proposed at: Pemulwuy Project - Redfern NSW 2016.

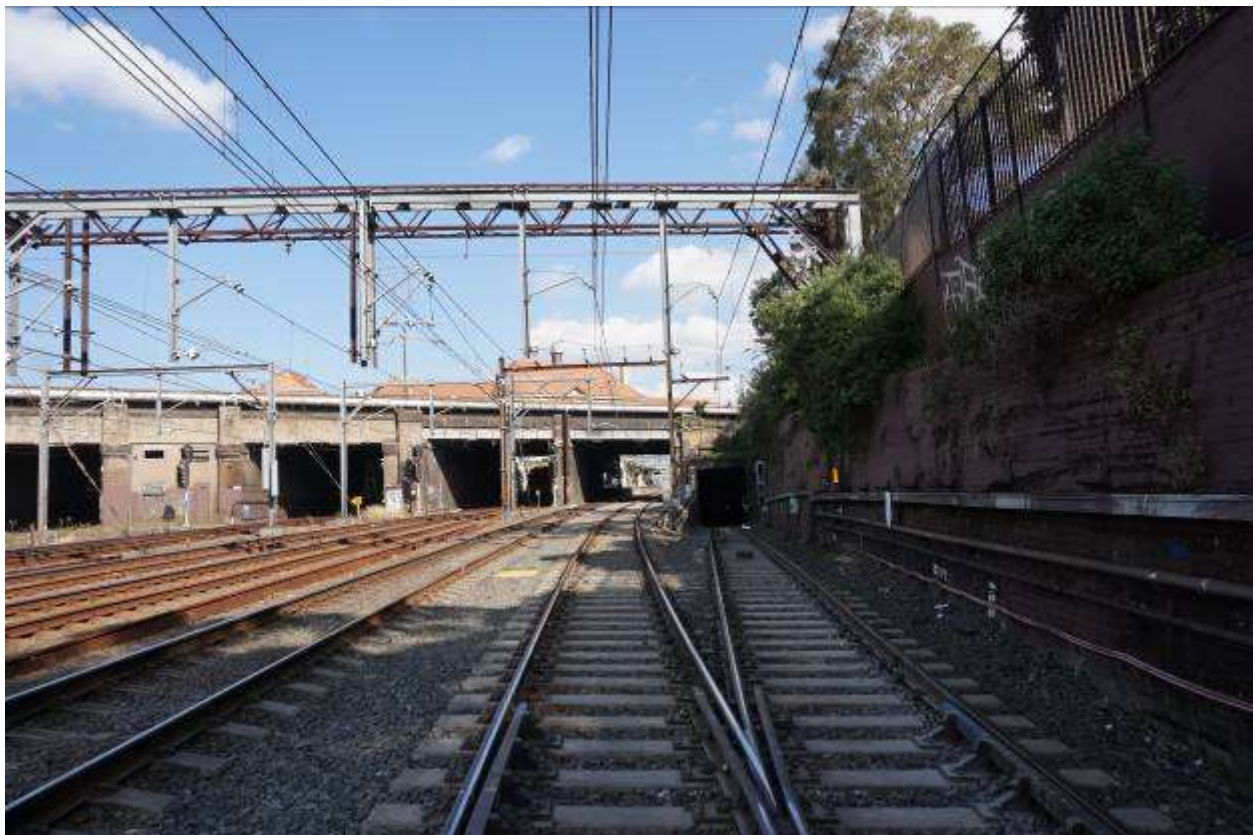
Figure 272 – General condition of steel portal haunch and overhead power supply system observed from Railway Corridor

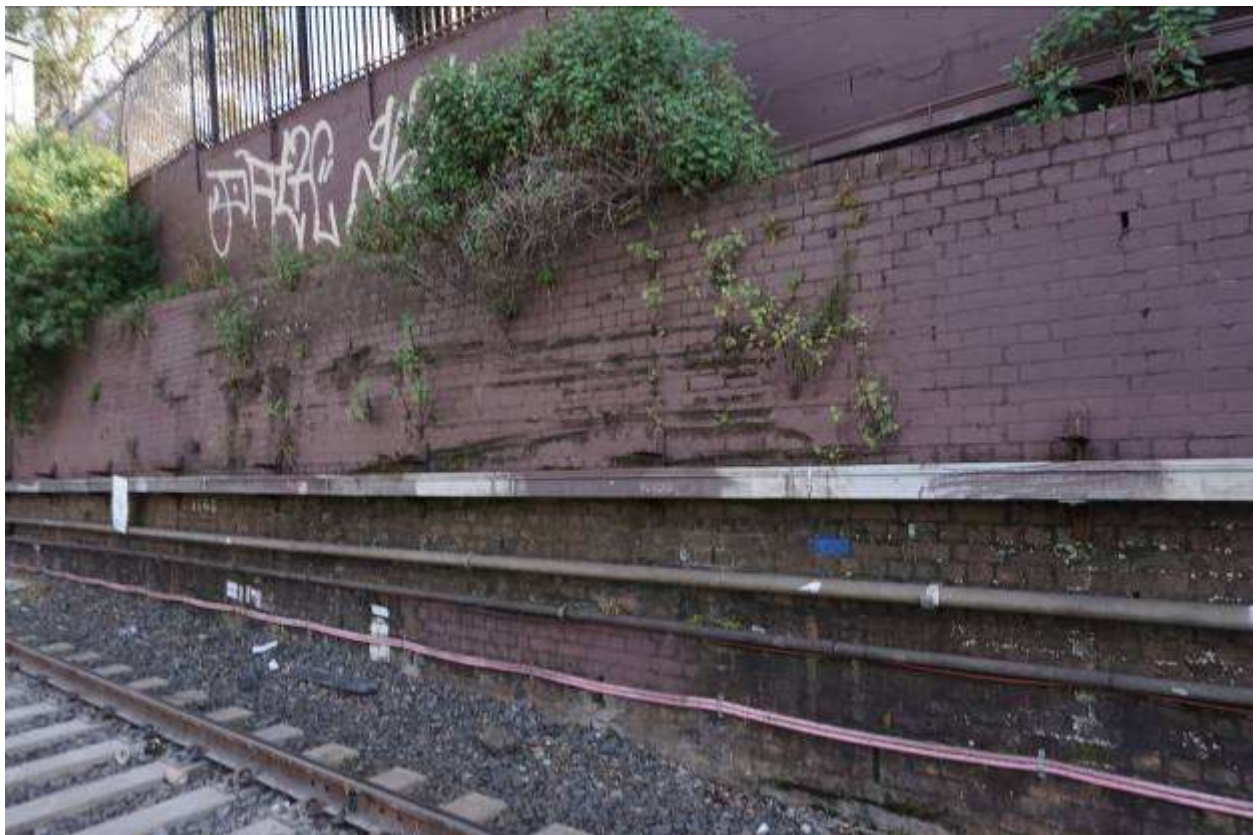
Figure 274 – General condition of RailCorp signal troughing observed from Railway Corridor

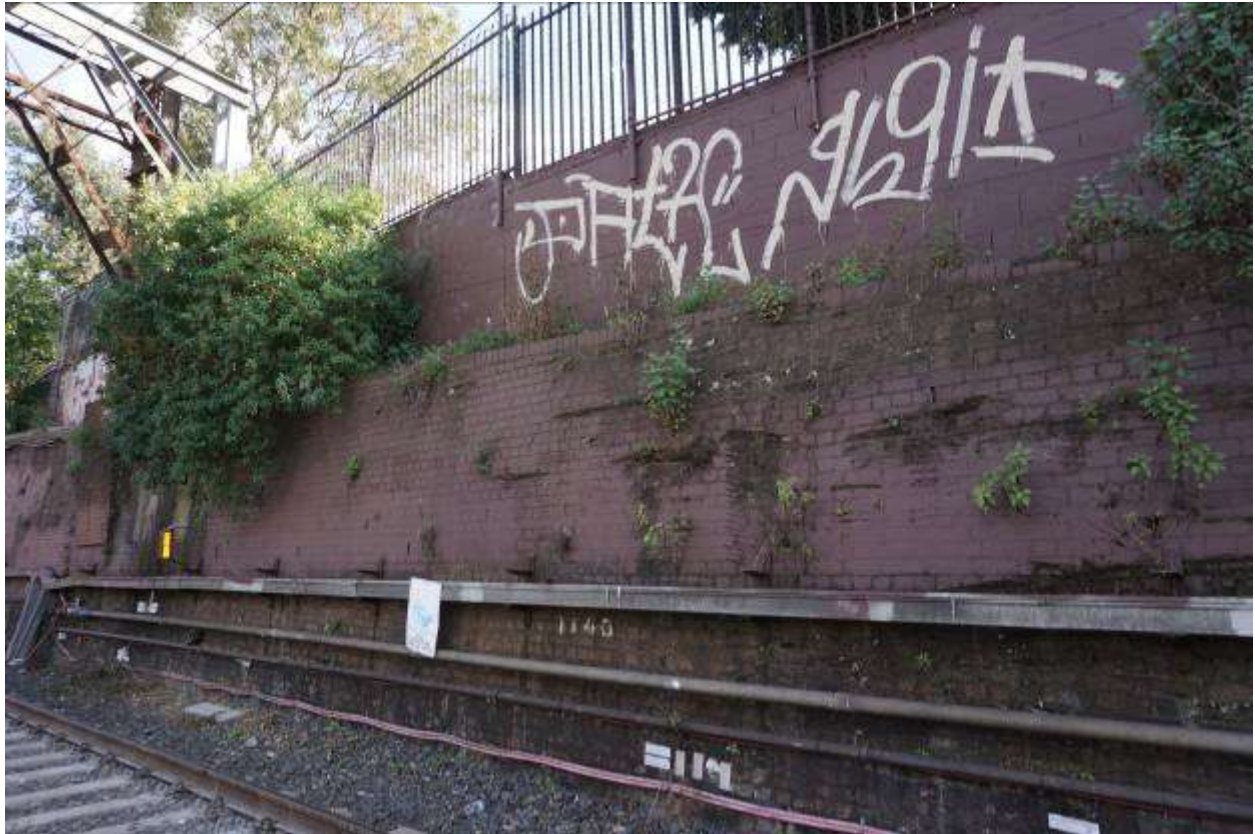
Figure 275 – General condition of RailCorp signal troughing observed from Railway Corridor

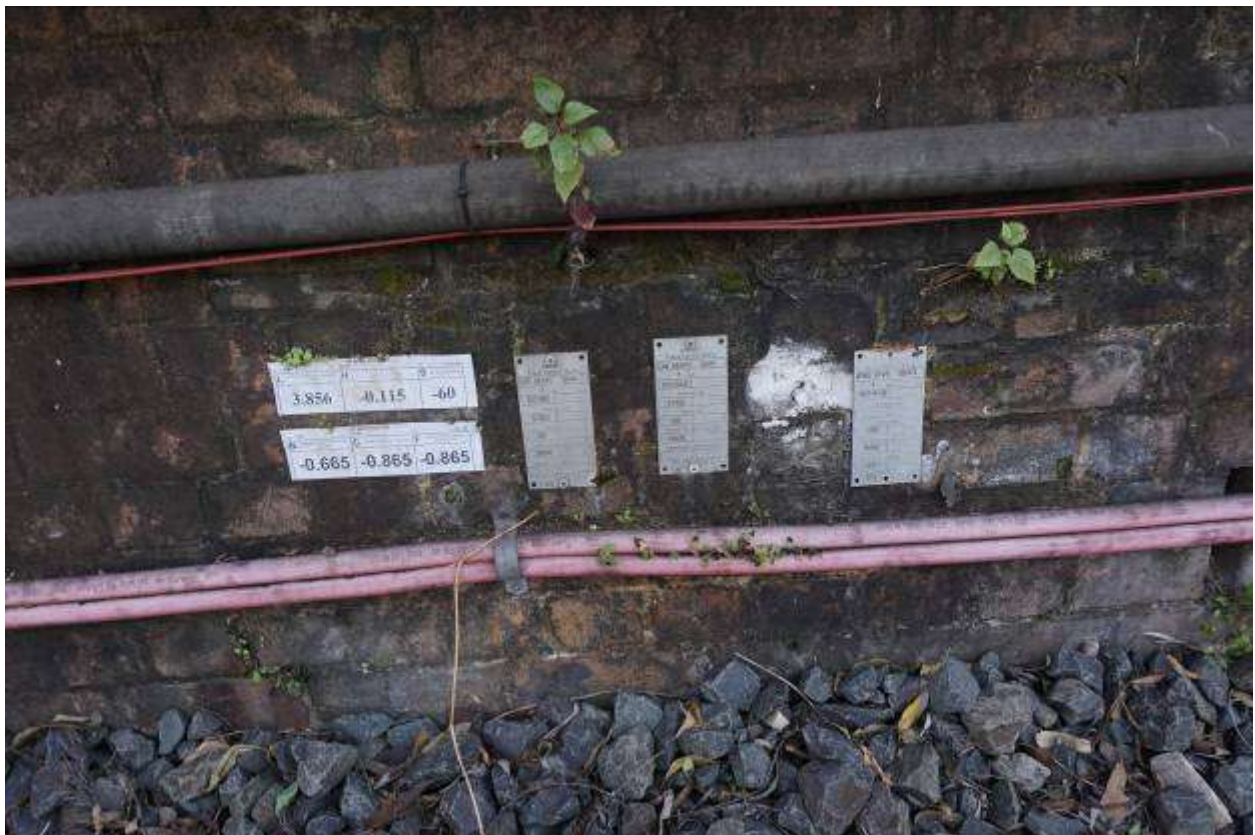
Figure 276 – General condition of Survey Track Control Mark observed from Railway Corridor

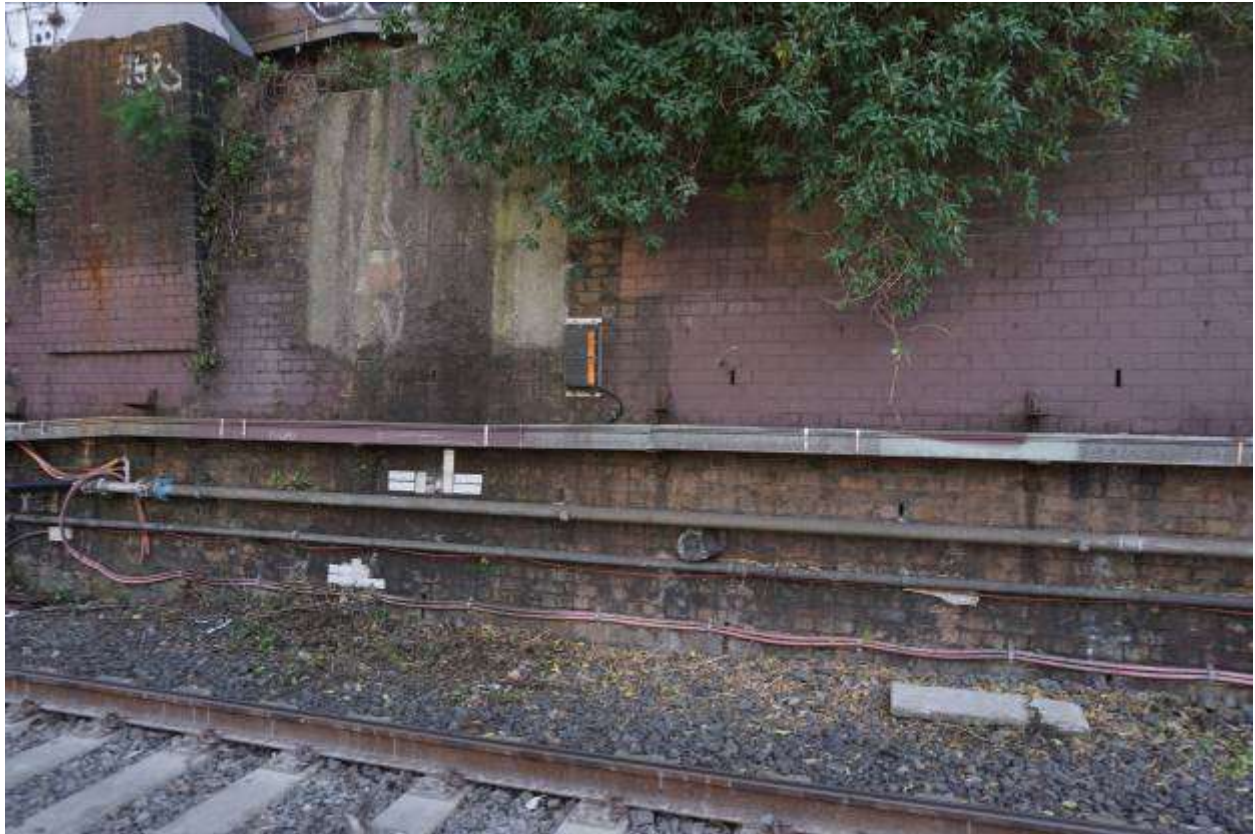
Figure 277 – General condition of RailCorp signal troughing observed from Railway Corridor

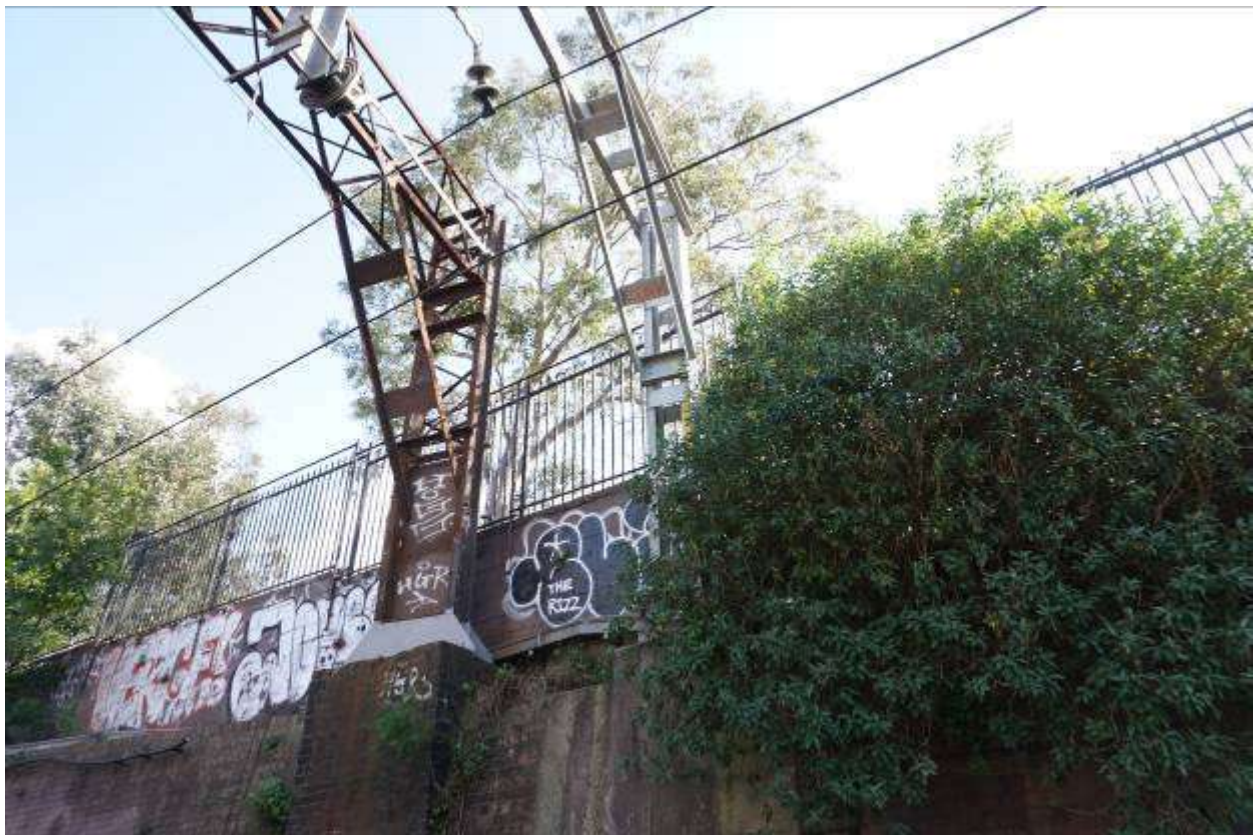
Figure 278 – General condition of steel portal haunch observed from Railway Corridor

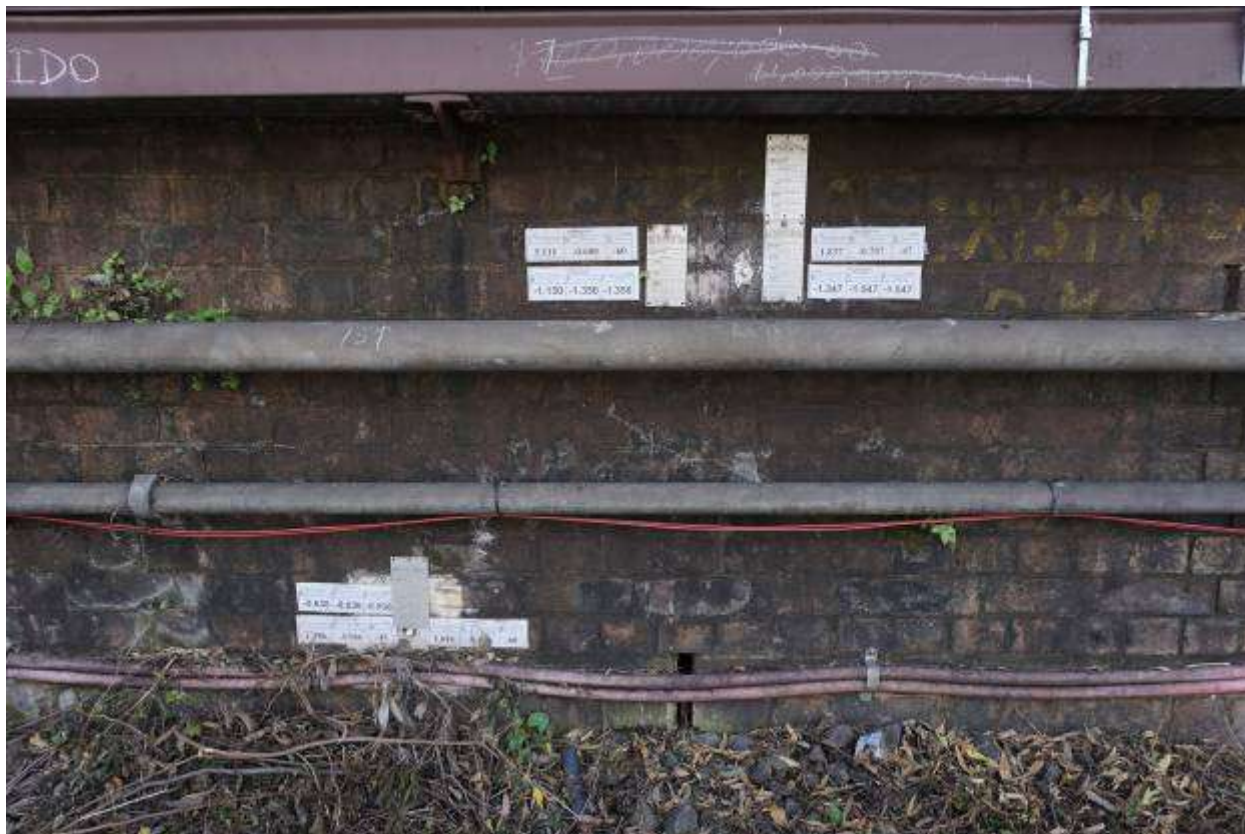
Figure 279 – General condition of Survey Track Control Mark observed from Railway Corridor

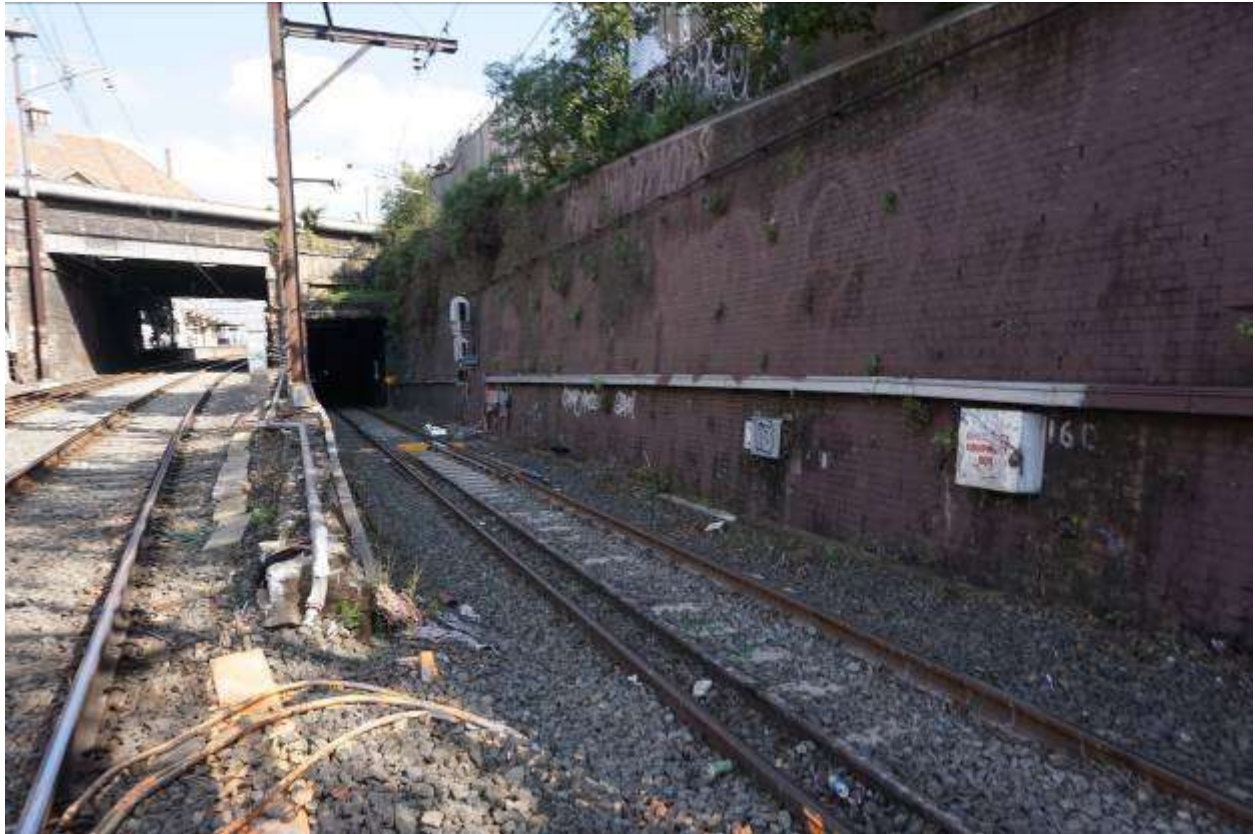
Figure 281 – General condition of RailCorp signal troughing observed from Railway Corridor

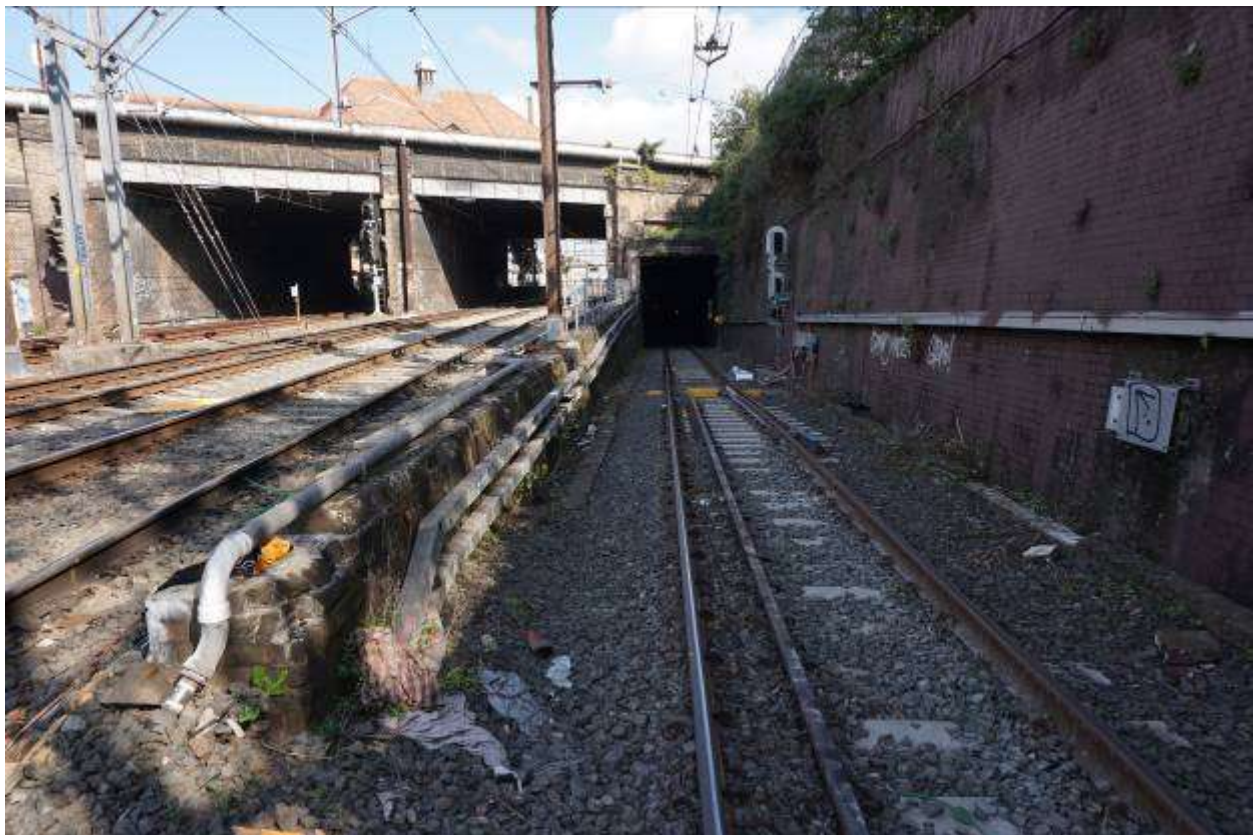
Figure 282 – General condition of railway corridor observed from Railway Corridor

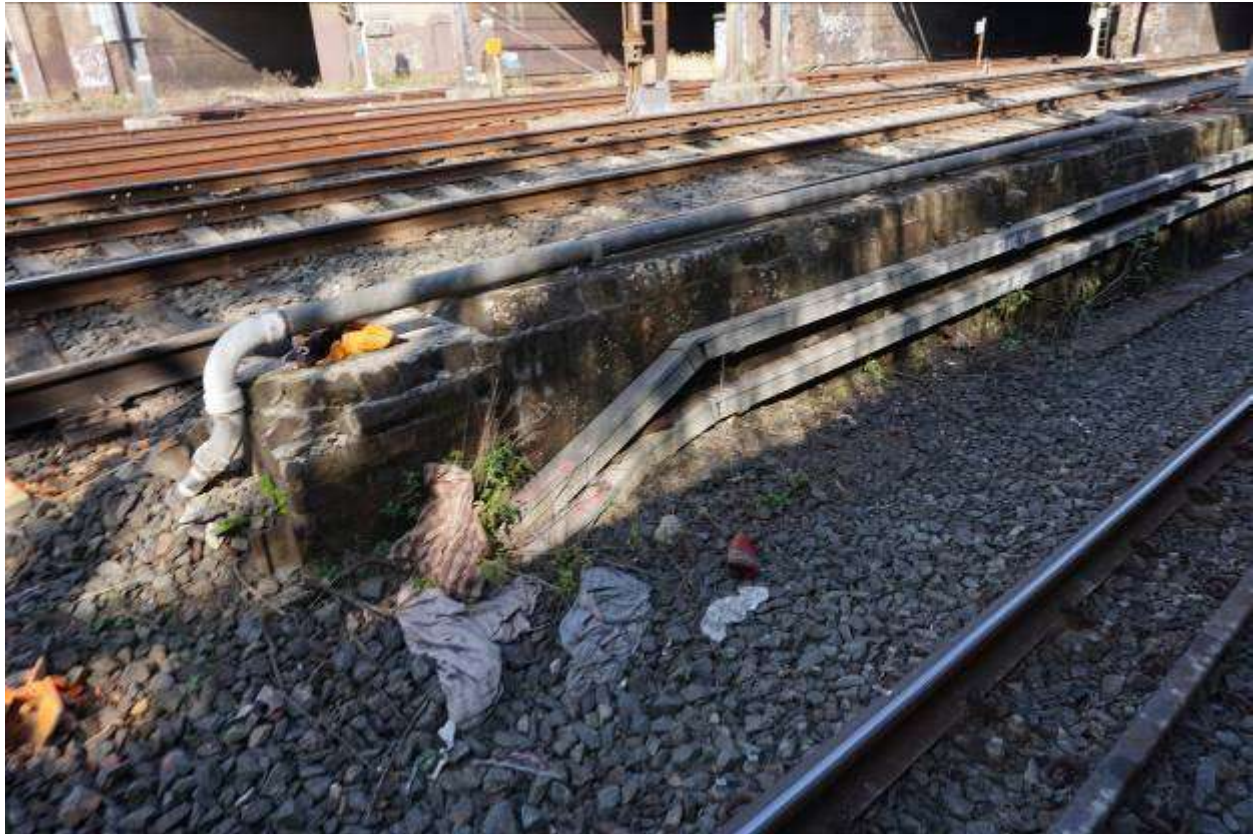
Figure 283 – General condition of RailCorp signal troughing observed from Railway Corridor

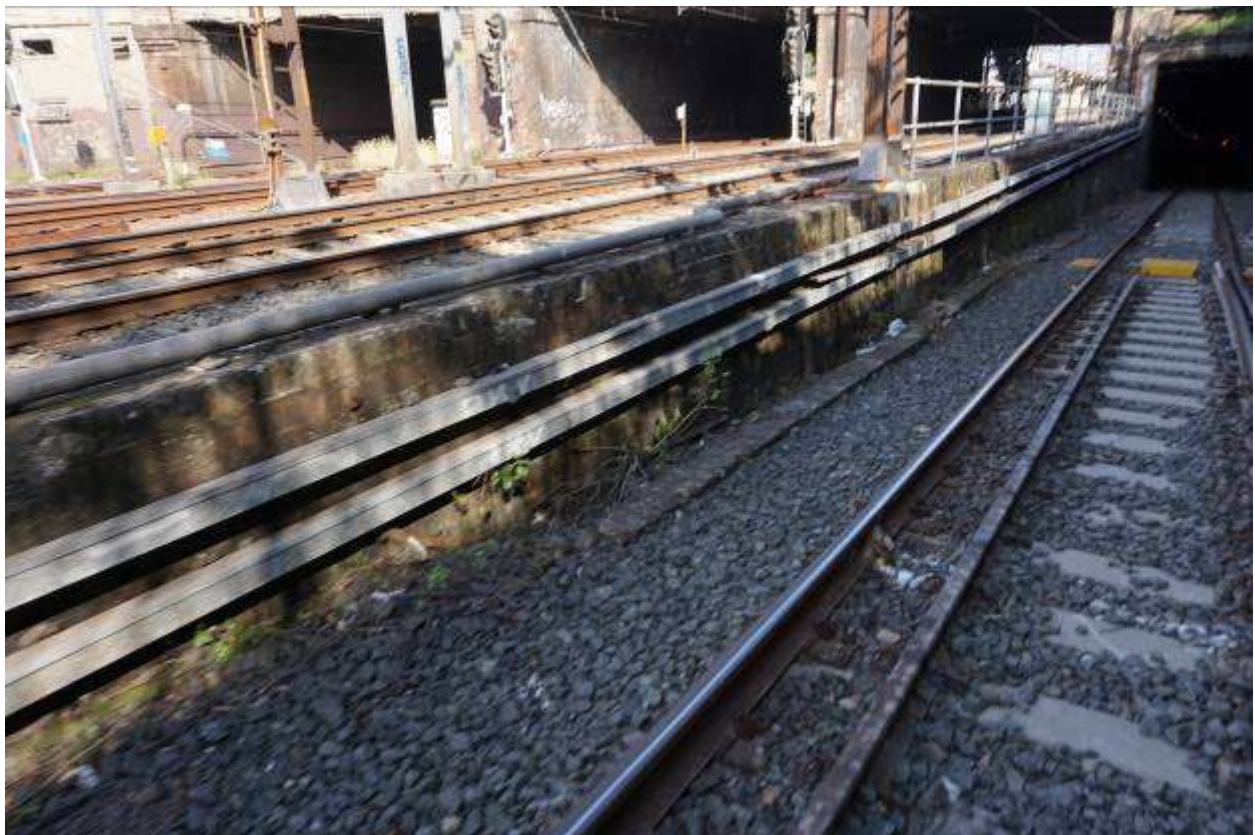
Figure 284 – General condition of RailCorp signal troughing observed from Railway Corridor

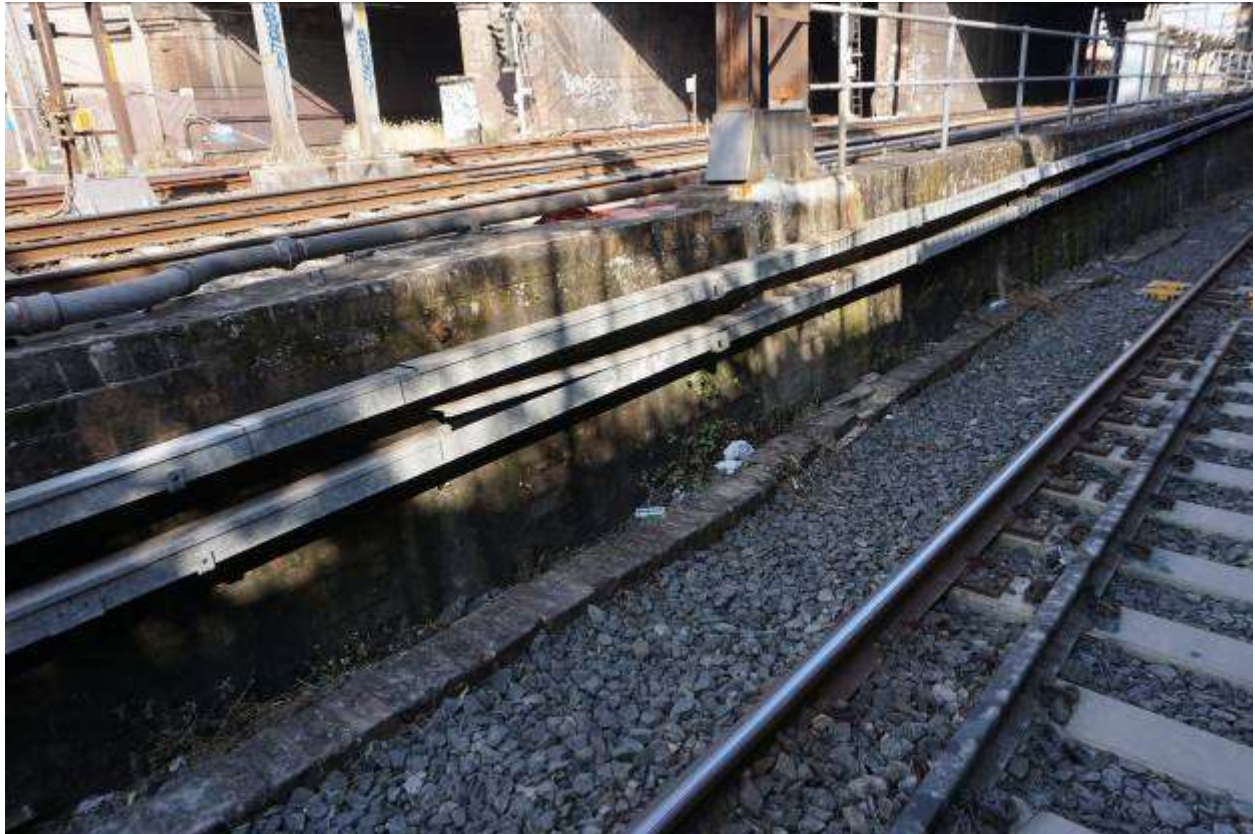
Figure 285 – General condition of RailCorp signal troughing observed from Railway Corridor

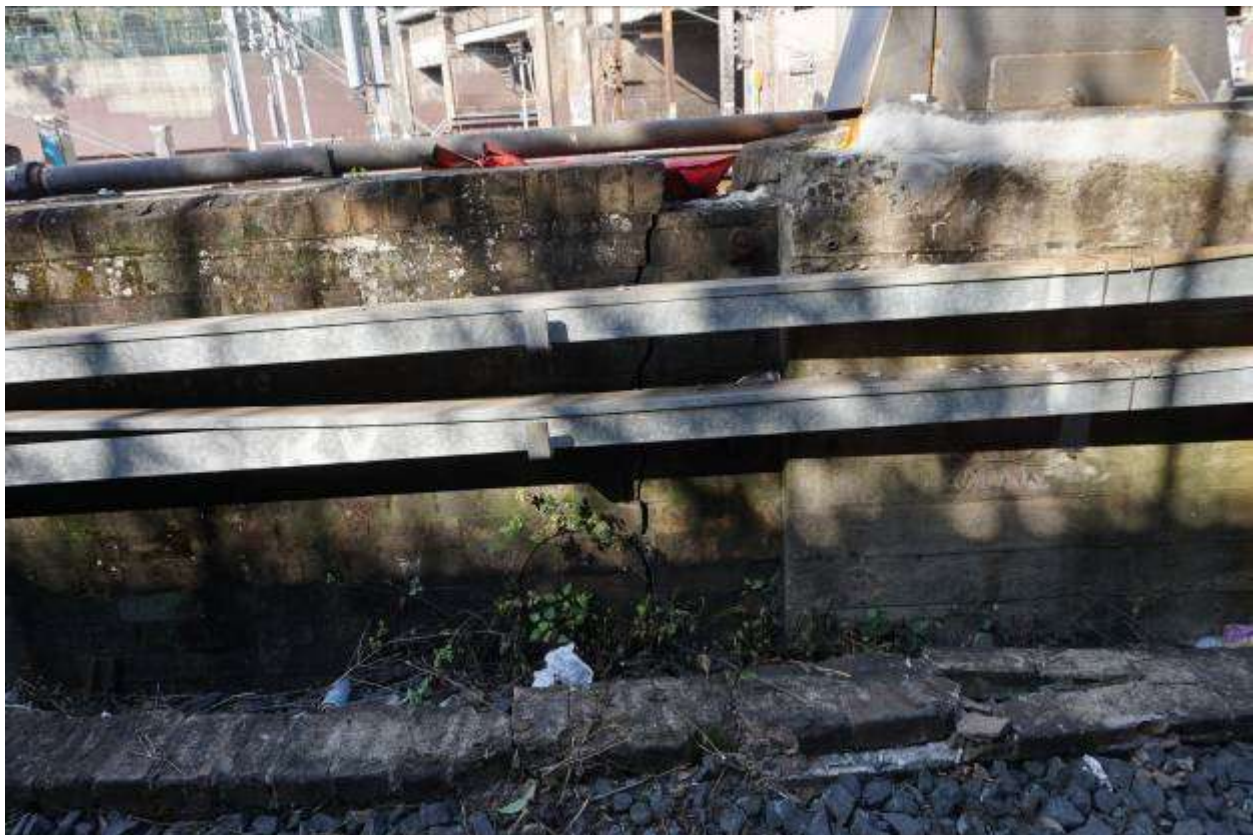
Figure 286 – Crack propagation through retaining wall adjacent to RailCorp signal troughing observed from Railway Corridor

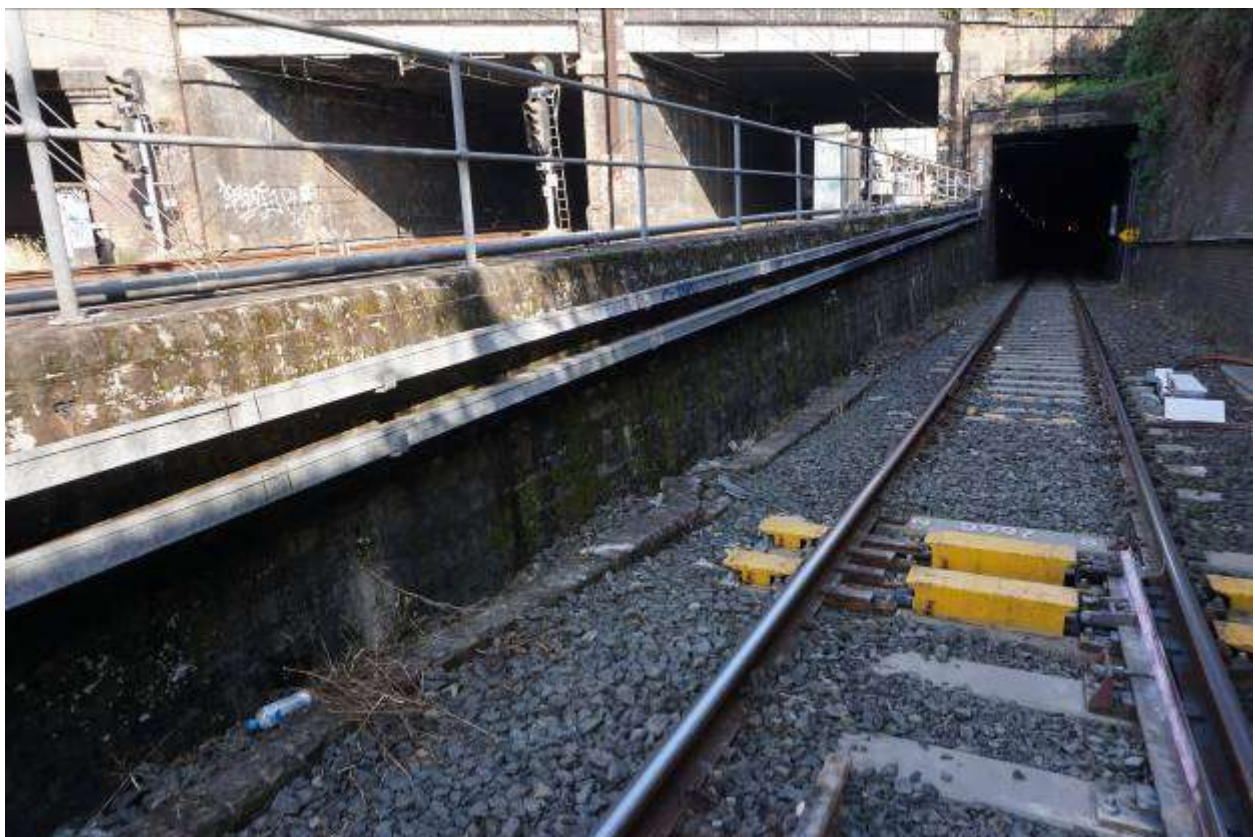
Figure 288 – General condition of RailCorp signal troughing observed from Railway Corridor

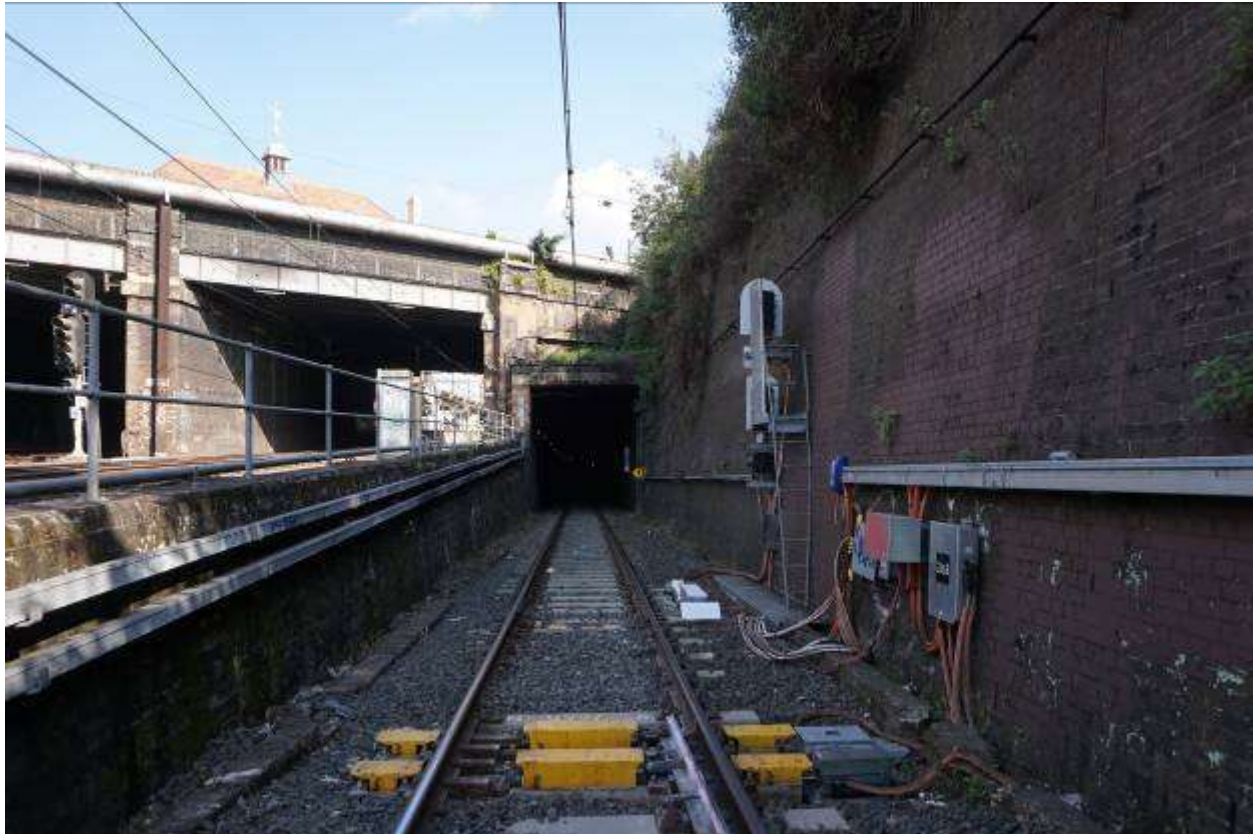
Figure 289 – General condition of railway corridor observed from Railway Corridor

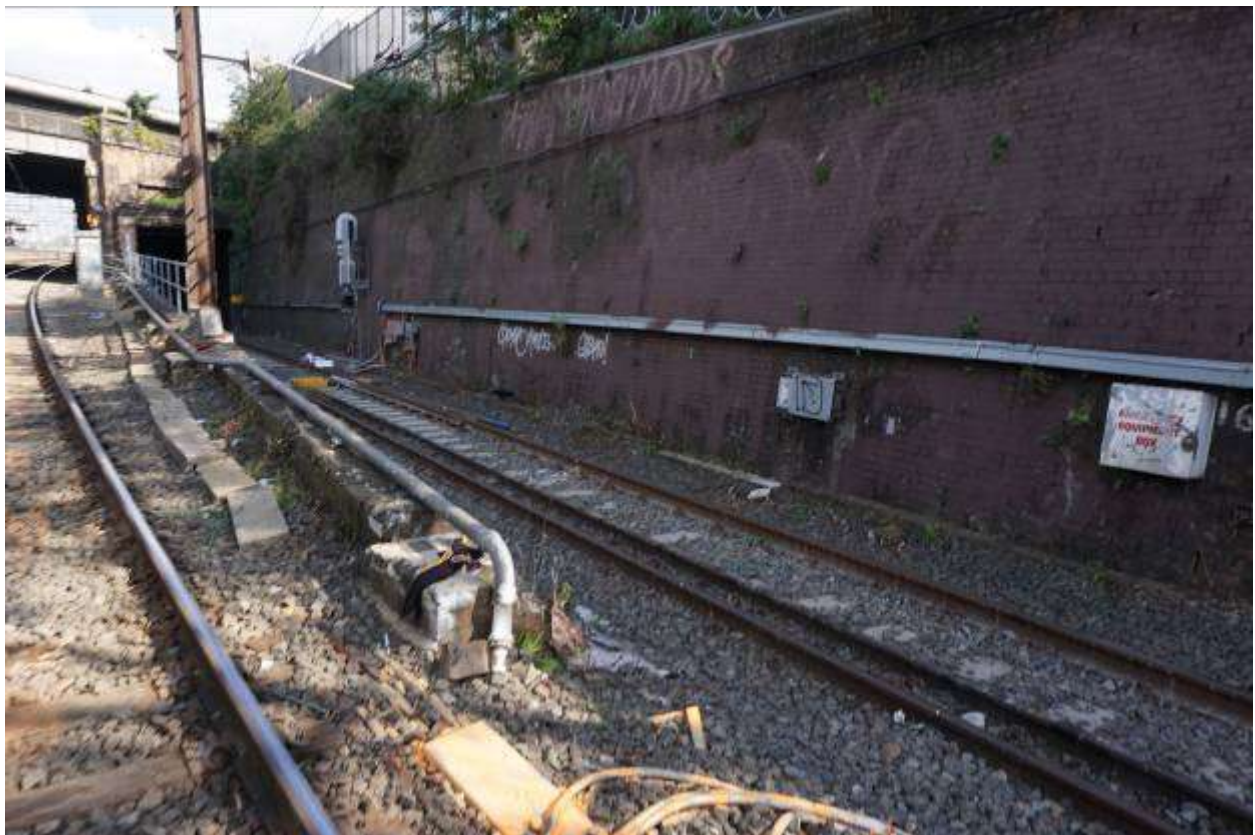
Figure 290 – General condition of RailCorp signal troughing observed from Railway Corridor

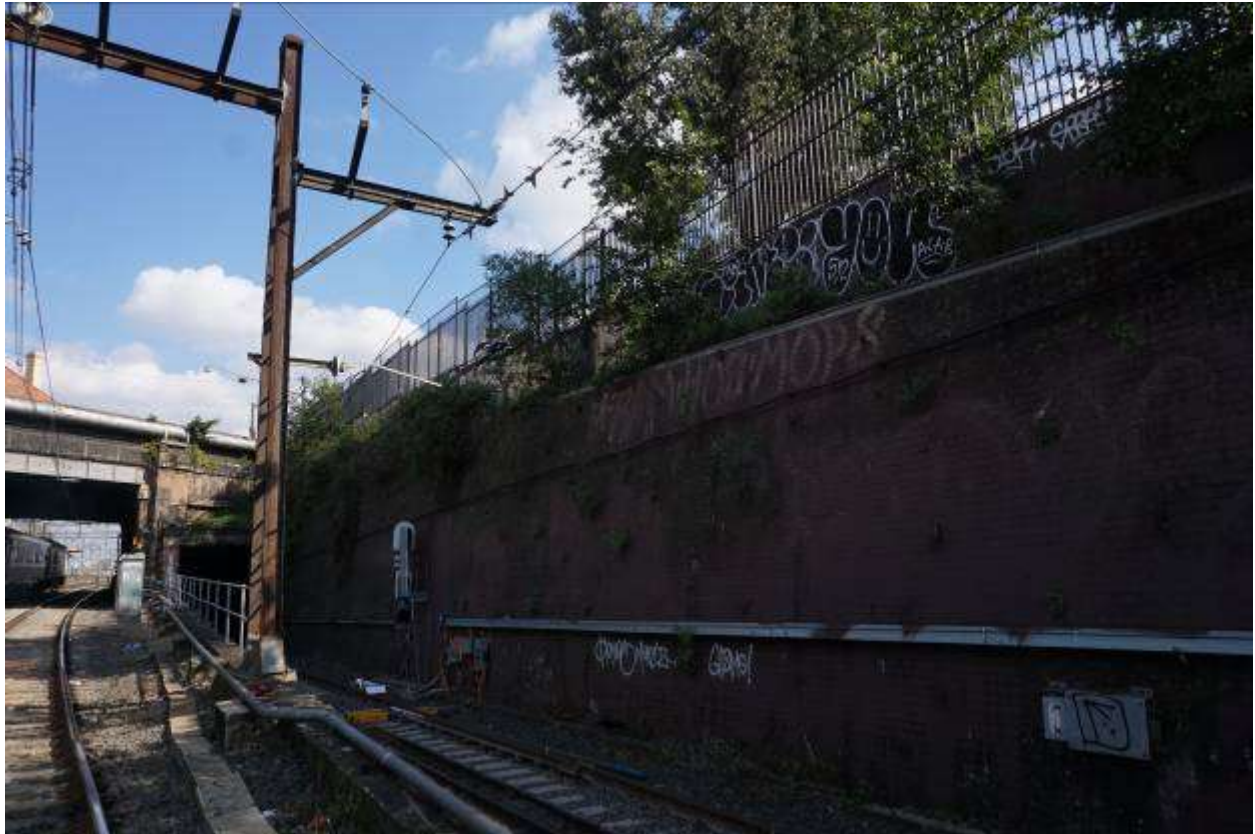
Figure 291 – General condition of steel portal haunch and overhead power supply system observed from Railway Corridor

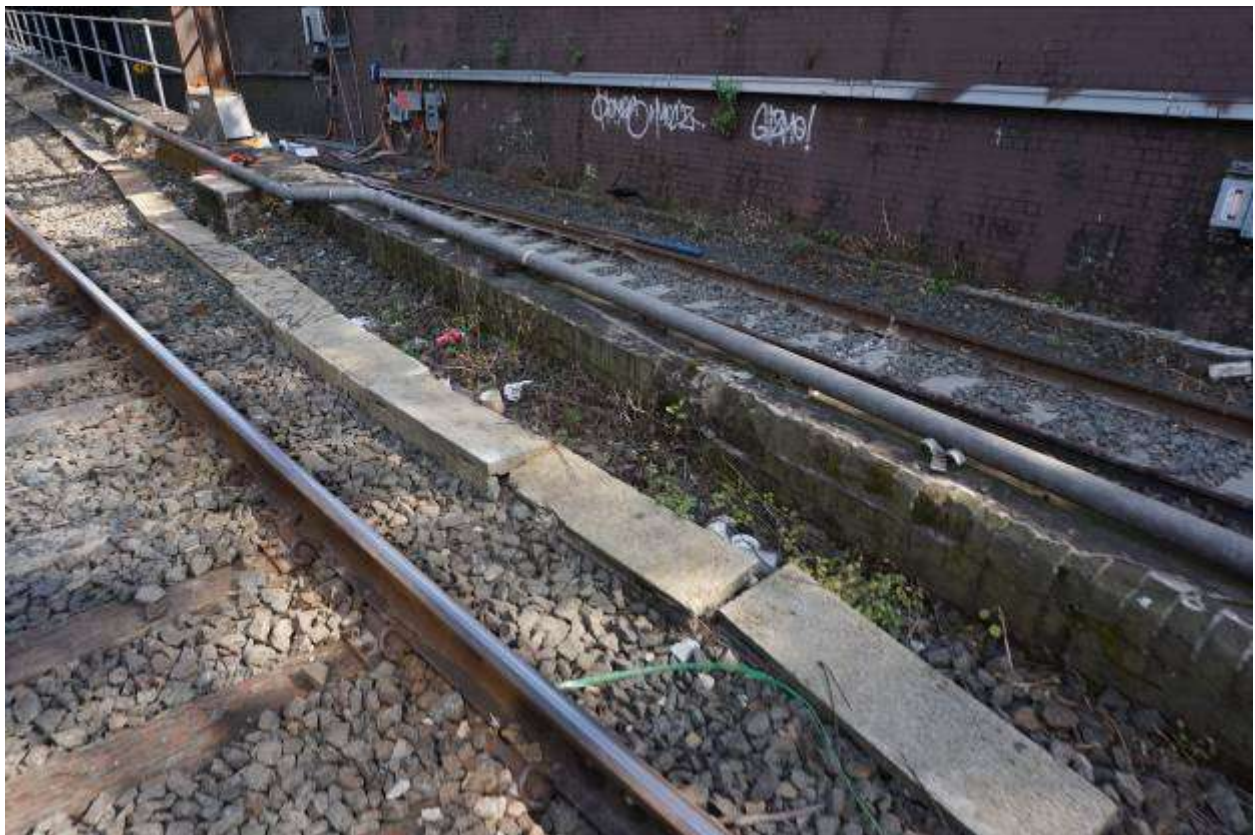
Figure 292 – General condition of railway retaining wall observed from Railway Corridor

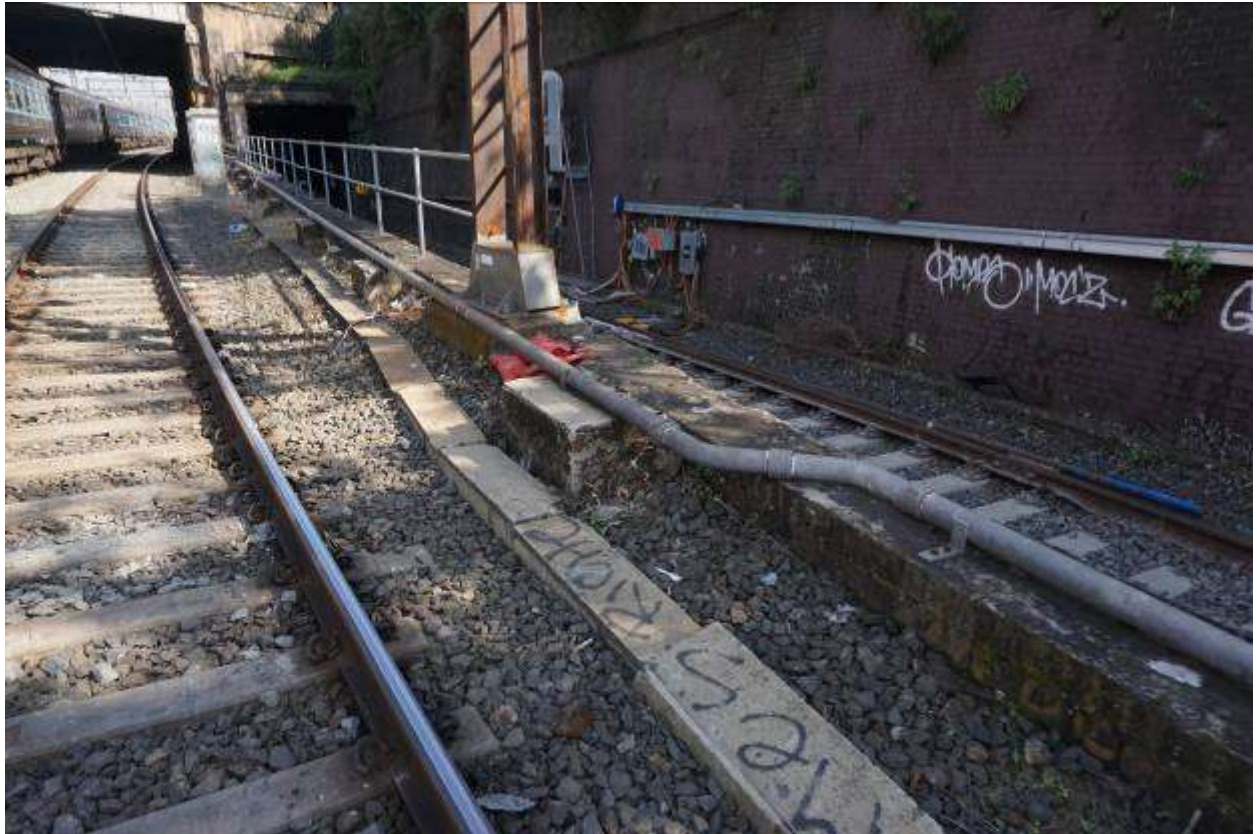
Figure 293 – General condition of railway corridor observed from Railway Corridor

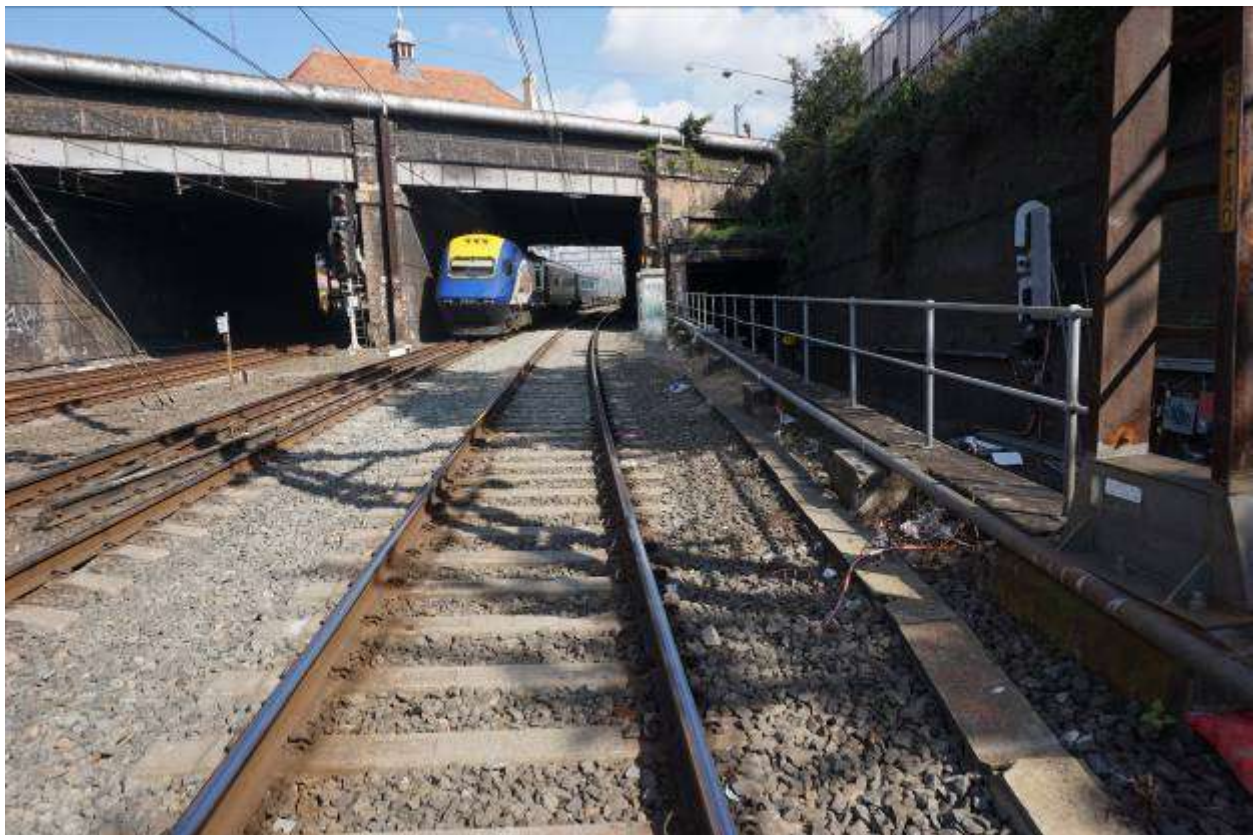
Figure 294 – General condition of railway corridor observed from Railway Corridor

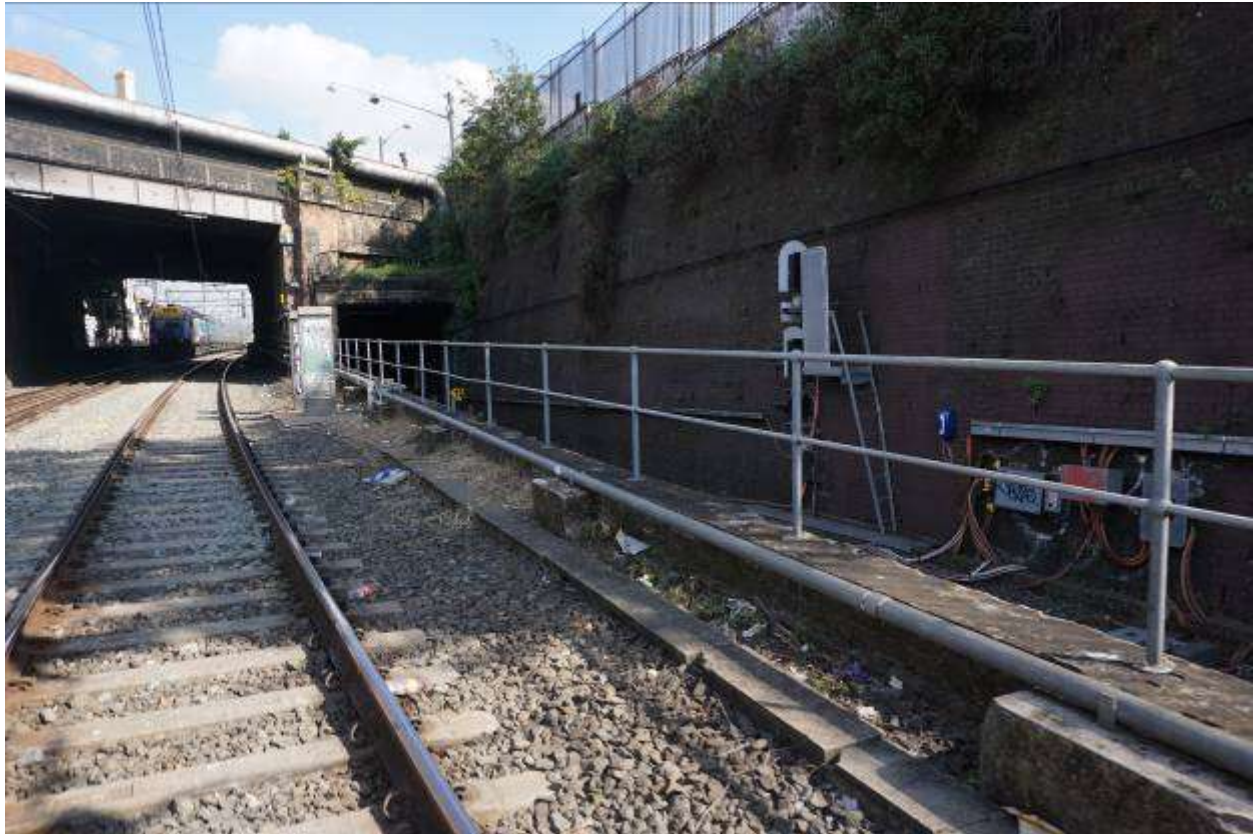
Figure 295 – General condition of railway corridor observed from Railway Corridor
