Re: Dilapidation Report for Property
No: Pemulwuy Project - Redfern NSW 2016

Job: 170037.0
Date: MAY 2017

SUMMARY

This report serves as a record of the condition of the RailCorp infrastructure assets of the "Metro Illawarra & South Coast" line, which is adjacent to the subject site, prior to the commencement of any works proposed at: Pemulwuy Project - Redfern NSW 2016.

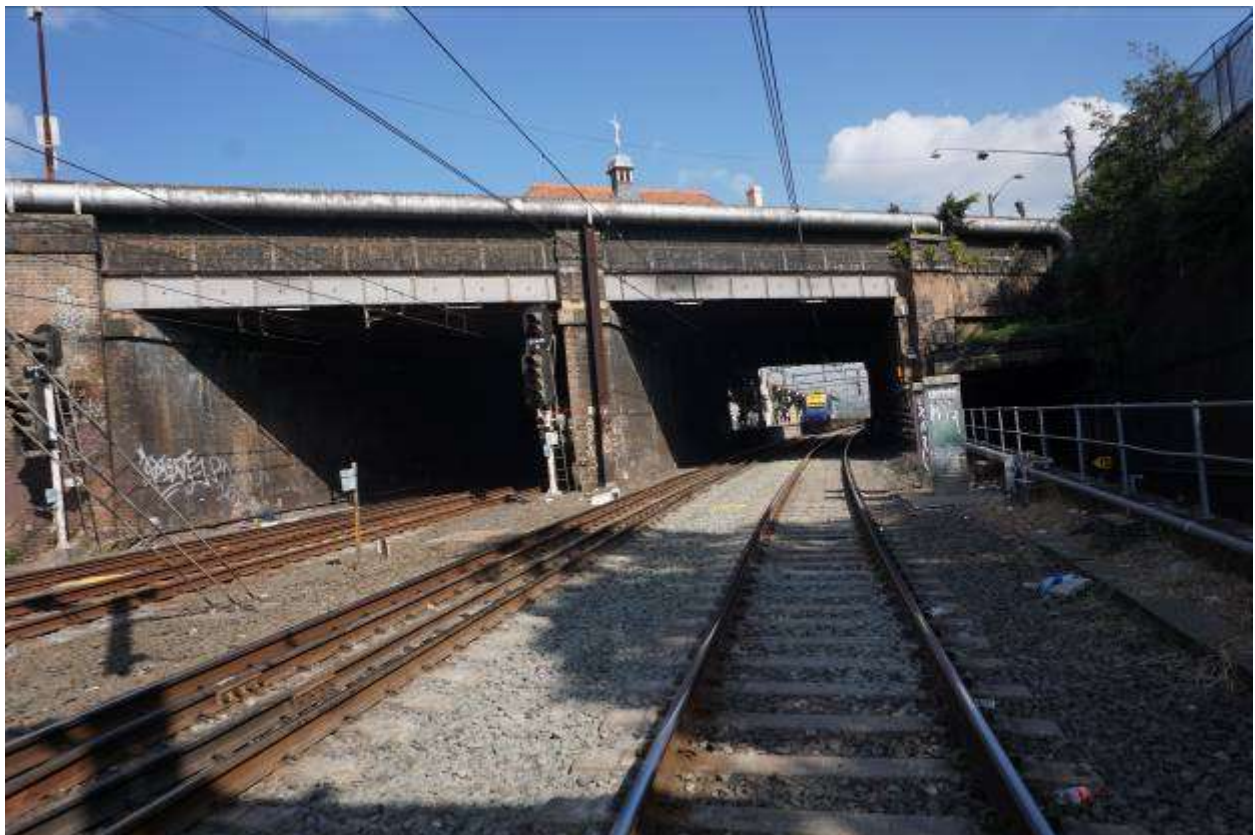
Figure 296 – General condition of railway corridor observed from Railway Corridor

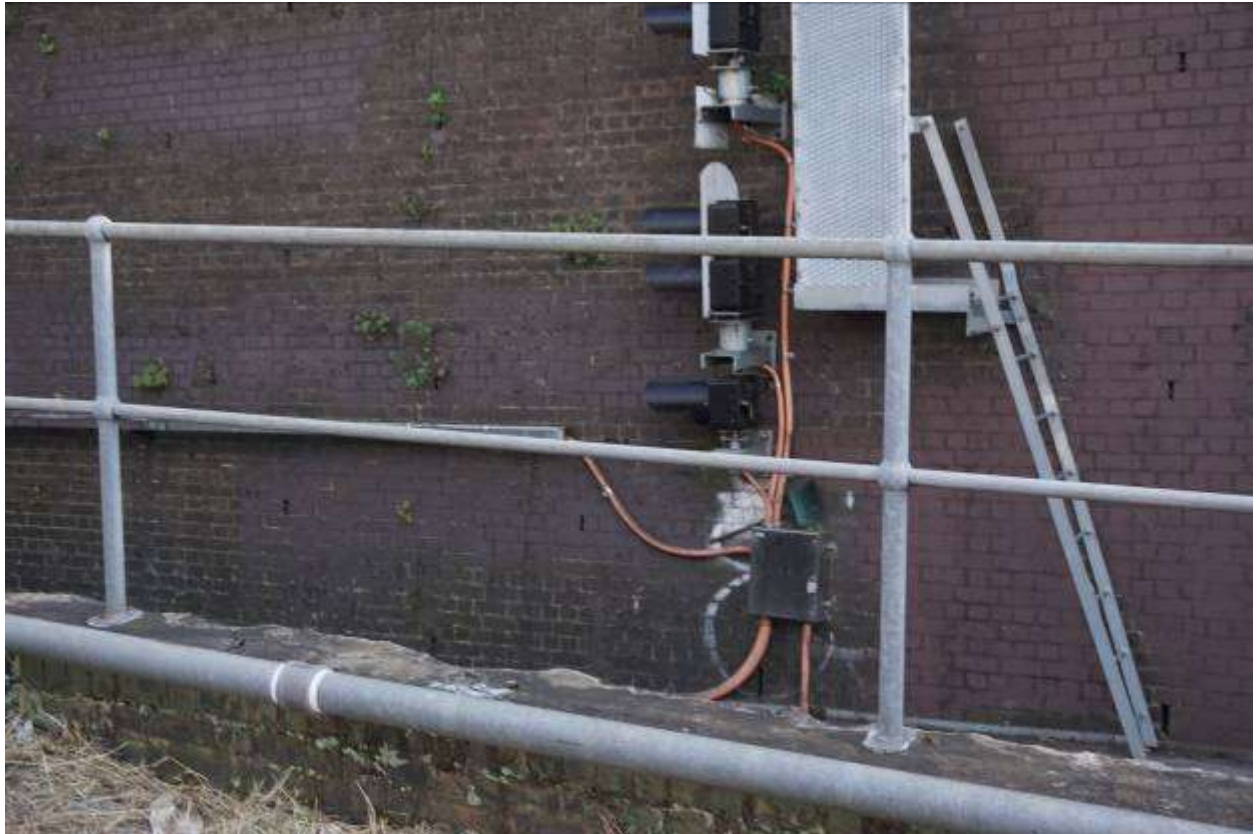
Figure 297 – General condition of RailCorp traffic signal observed from Railway Corridor

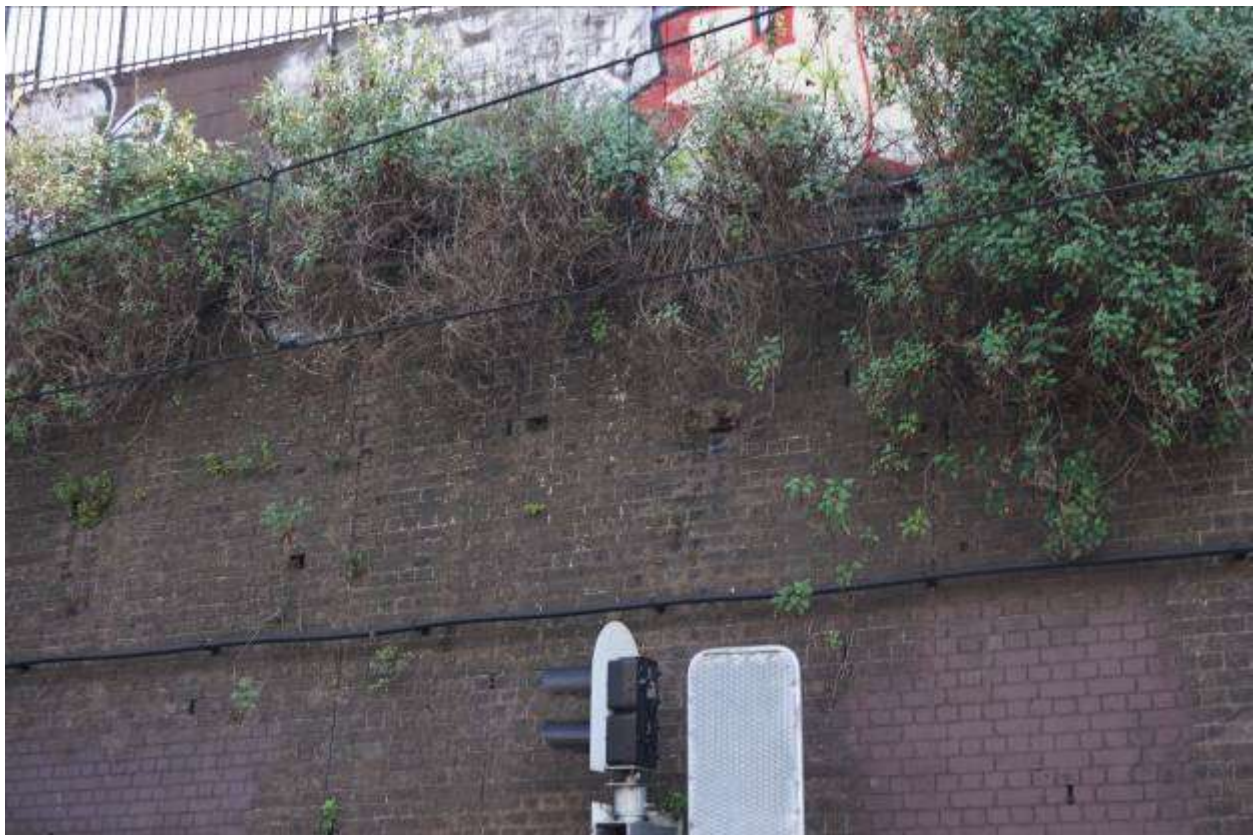
Figure 298 – General condition of overhead power supply system observed from Railway Corridor

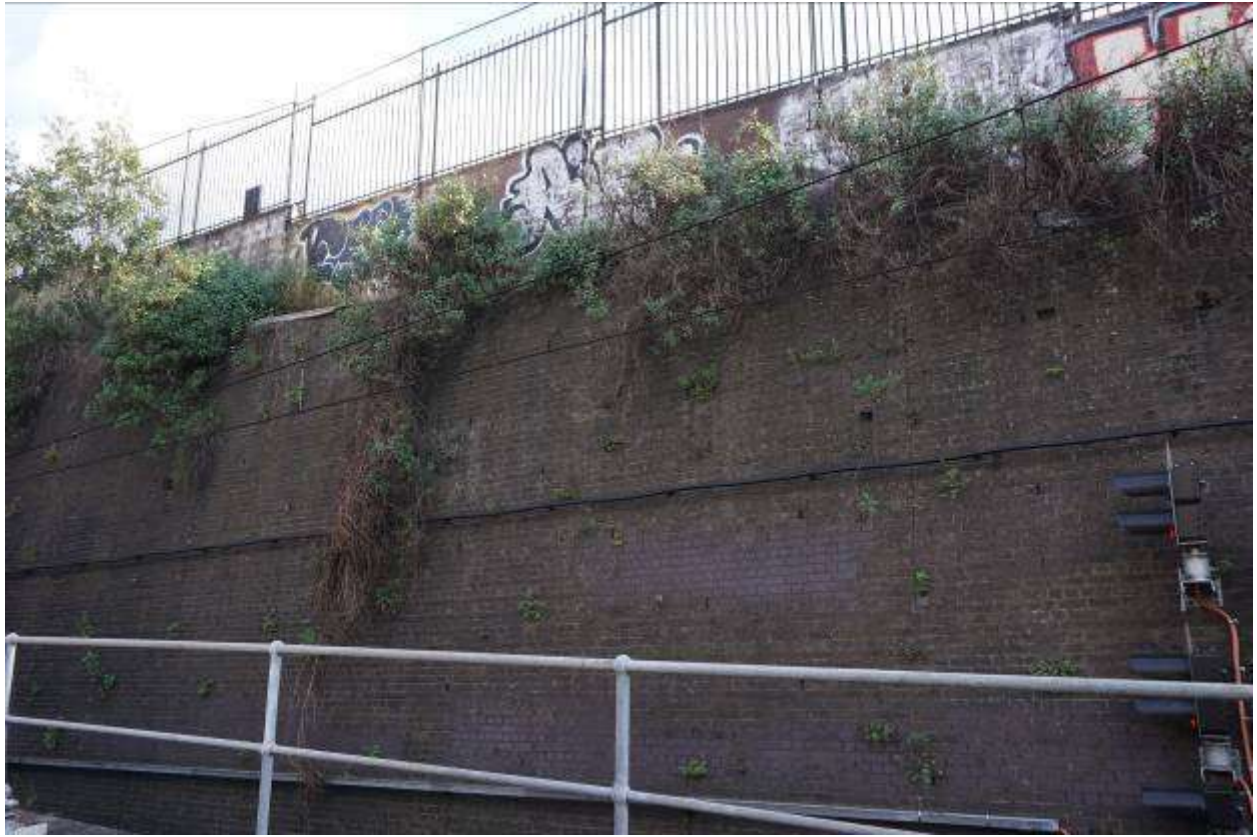
Figure 299 – General condition of overhead power supply system observed from Railway Corridor

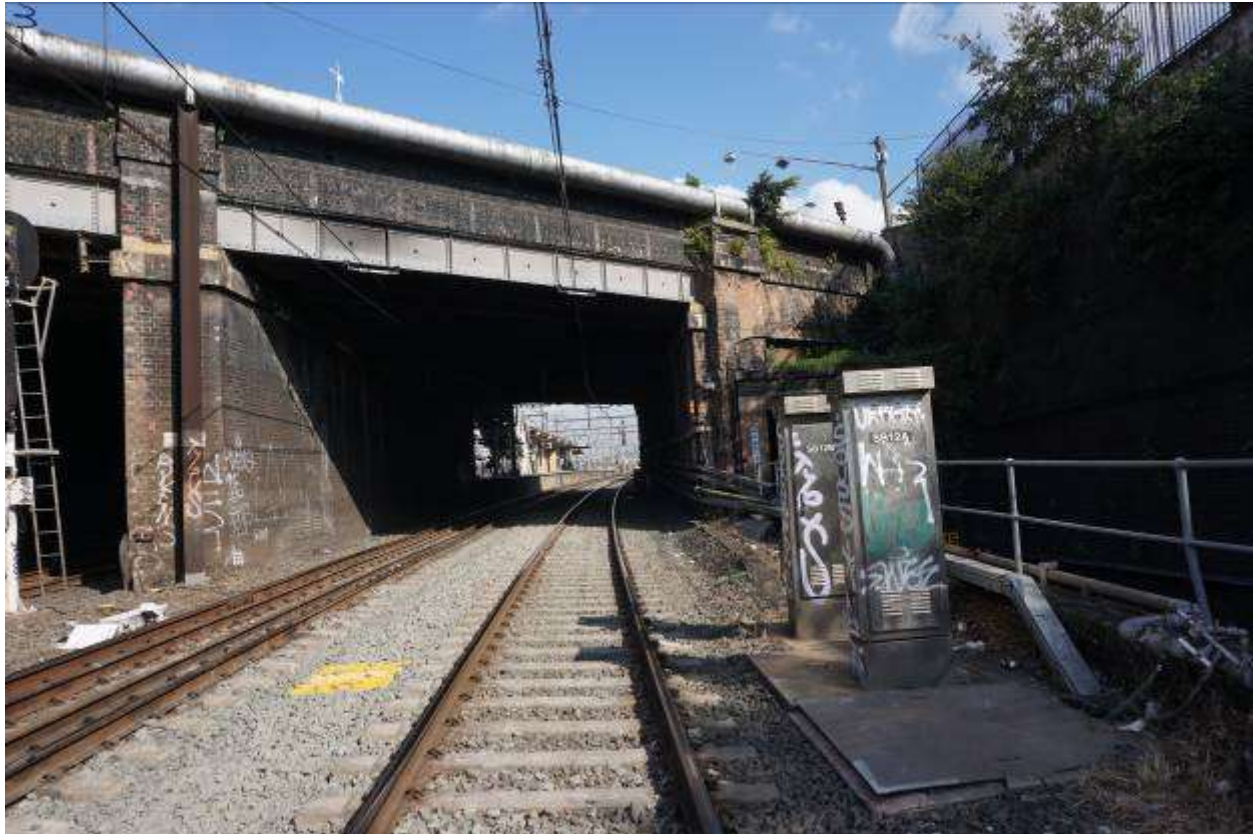
Figure 301 – General condition of railway corridor observed from Railway Corridor

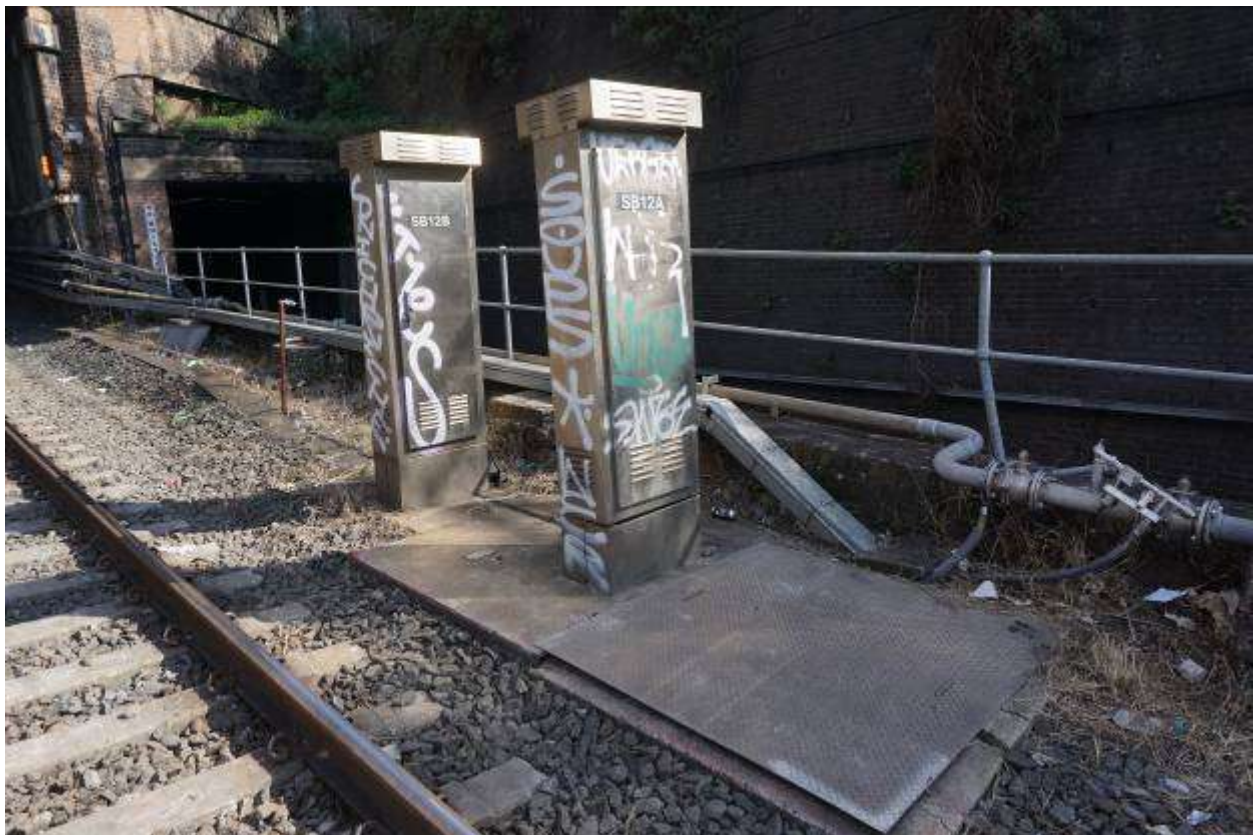
Figure 302 – General condition of RailCorp furniture observed from Railway Corridor

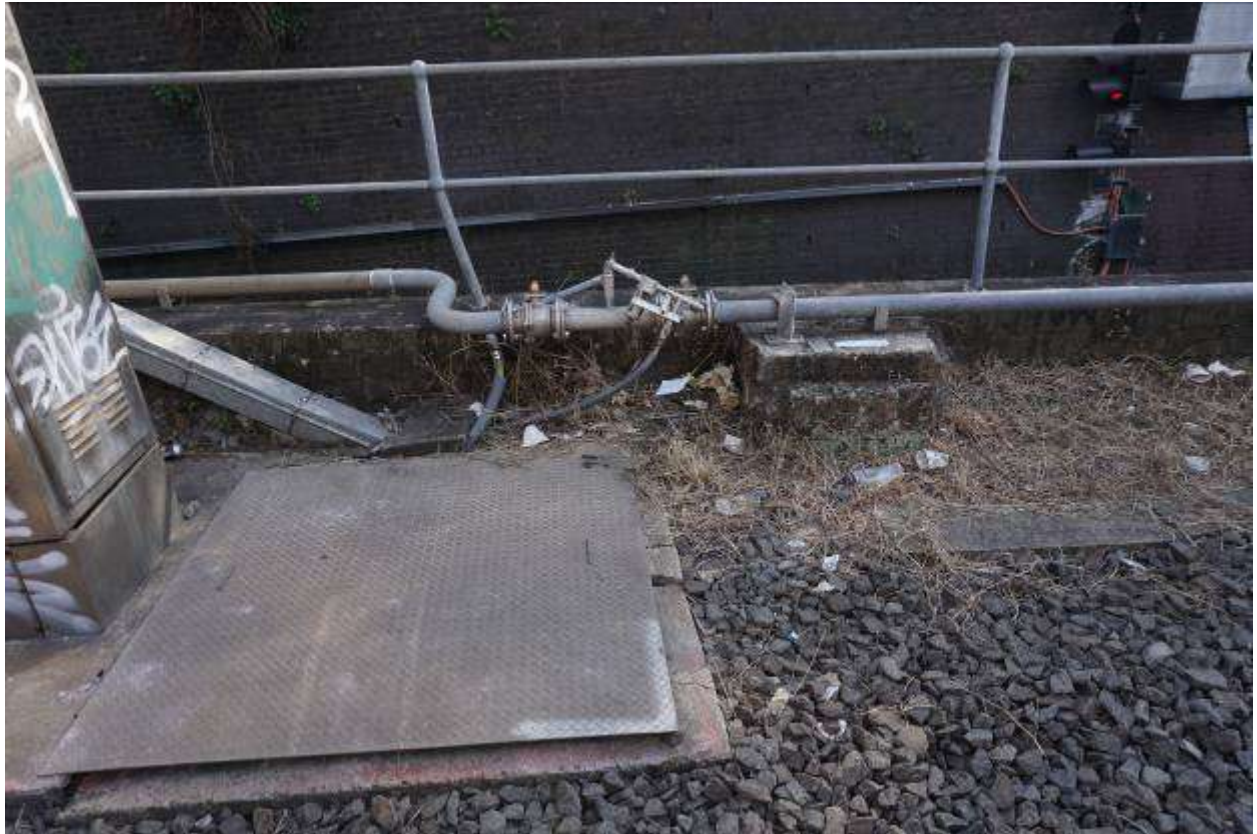
Figure 303 – General condition of RailCorp furniture observed from Railway Corridor

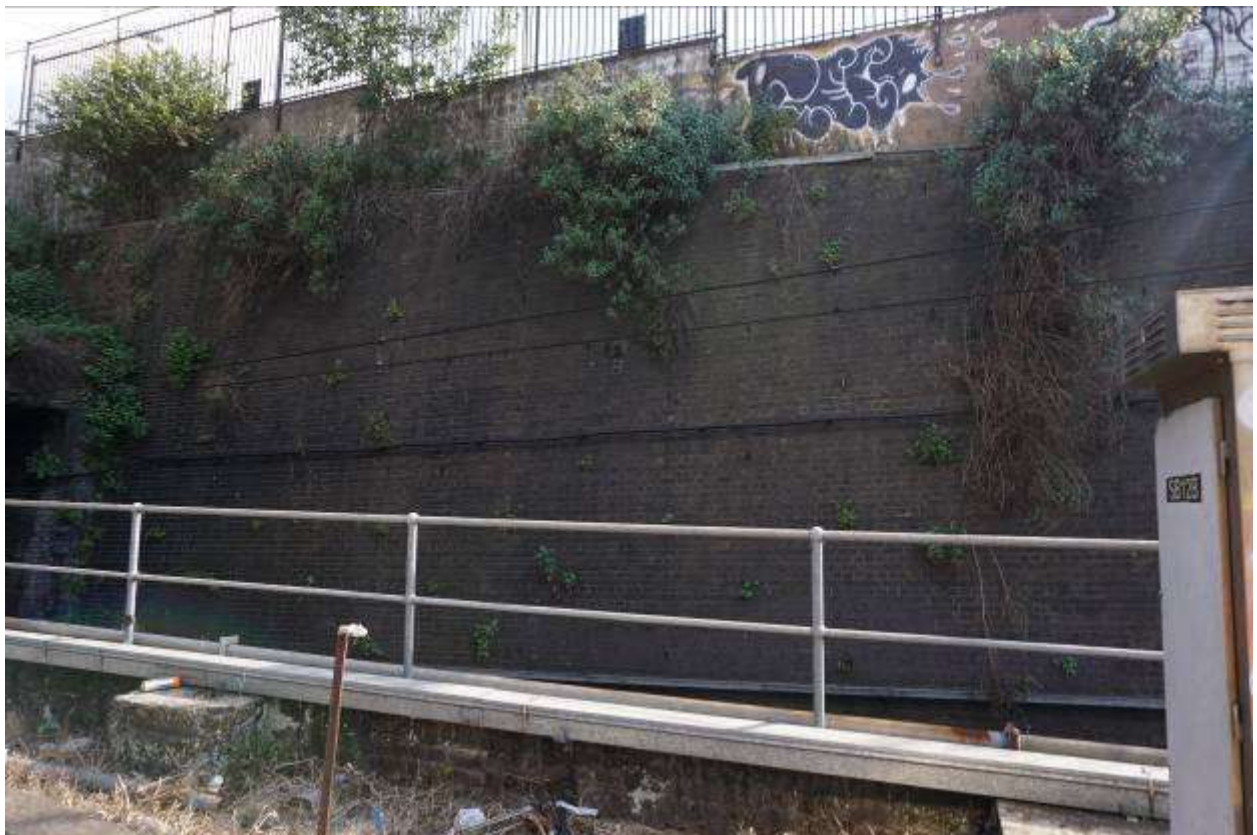
Figure 304 – General condition of RailCorp boundary wall observed from Railway Corridor

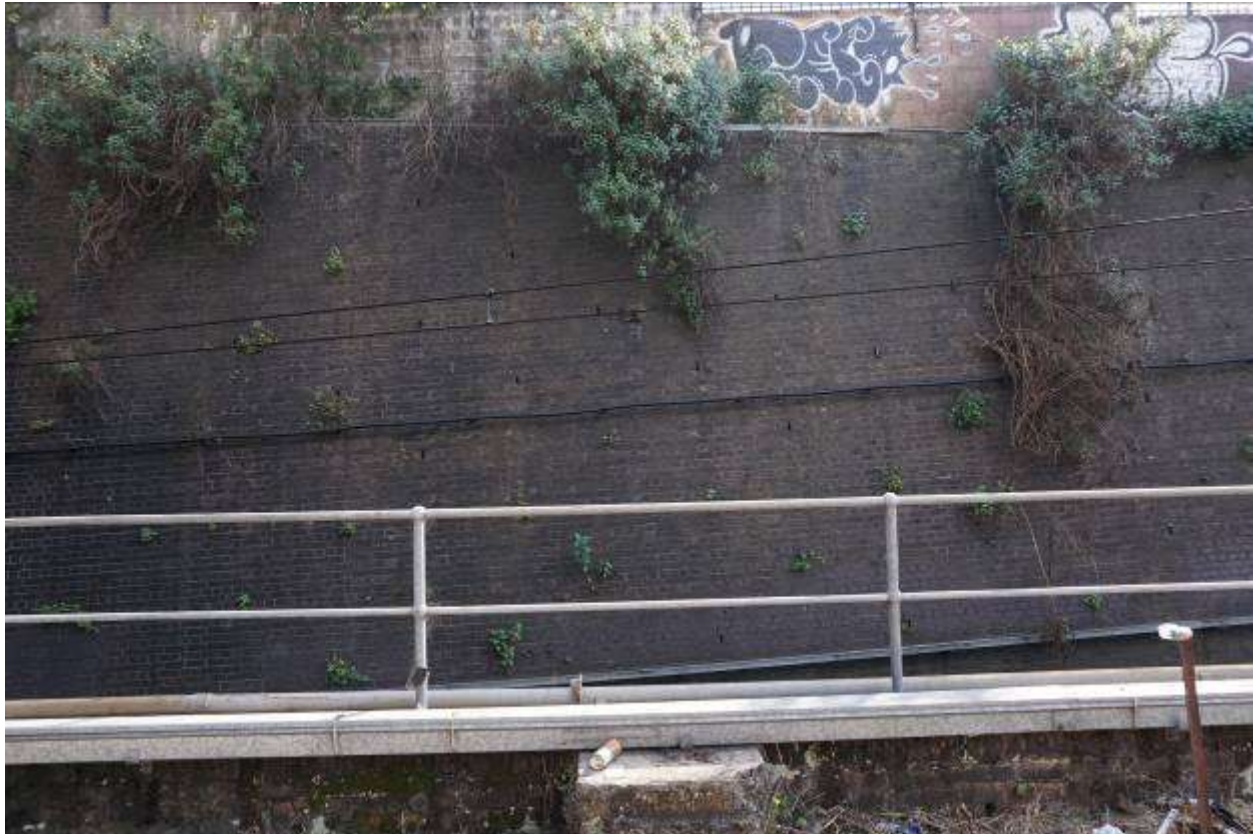
Figure 305 – General condition of RailCorp boundary wall observed from Railway Corridor

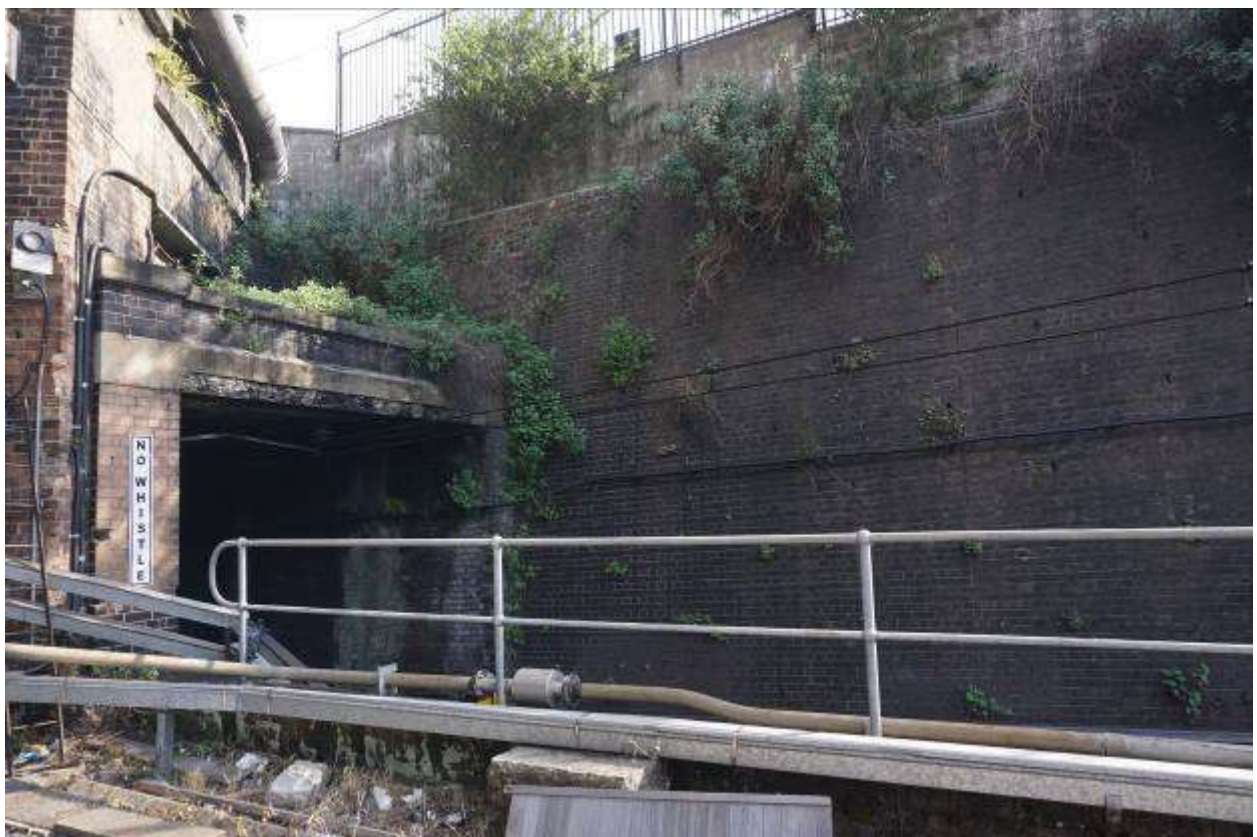
Figure 306 – General condition of RailCorp boundary wall observed from Railway Corridor

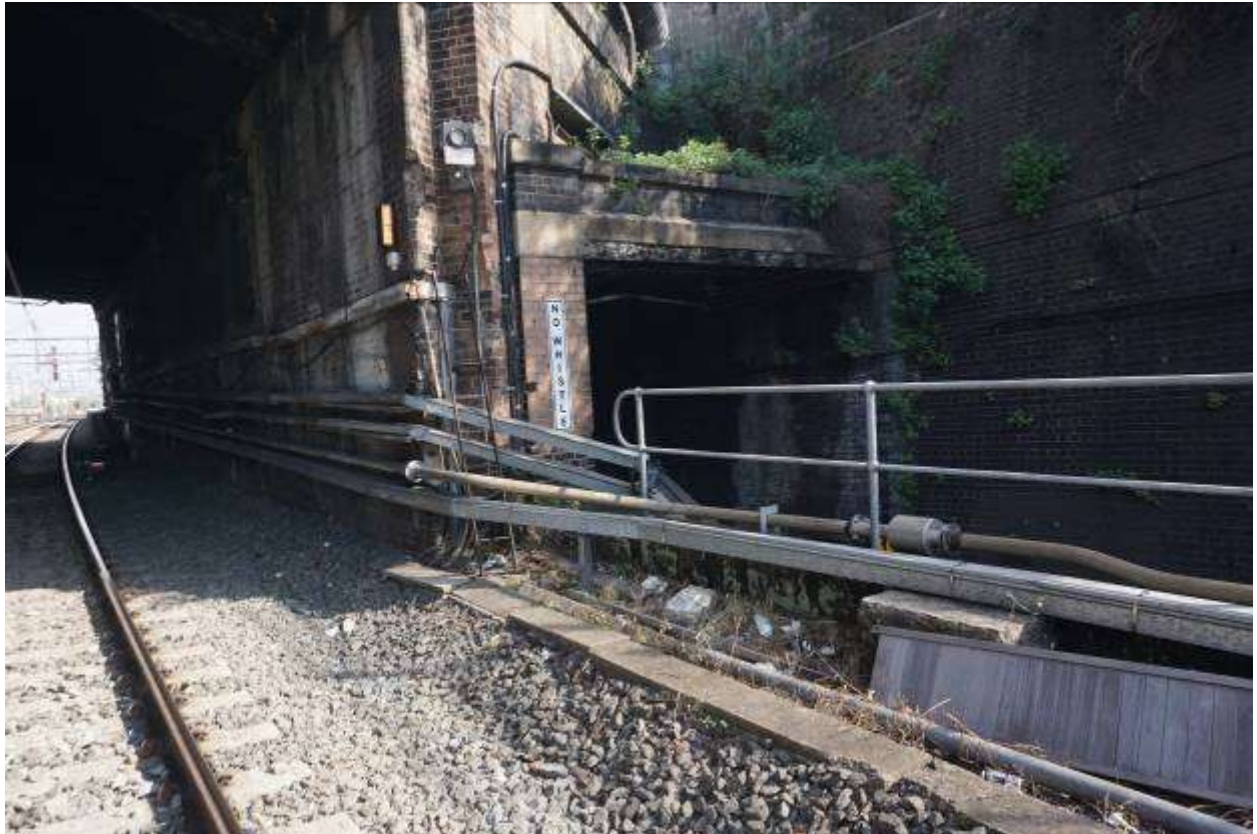
Figure 307 – General condition of RailCorp boundary wall observed from Railway Corridor

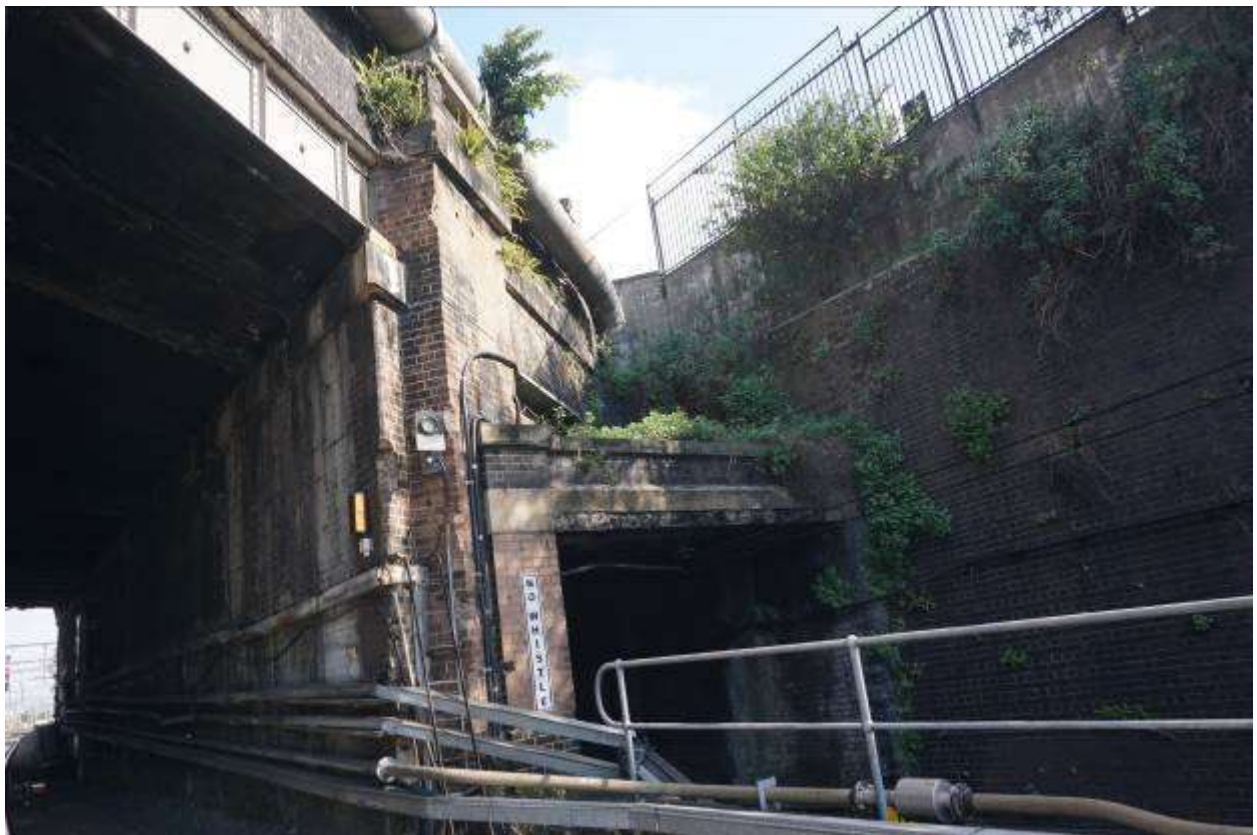
Figure 308 – General condition of RailCorp underpass observed from Railway Corridor

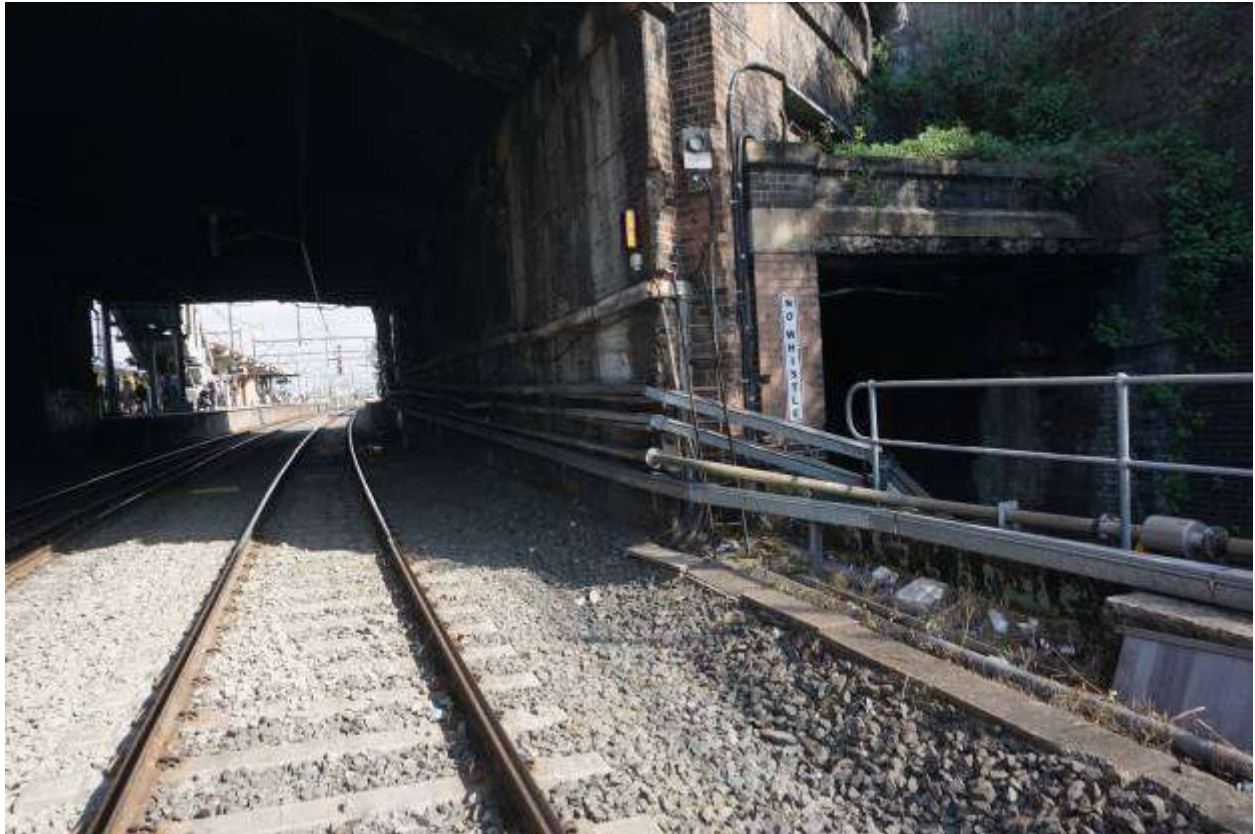
Figure 309 – General condition of RailCorp underpass observed from Railway Corridor

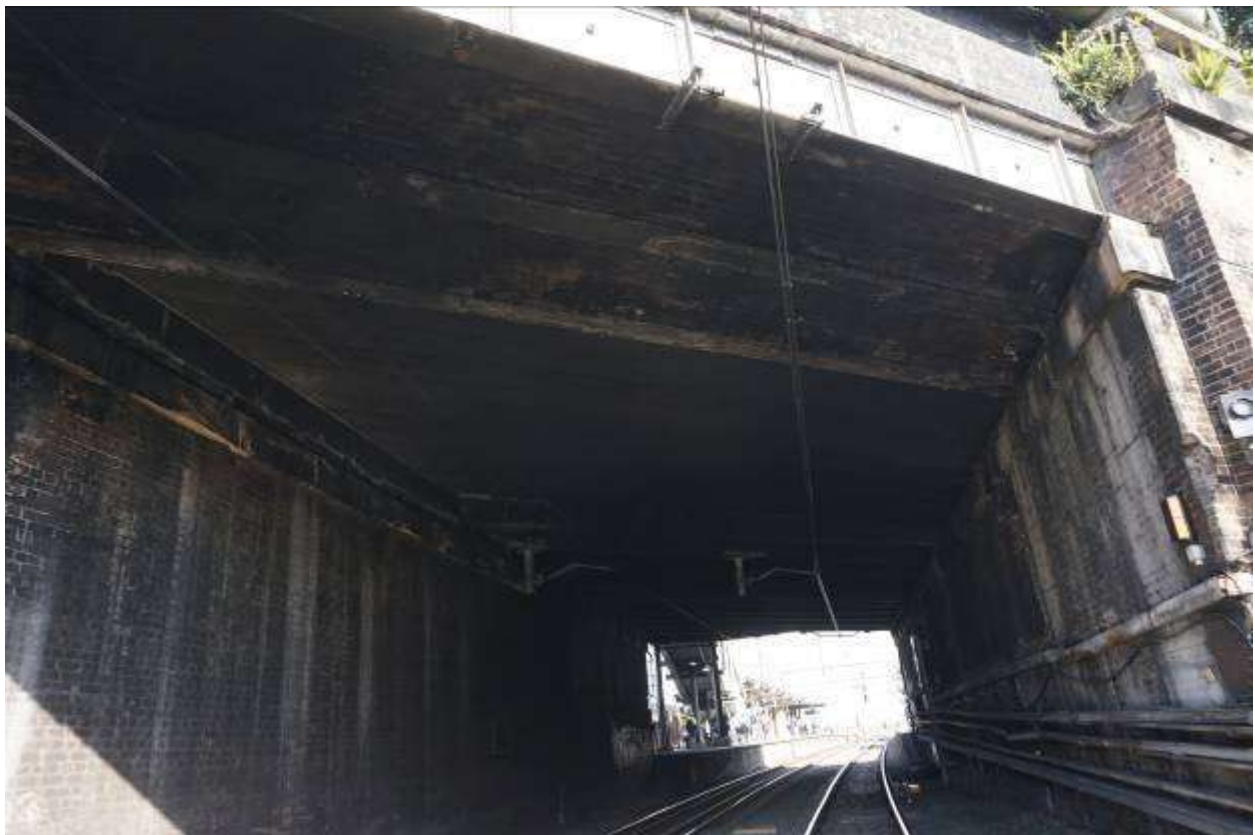
Figure 310 – General condition of RailCorp underpass observed from Railway Corridor

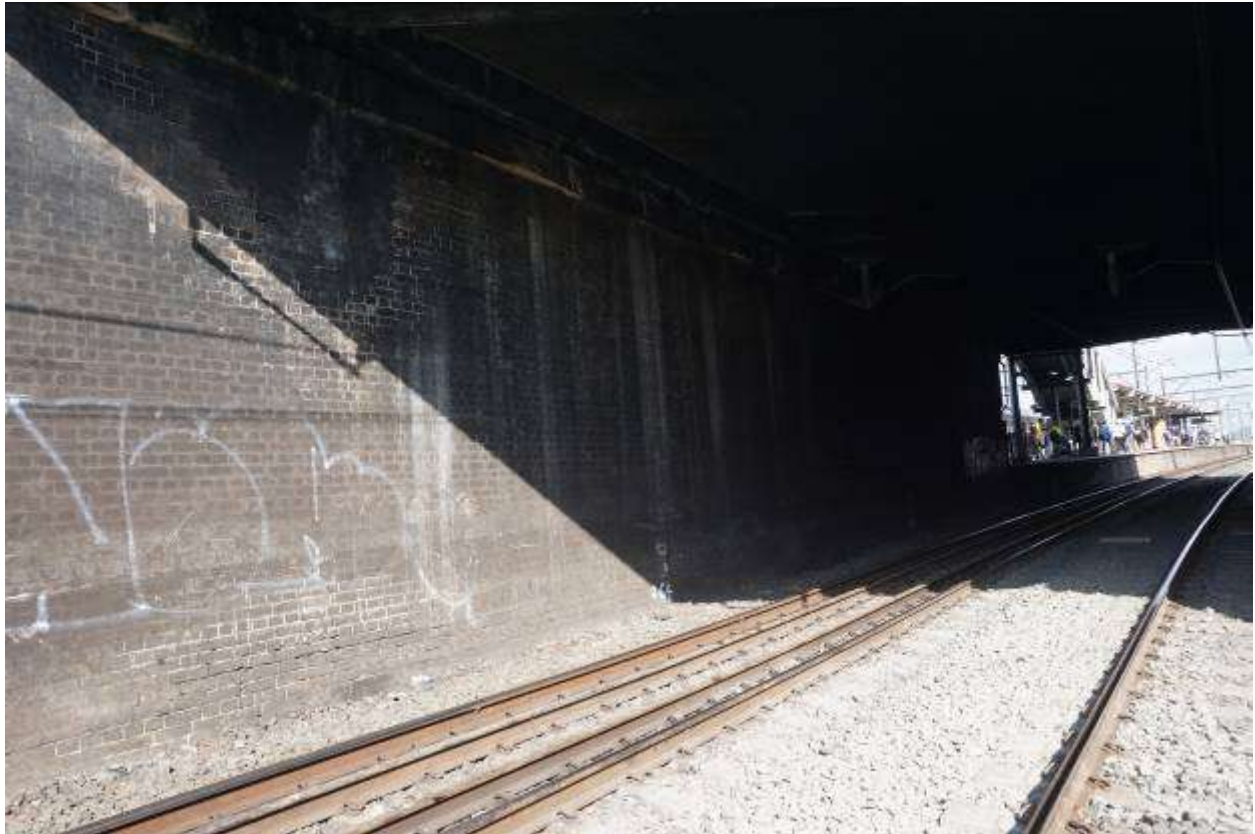
Figure 311 – General condition of RailCorp underpass observed from Railway Corridor

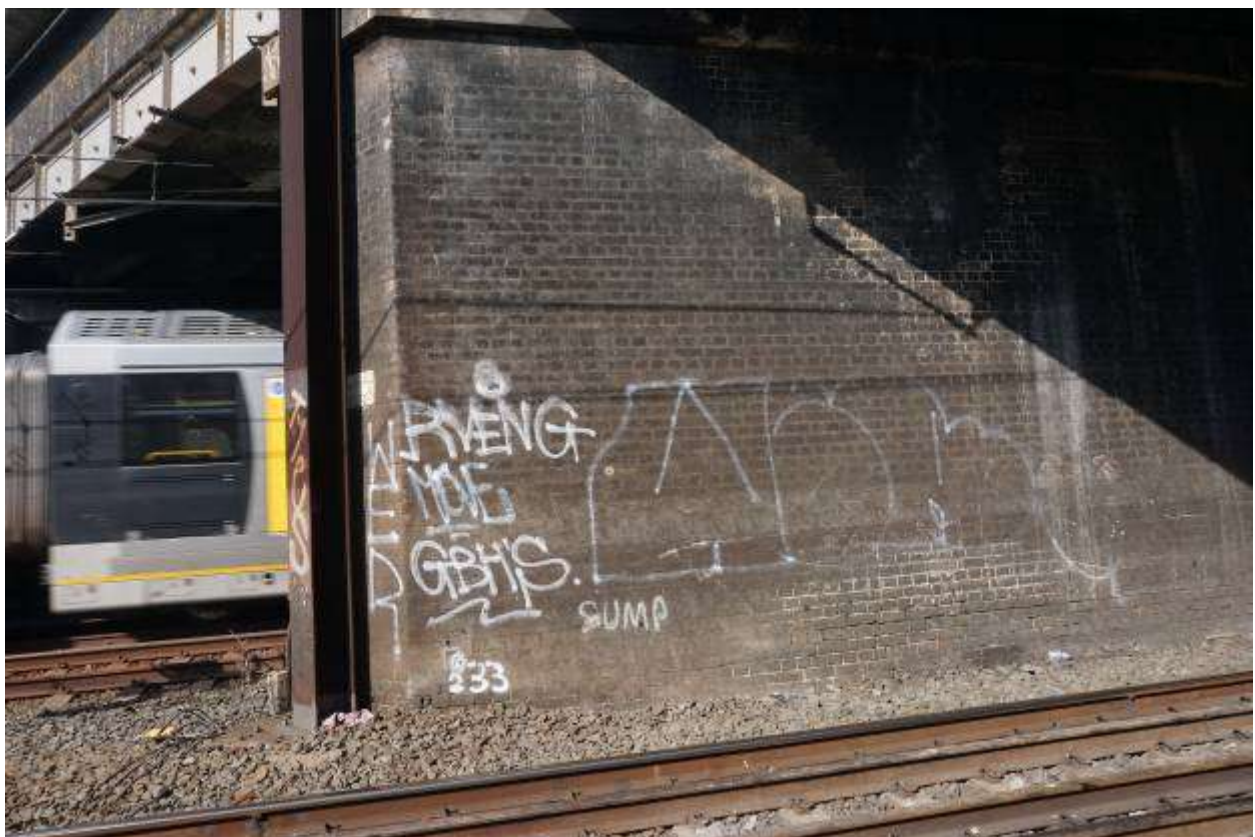
Figure 312 – General condition of RailCorp underpass observed from Railway Corridor

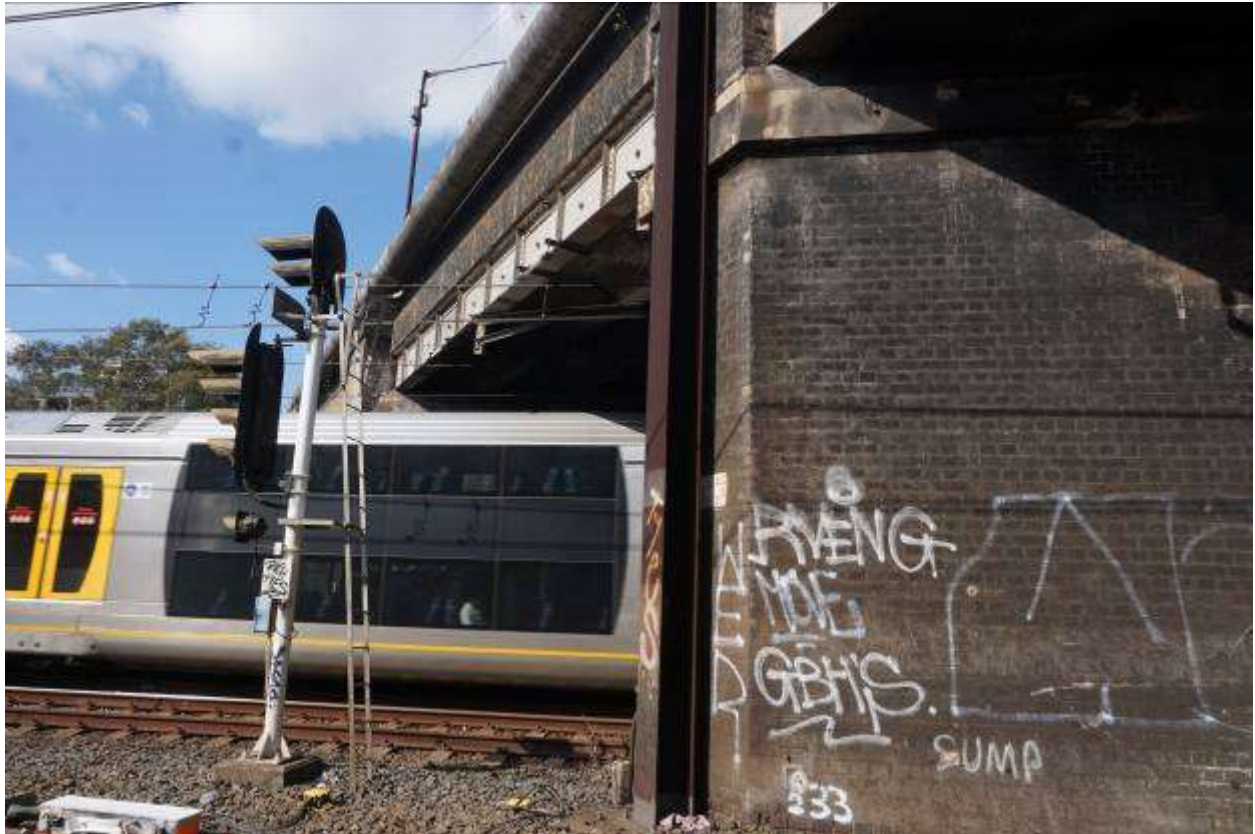
Figure 313 – General condition of RailCorp underpass observed from Railway Corridor

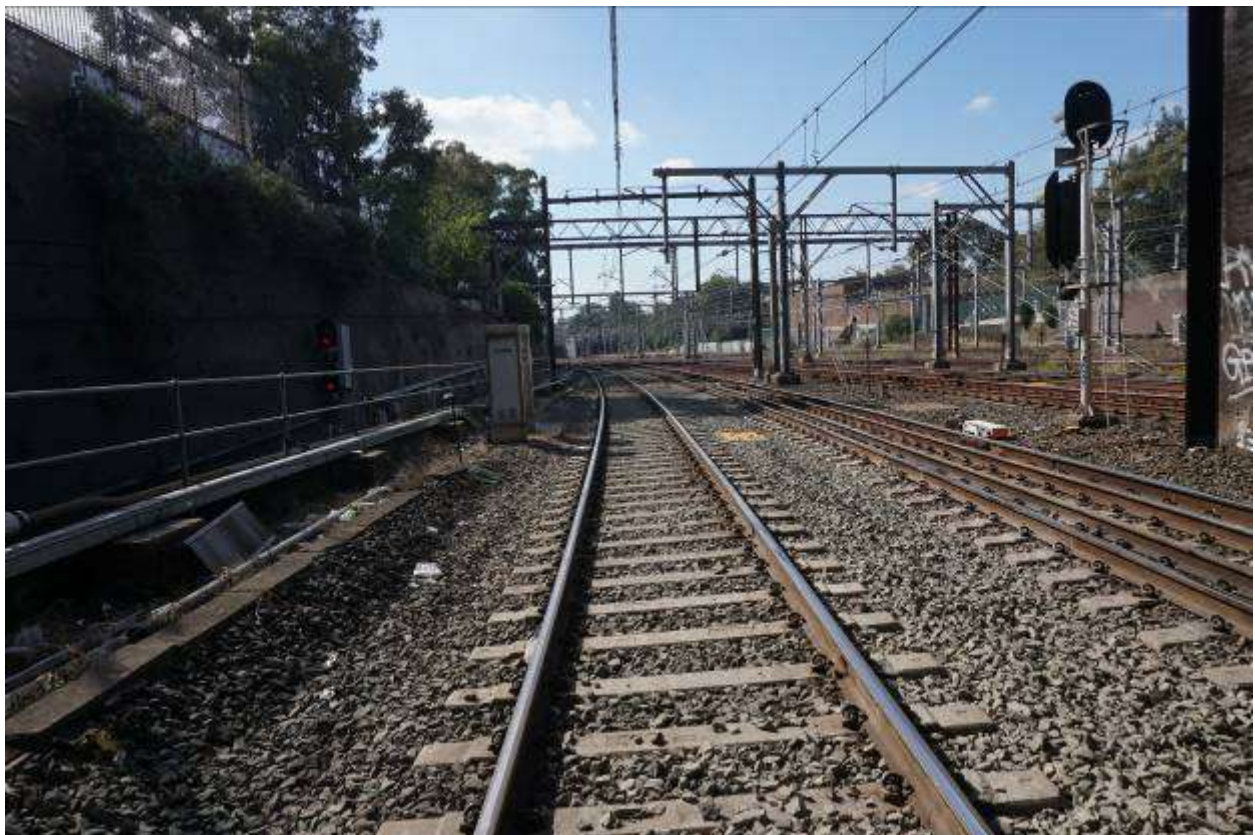
Figure 314 – General condition of railway corridor observed from Railway Corridor
