TILLEGRA DAM DESIGN - CONSULTANCY 361802

Storage Rim Stability and Seepage Potential
Engineering Geotechnical Report

**STORAGE RIM LANDSLIDE
GEOTECHNICAL ASSESSMENT**

Report PSM1271.R1

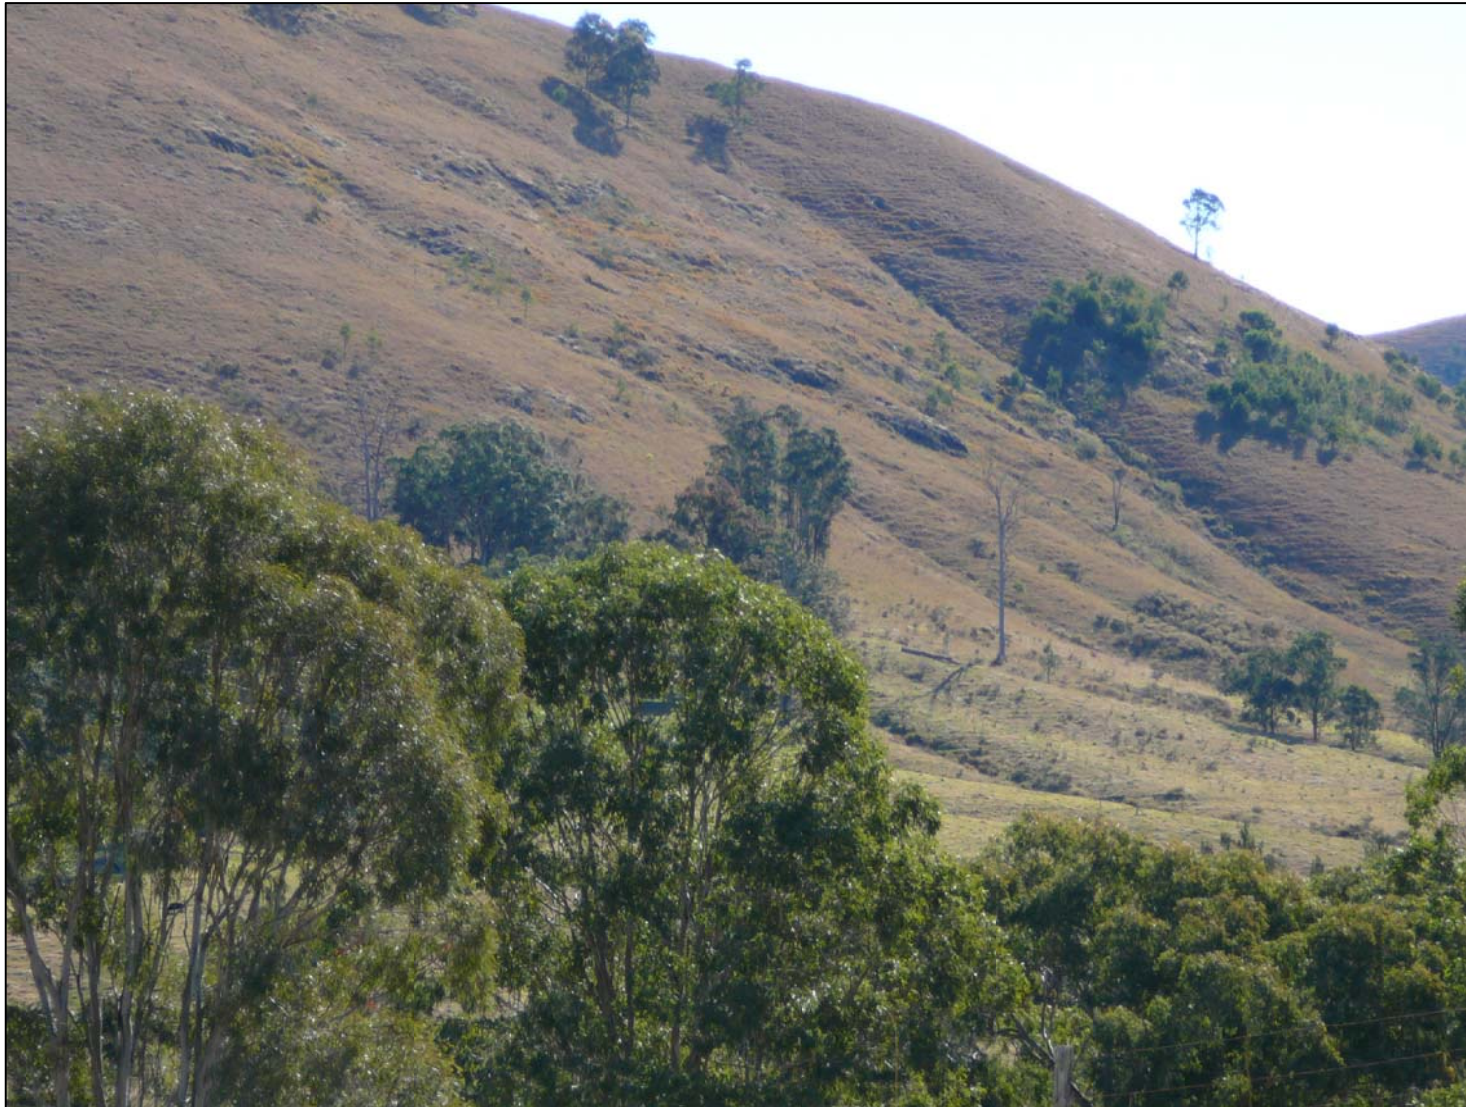
Figure 2

“Slide 8A” was identified as part of earlier studies as a possible landslide (Reference 11). The area has now been mapped by Commerce and that investigation has shown there is significant rock outcrop across the area, Figure 2.

NSW Department of Commerce
Tillegra Dam
Storage Rim Landslide Assessment
VIEW OF EASTERN FLANK OF
GEOMORPHOLOGICAL UNIT A

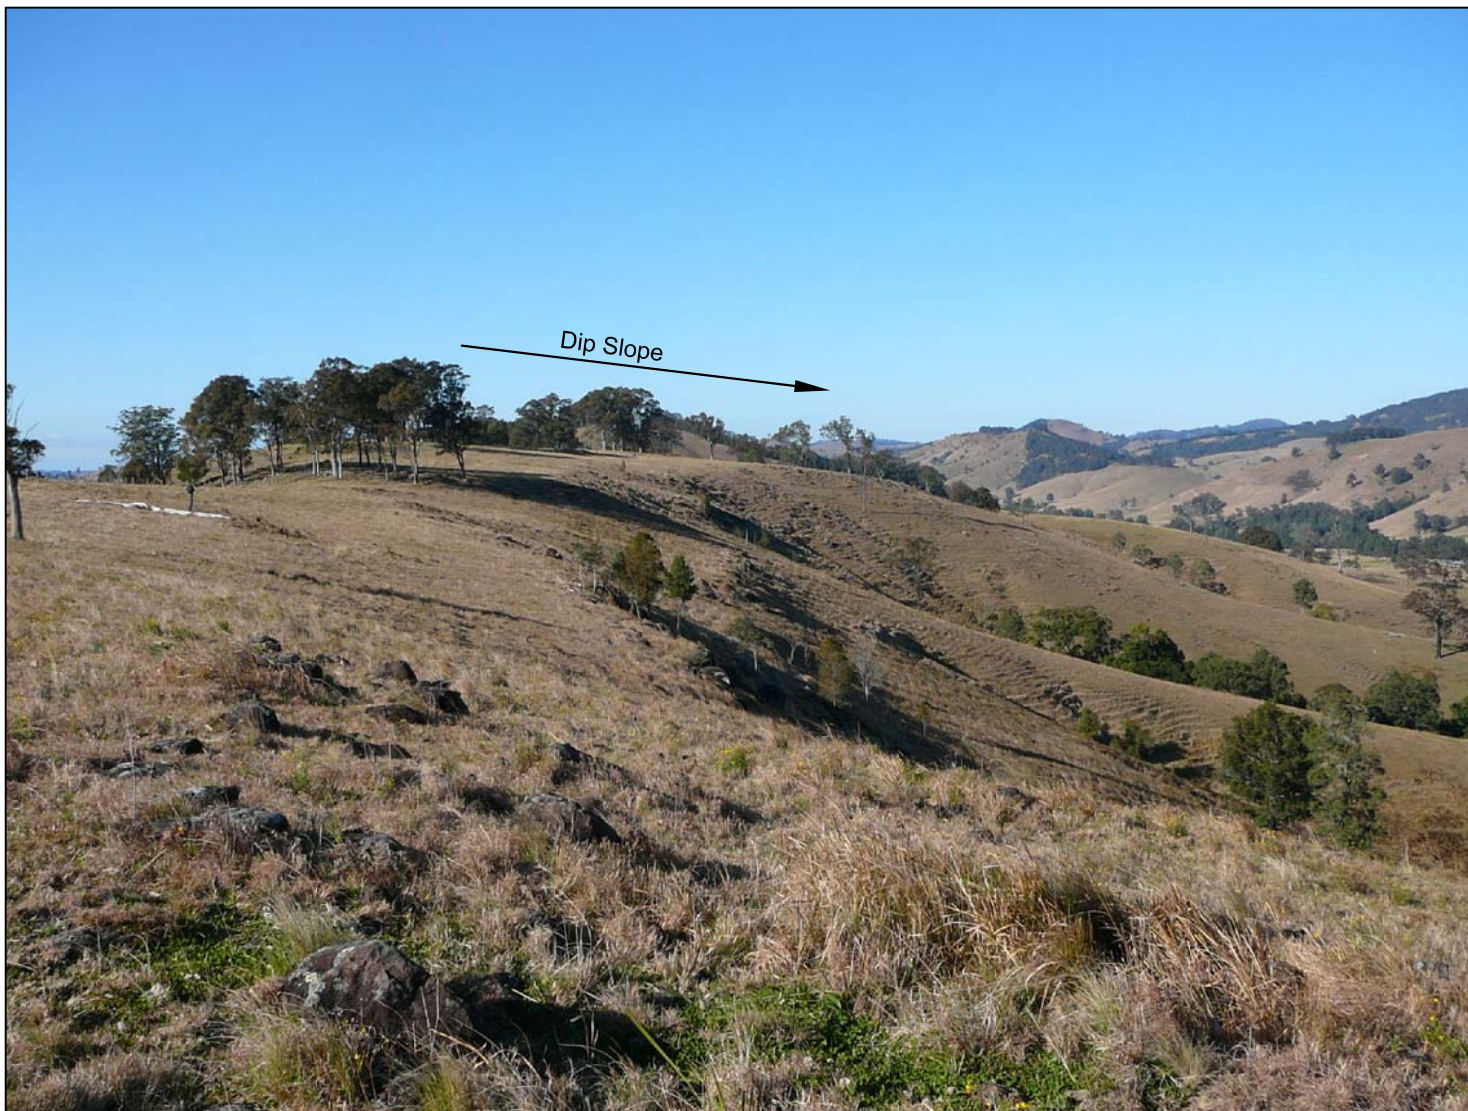
Figure 4

Note: Bedding dip to the West
into the storage.

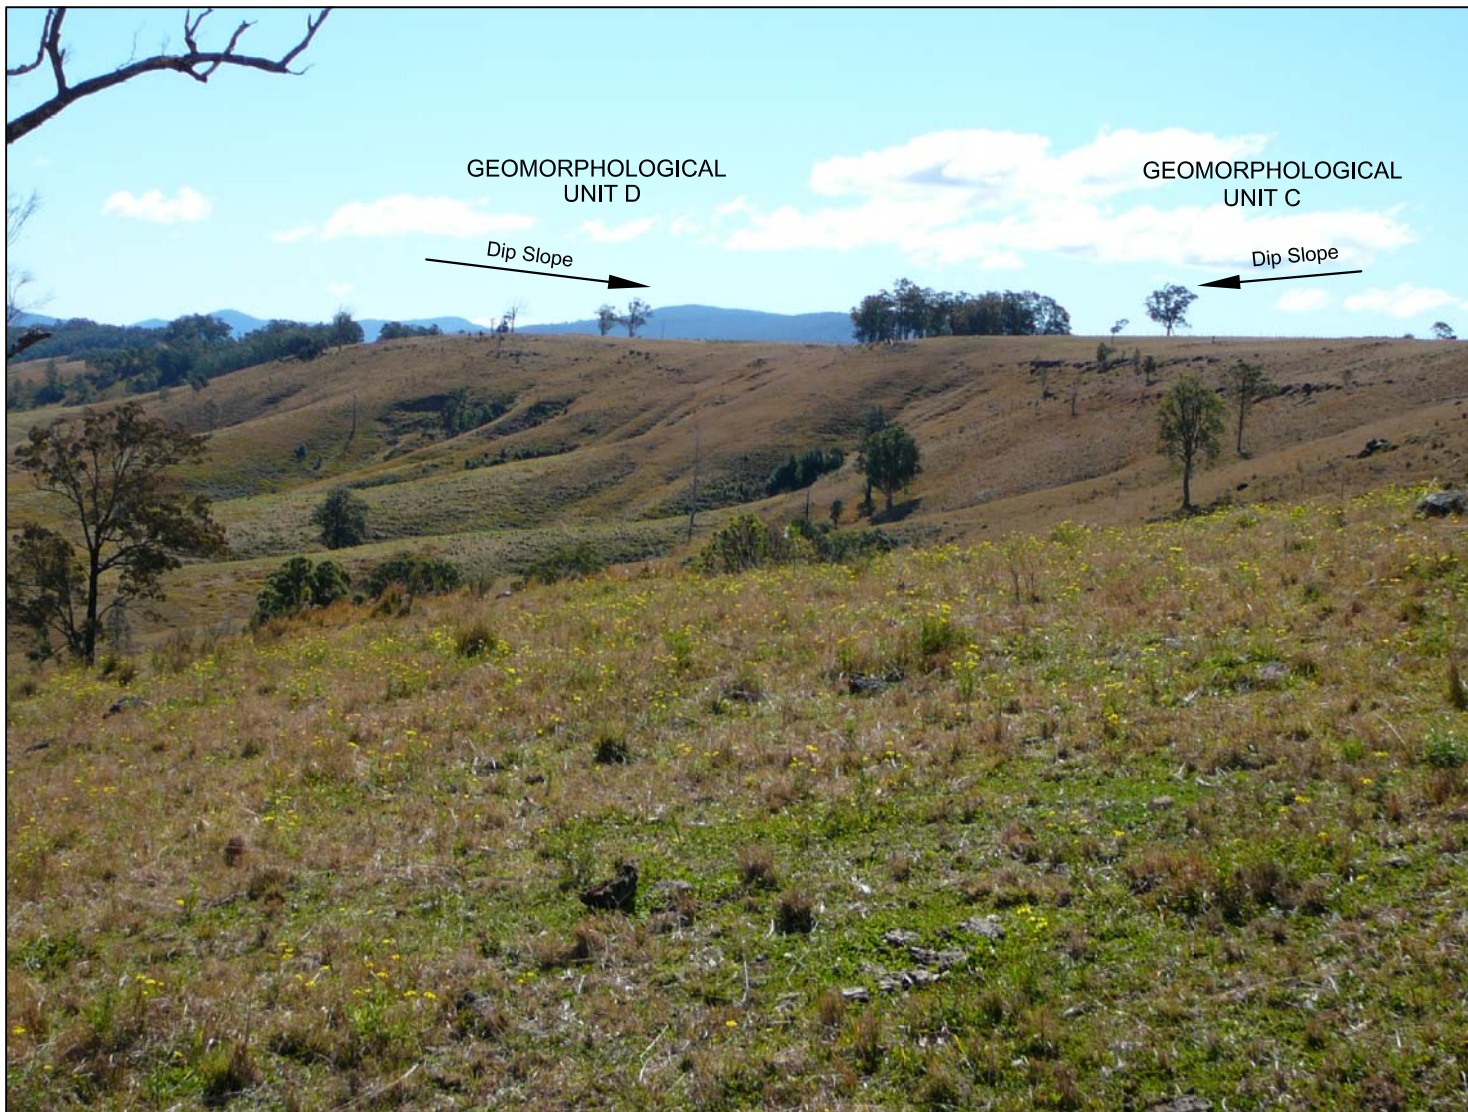
Figure 6

Slide 1A is located in Domain 1, where the bedding dips at a shallow angle out of the reservoir, Figure 6. The slide is small and estimated at 4,000m³. This slide is a slump of weathered soil/rock in conglomerate.

NSW Department of Commerce
Tillegra Dam
Storage Rim Landslide Assessment
COMPARISON OF
GEOMORPHOLOGICAL UNITS C & D
(View to North)

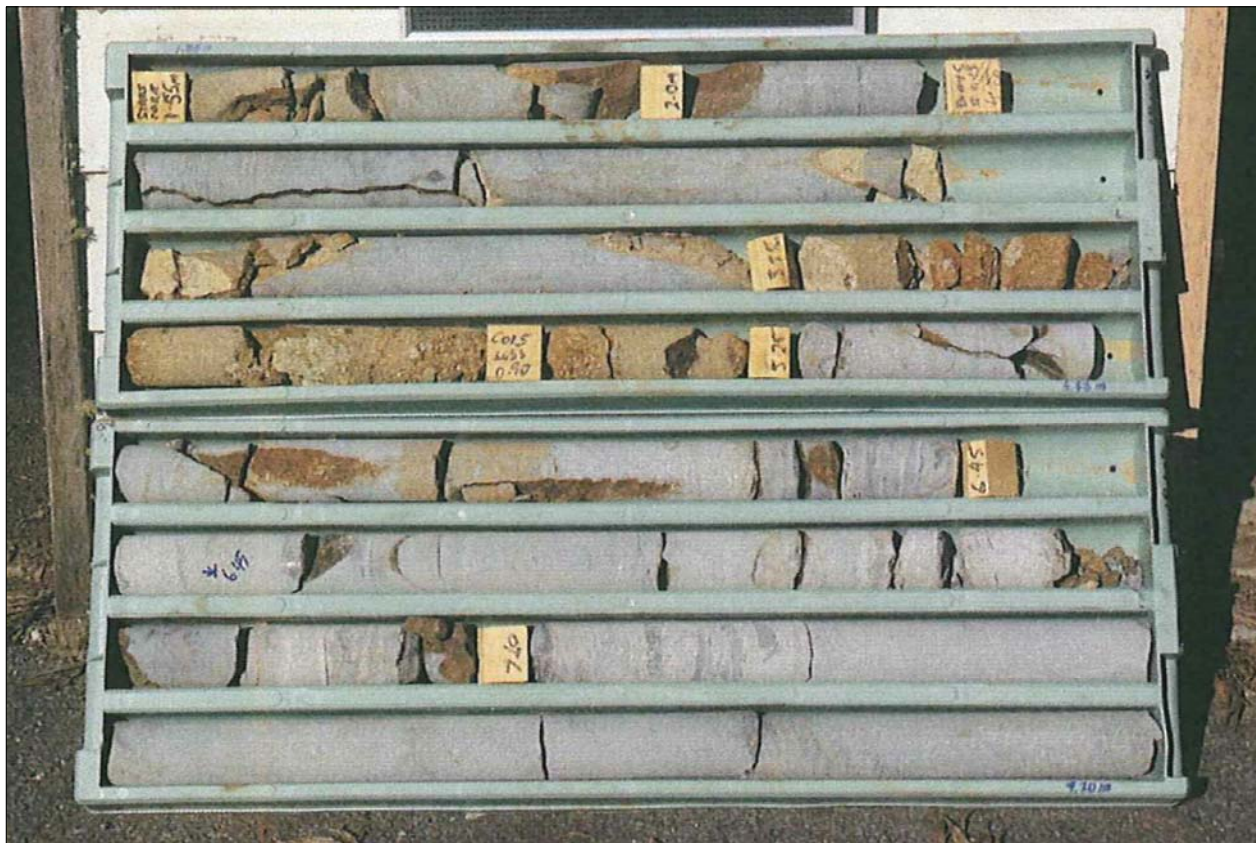
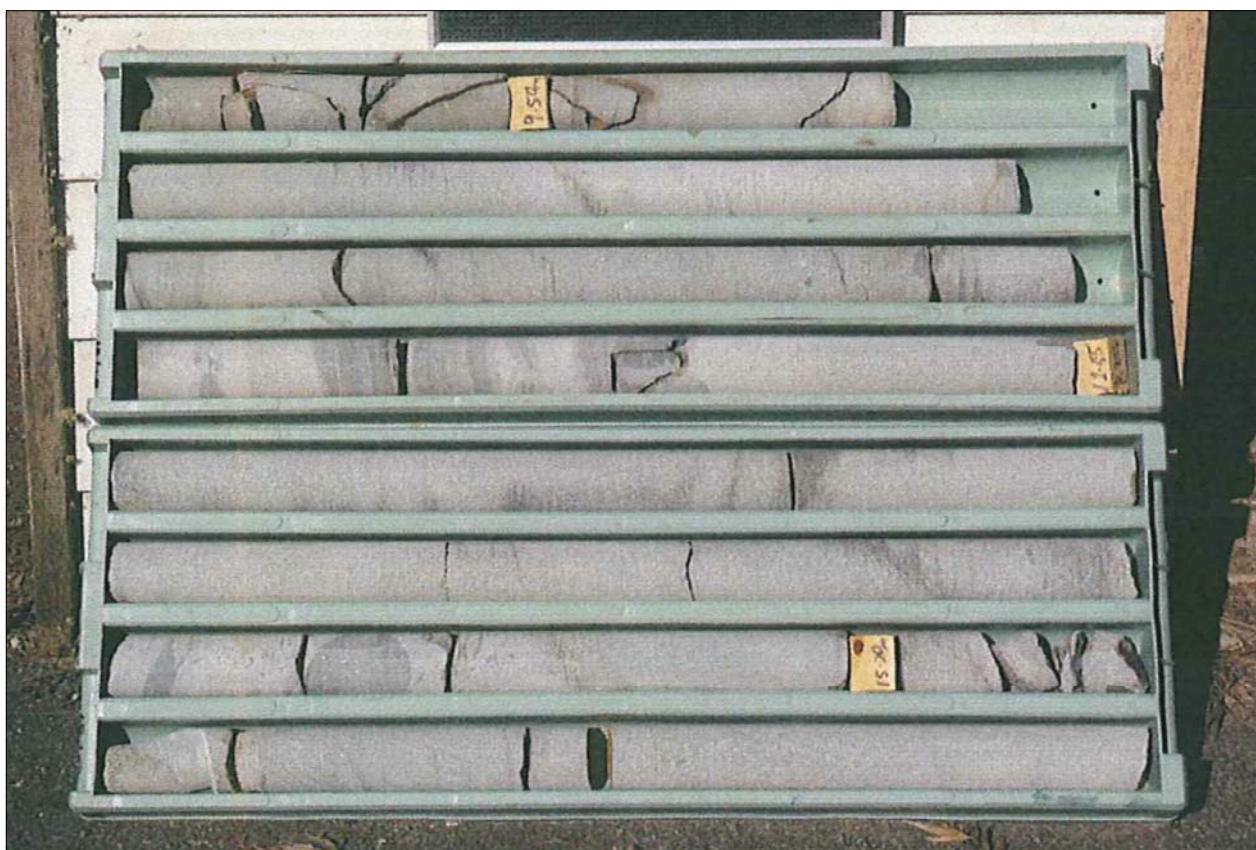
7. The landslide shows a history of sliding at two different elevations.
8. The landslide is relatively shallow, about 5 to 8m deep.
9. The sliding planes are very thin, and very irregular. They appear to have formed by weathering and/or alteration of the upper boundary of the lithic sandstones immediately below meta-shale layers. Figure 8 shows a core loss and weathering reversal below a meta-shale layer at 3.3m depth in DDH29. Similar features are also evident in DDH30, Figure 9. This is not a “classic” sedimentary landslide plane.

NSW Department of Commerce
Tillegra Dam
Storage Rim Landslide Assessment
DDH30
FROM 1.5 to 16m DEPTH

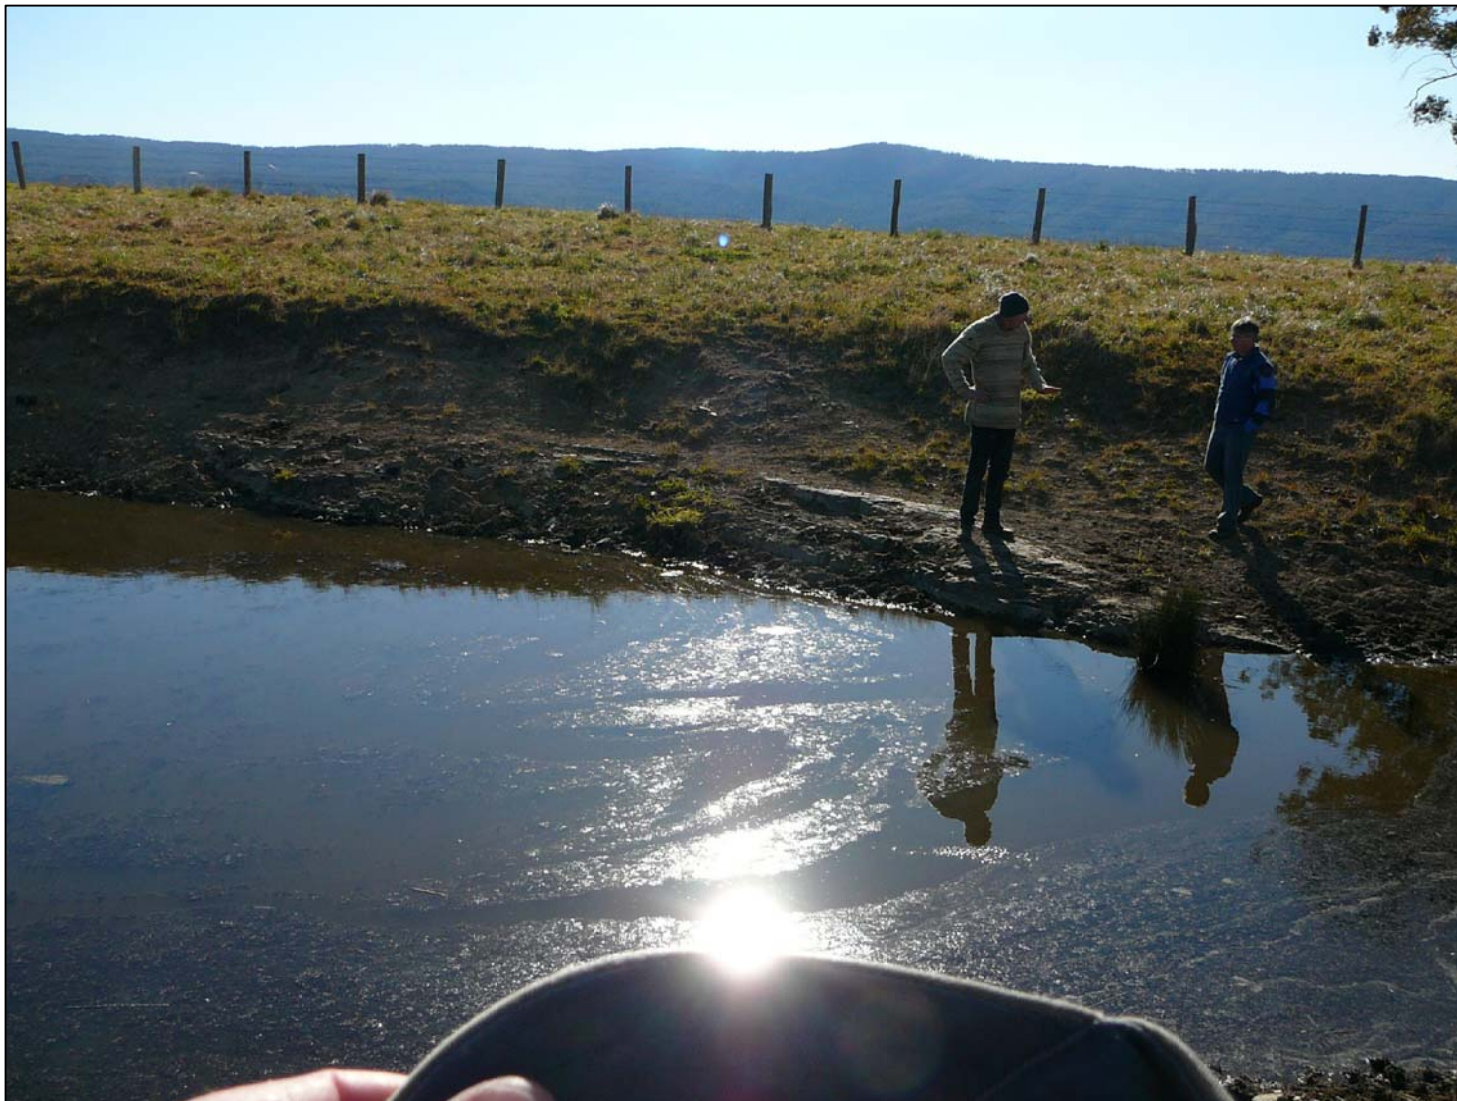
Figure 10

The test pits and the natural exposures in farm dams around the site, confirm the upper part of this geotechnical model, Figure 10.

NSW Department of Commerce
Tillegra Dam
Storage Rim Landslide Assessment
SMALL DAM ON THE WAY TO SLIDE 1A
BEDDING DIPS EAST TO SOUTH EAST
AT 5 to 7°

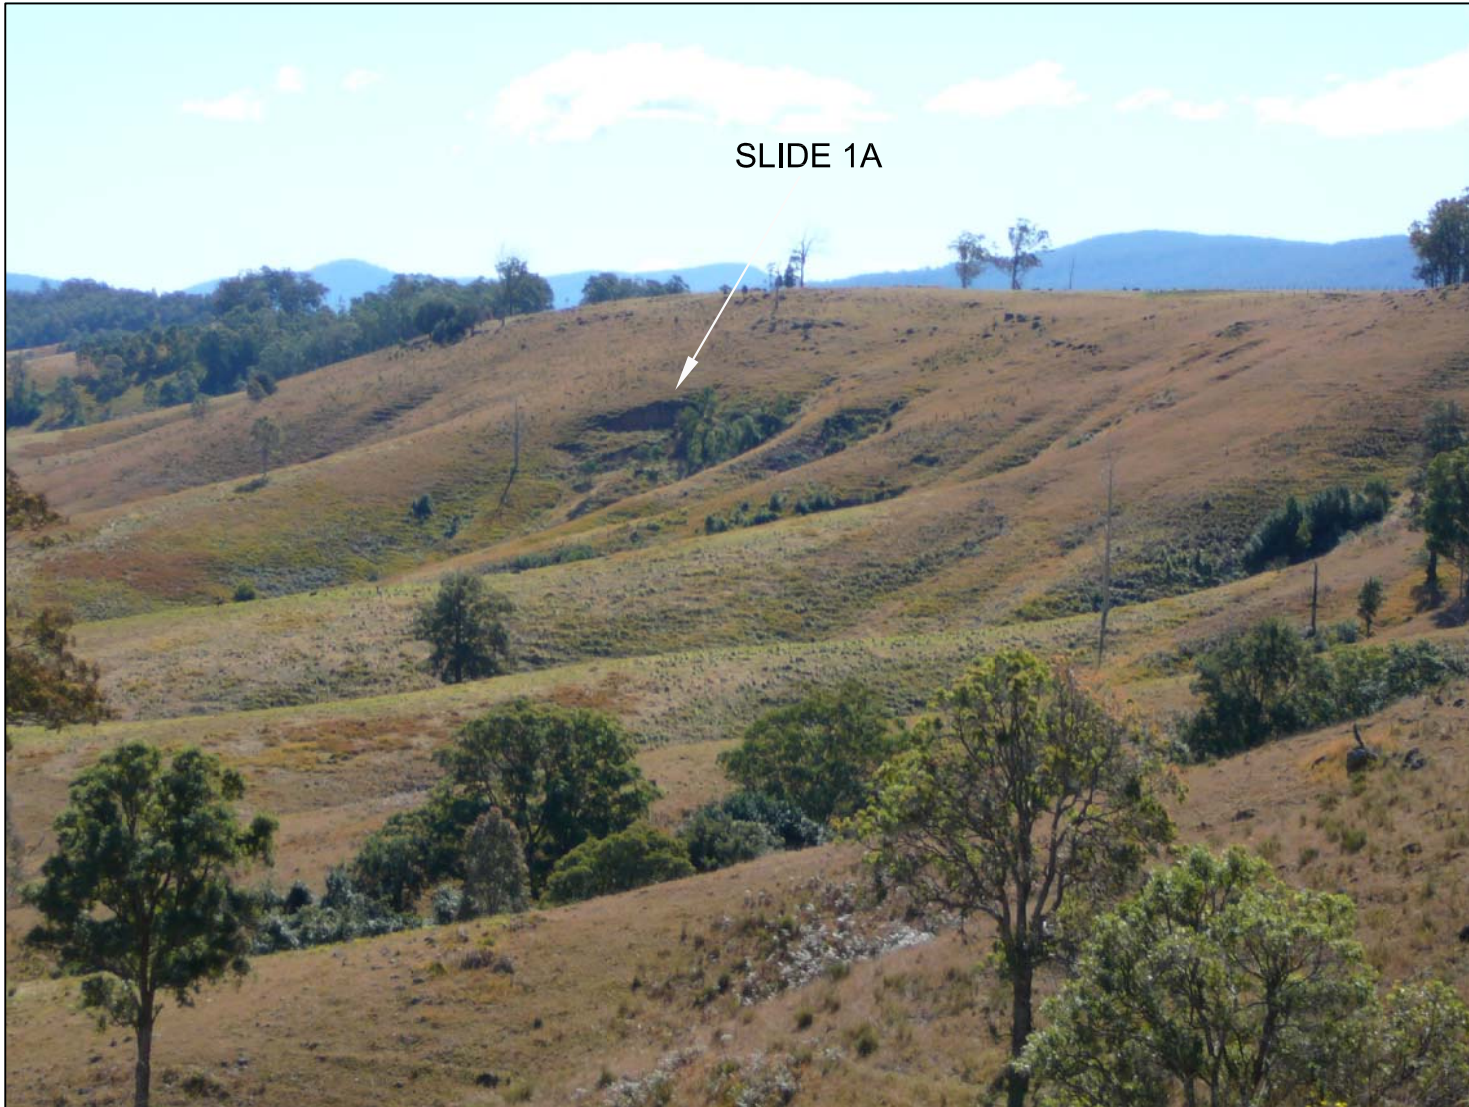
Figure 15

The slide is located at the head of a steeply incised creek, Figure 15. The slump has only travelled a short distance, with the only significant travel shown by some boulders in the outwash fan, Figure 16.

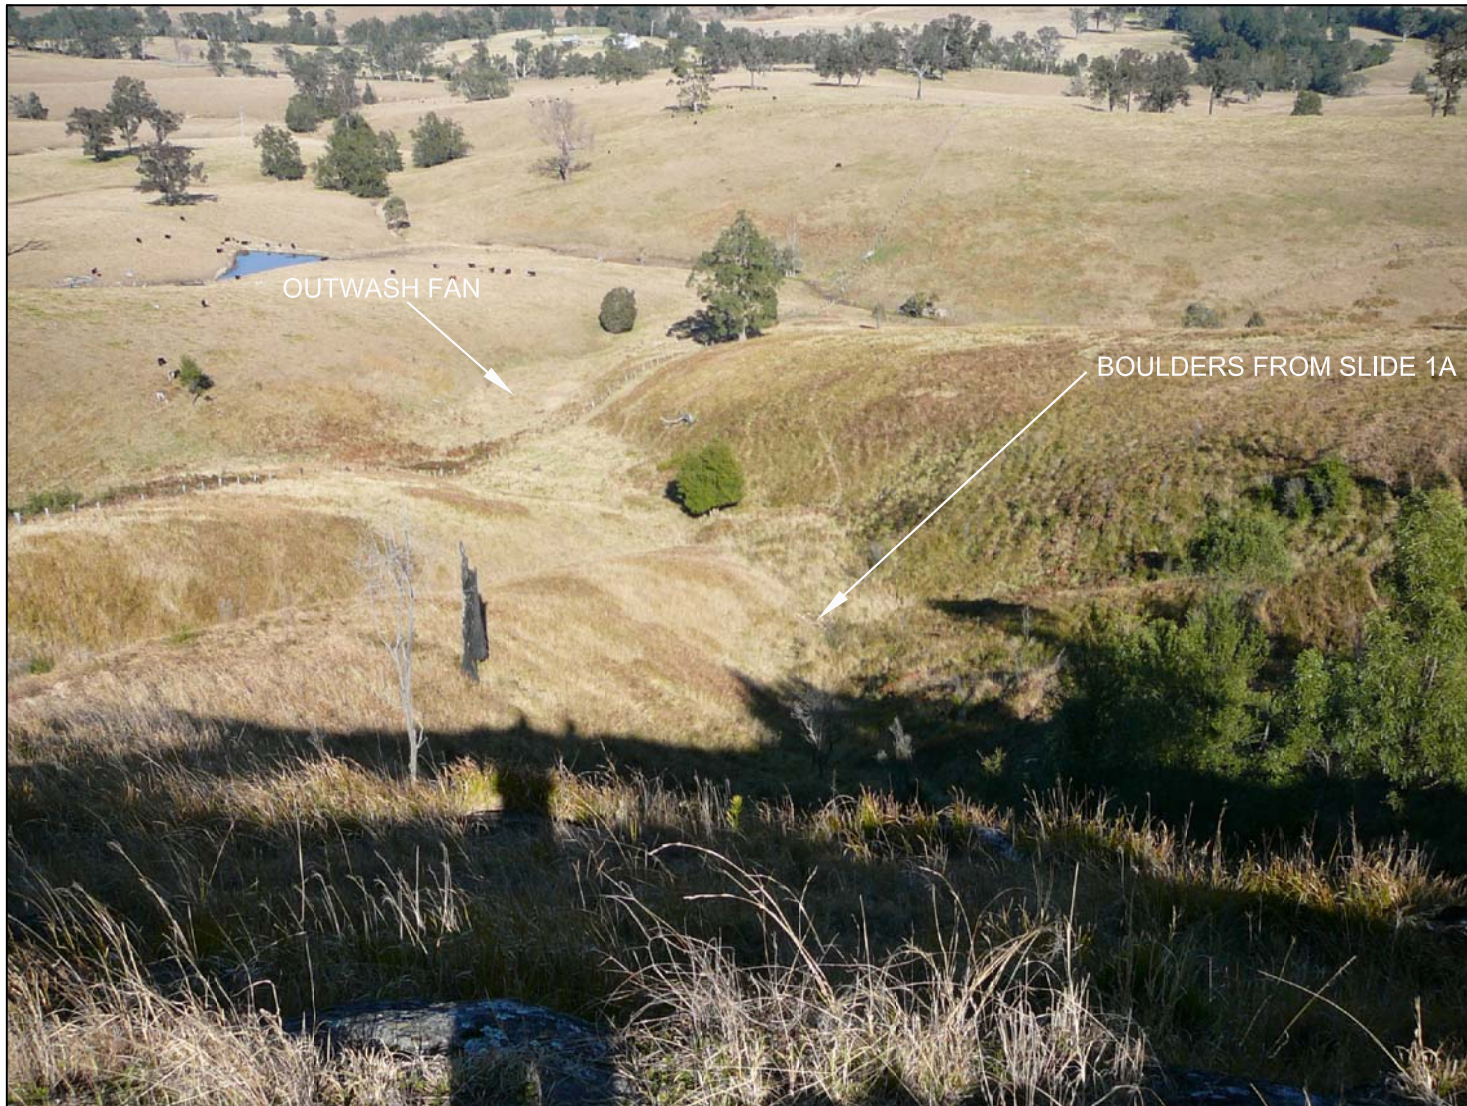
Figure 16

This area shows evidence of an older smaller slide to the south and adjacent to Slide 1A. The old outwash fan, Figure 16, is assumed to have been formed over a long period from landslide debris and erosion of earlier slides.

NSW Department of Commerce
Tillegra Dam
Storage Rim Landslide Assessment
VIEW LOOKING DOWNSTREAM
SLIDE 1A

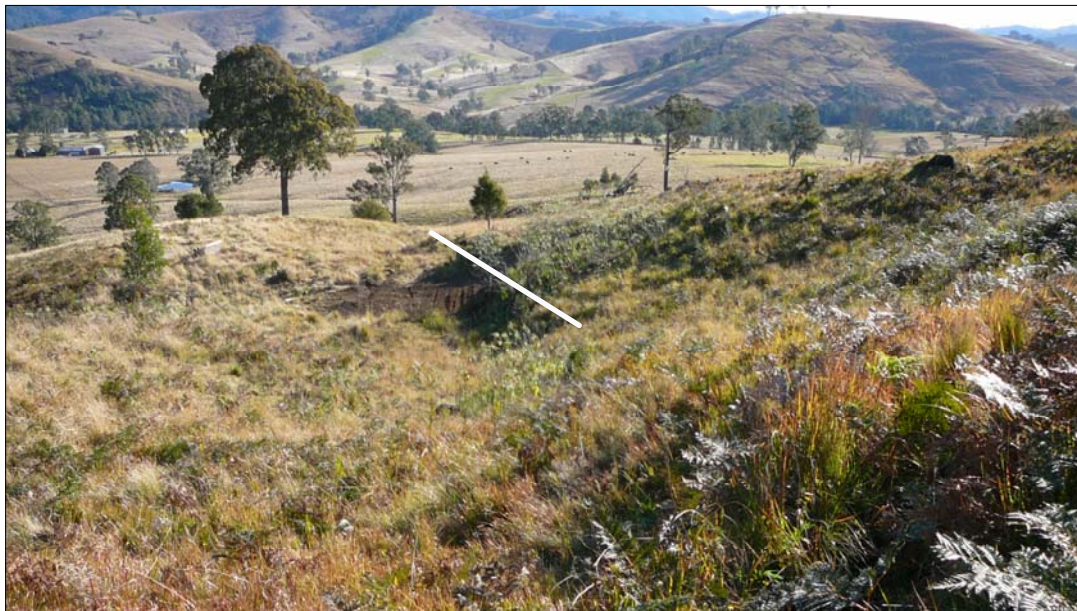
Figure 21 shows structural mapping data for the landslide shown as a lower hemisphere equal area stereographic projection of the poles to all planes. This mapping is from the test pits. As shown, the alignment of the landslide scarps approximately matches the joint set data. This infers a bedrock controlled sliding event. Figure 22 illustrates this linear control on the recently reactivated landslide scarps.

LANDSLIDE CONTROLS

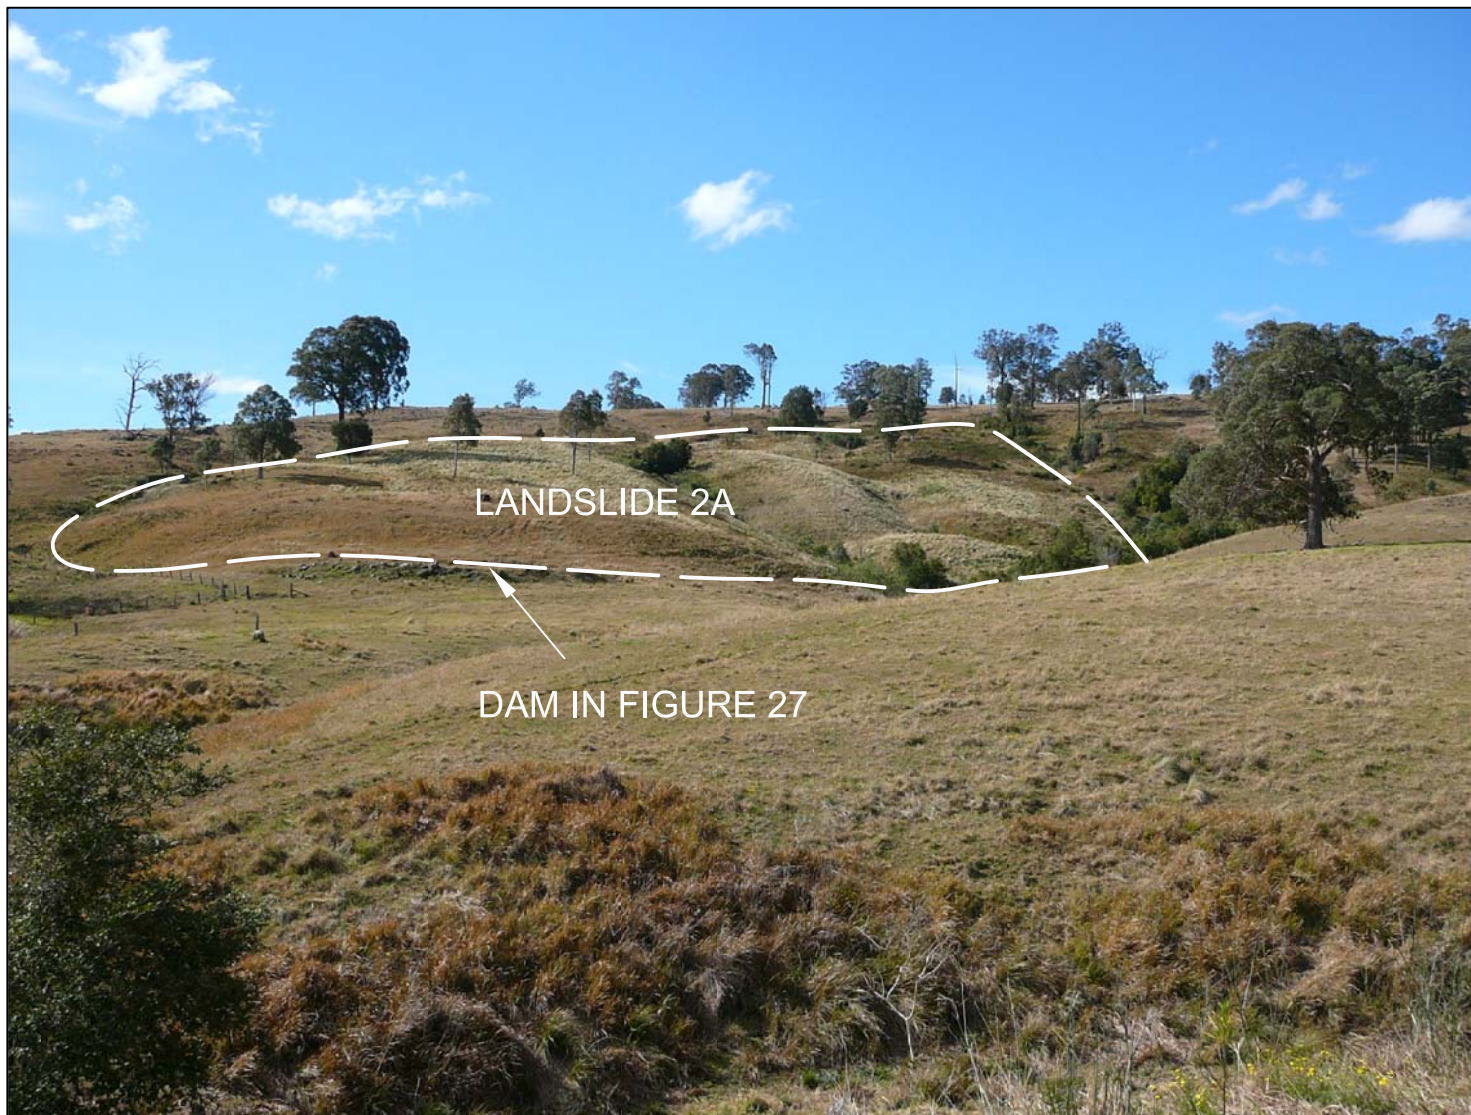
Figure 23 is a view to the northeast, up Landslide 2A. This figure, in conjunction with the figures referred to below provide the basis for a description of the surface features of the landslide:

1. The landslide comprises three parallel lobes, Figure 23.
2. The active landslide is surrounded in the east northeast by a zone exhibiting small, probably intermittent creep, Figure 24.
3. The landslide is largely covered with tussock grass and the lobes show evidence of old small scale slumping reactivation of the toe, Figures 25 and 26.
4. The overall ground surface slope through the main part of the slide is only about $11\frac{1}{2}^{\circ}$.

5. At the toe of the main landslide lobe, there is bedrock outcrop in a farm dam. The bedding in this outcrop dips 15° toward the southwest, Figures 23 and 27.
6. The colluvial fan is partly separated from the landslide by a farm dam with bedrock outcrop, Figures 27 and 28.
7. There are a number of very mature trees within the landslide itself that show minimal disturbance even though some are adjacent to the recently active scarp, Figure 29.

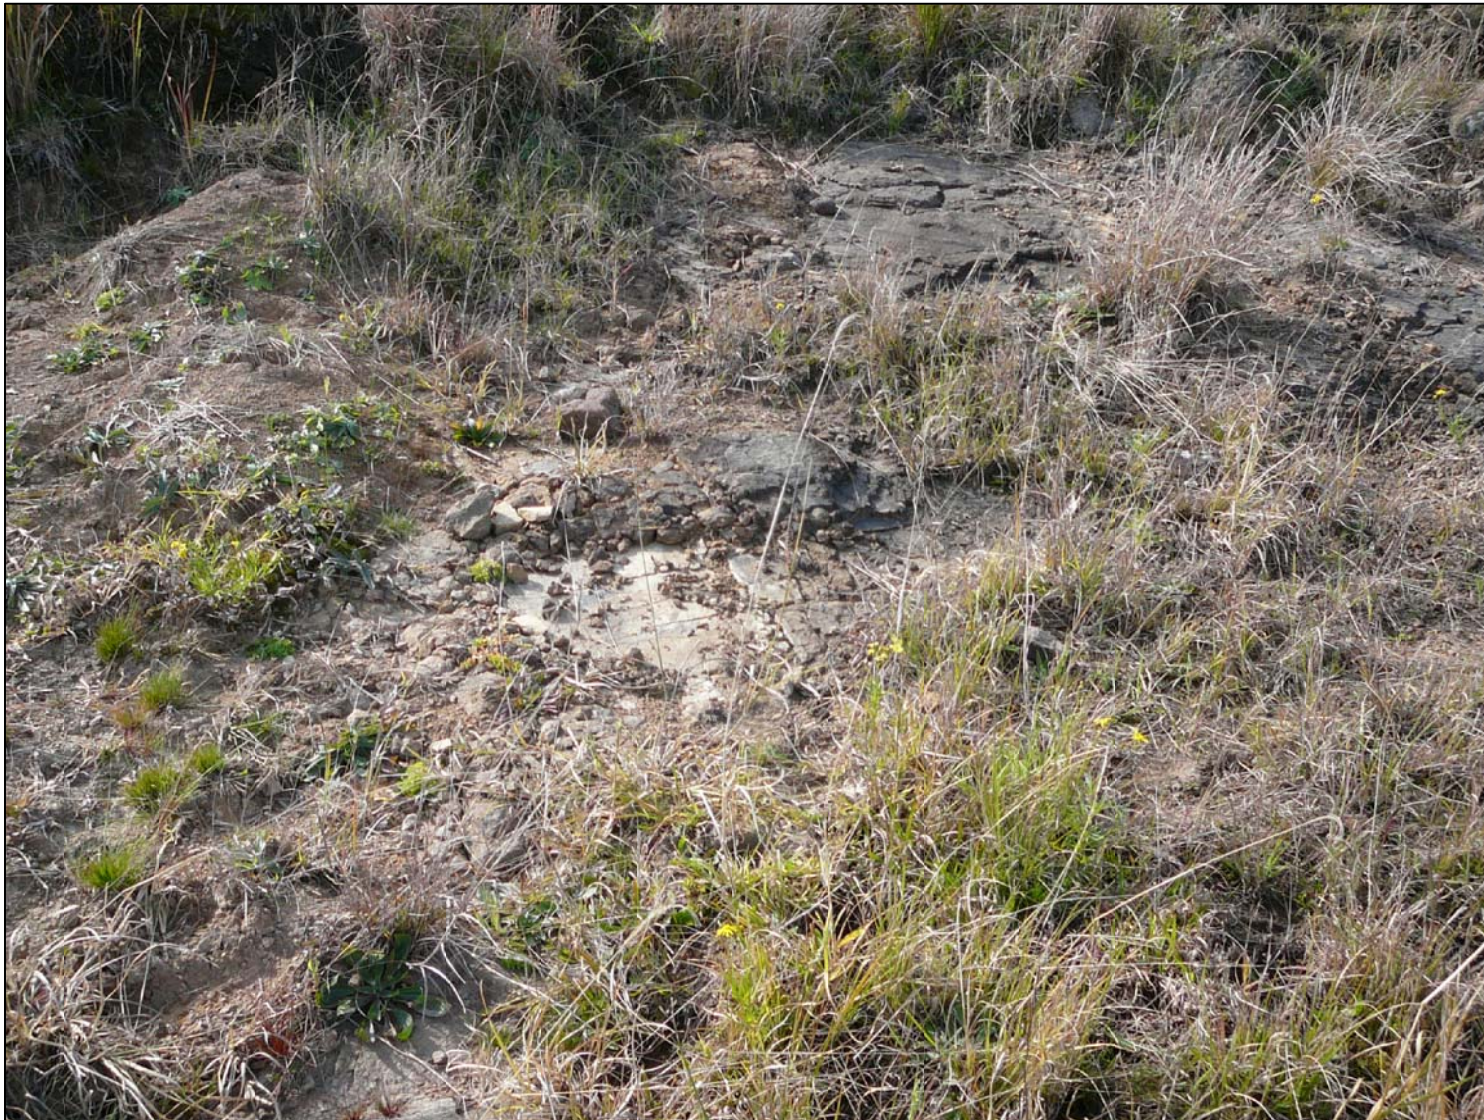
Figure 27

NSW Department of Commerce
Tillegra Dam
Storage Rim Landslide Assessment
BEDDING DIP 15° IN DAM AT
TOE OF SLIDE 2A

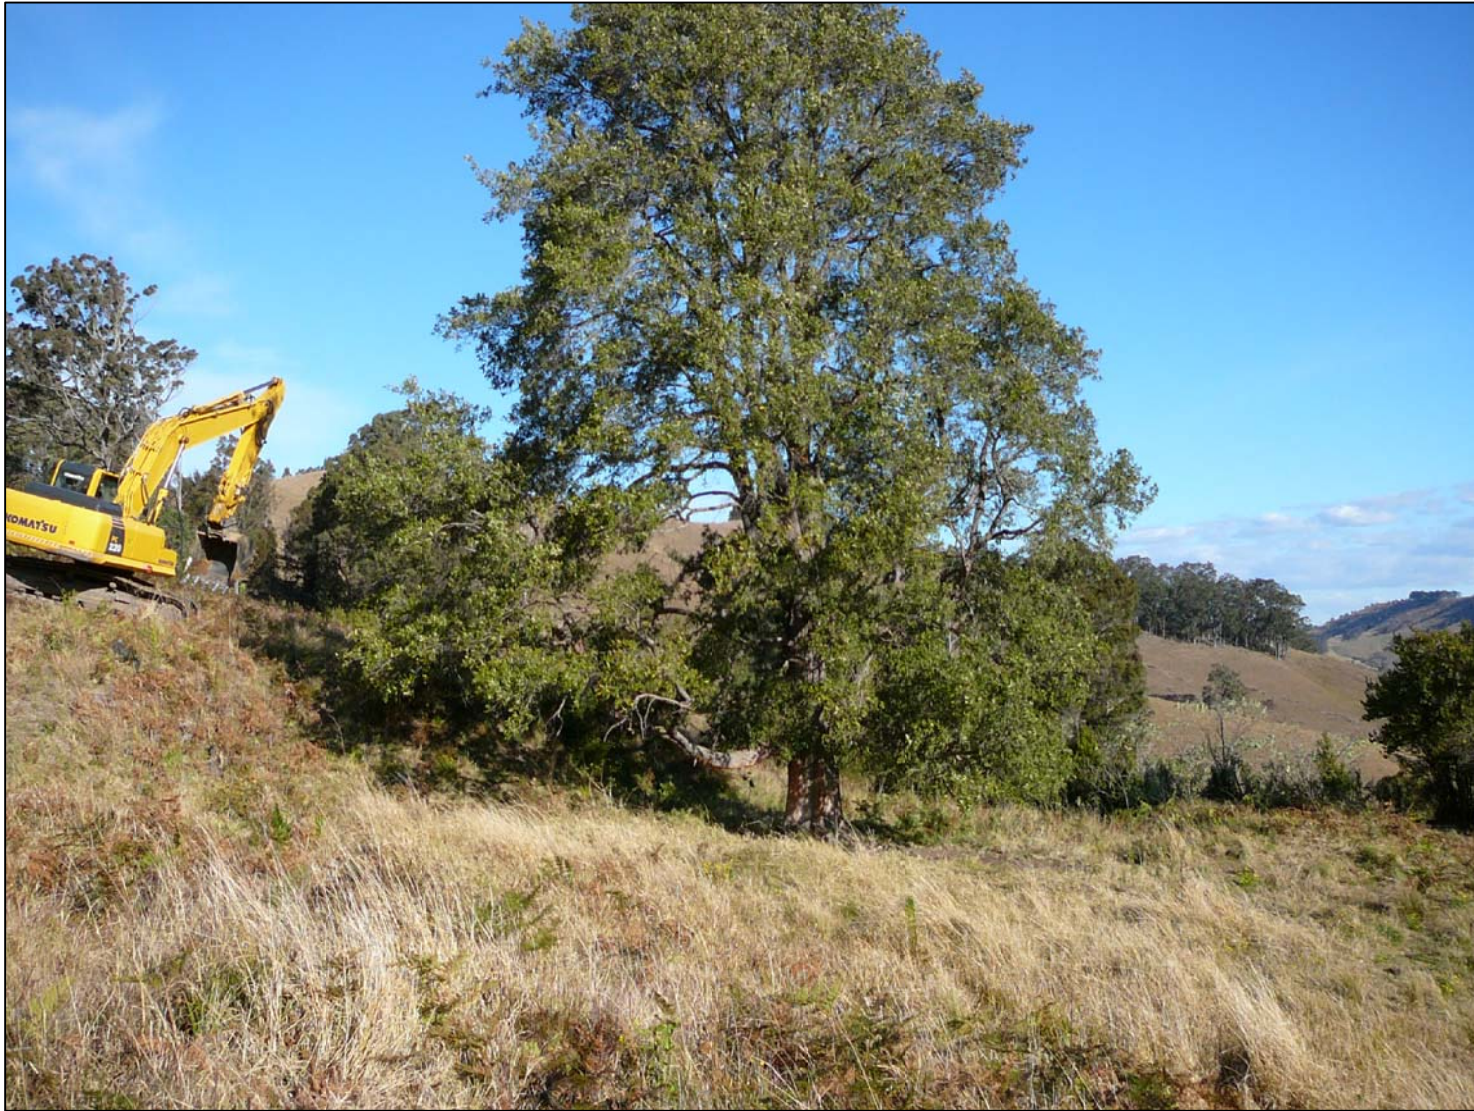
Figure 29

NSW Department of Commerce
Tillegra Dam
Storage Rim Landslide Assessment
SLIDE 2A - MATURE TREE
BELOW SLIDE SCARP

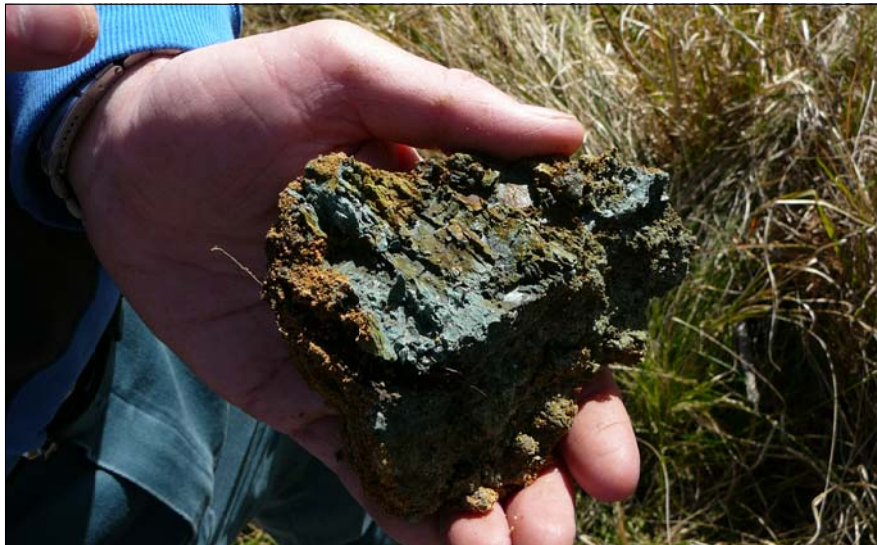
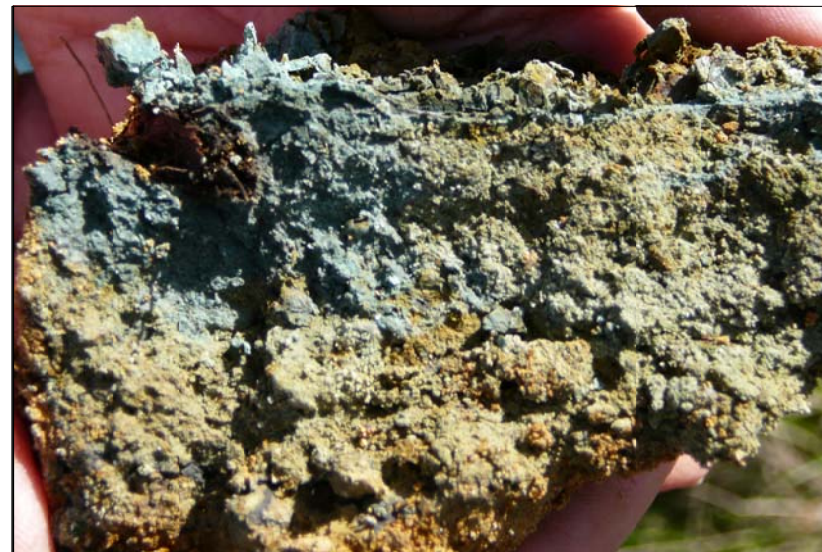
Figure 31

1. Two slide planes, at 2.1 and 5.5m depth, respectively, in Test Pit TP142 immediately above the recently active scarp in the main lobe of the landslide, Figure 30.
2. The lower slide plane is an extremely thin (<1mm thick) pale green coloured irregular clay layer, Figure 31.
3. The upper slide plane is a meta-shale layer that is still rock like, but shows significant aperture on joints, Figure 32.
4. The upper slide plane has been folded by the recent reactivation, Test Pit TP143, Figure 32.
5. Test Pits at the toe of the landslide did not intersect any slide plane; Test Pits TP149, TP150 and TP151.
6. The test pit at the toe of the main landslide lobe and located immediately above the outcrop in the farm dam, Test Pit TP149, showed brecciated rock with no distinct bedding or layering, Figure 33.

SURFACE OF CLAY LAYER

BASAL SLIDE PLANE
TP142

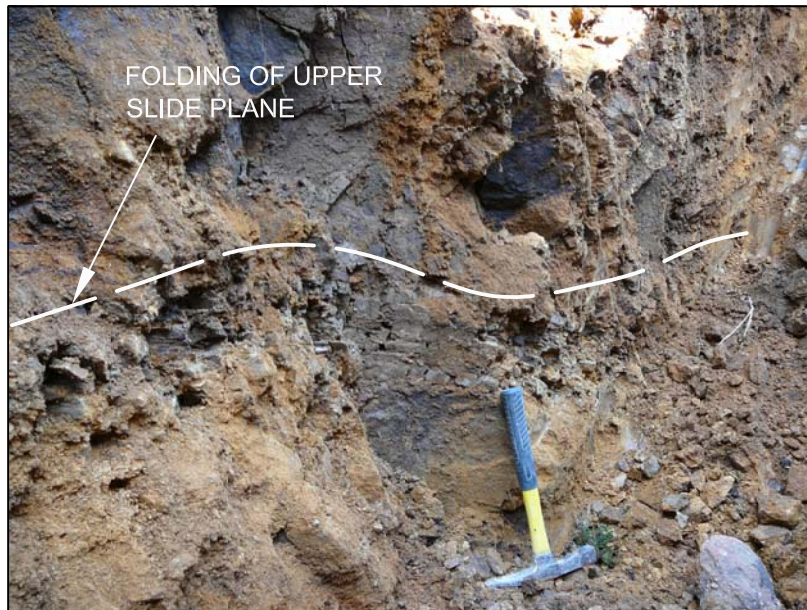
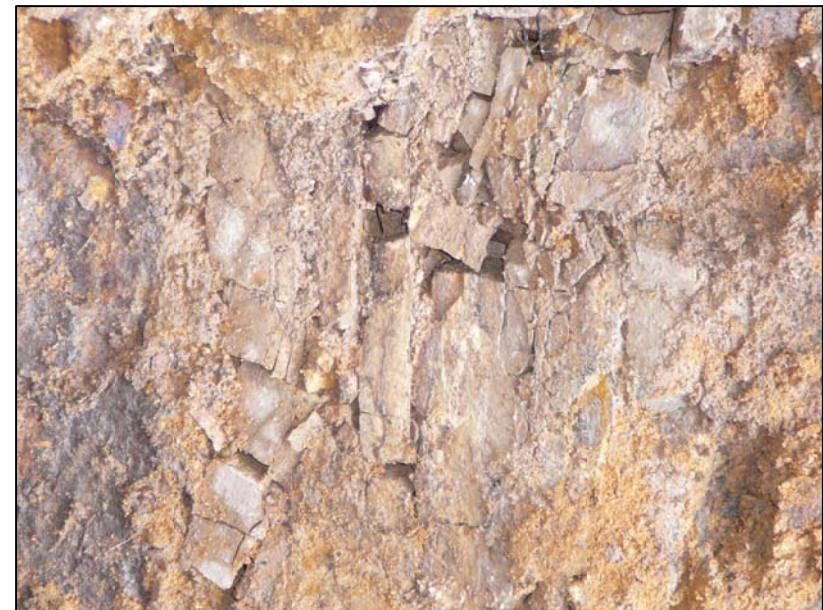
Figure 32

NSW Department of Commerce
 Tillegra Dam
 Storage Rim Landslide Assessment
 TWO SLIDE PLANES MULTI STOREY
 PLUS REMOBILISATION
 TP143

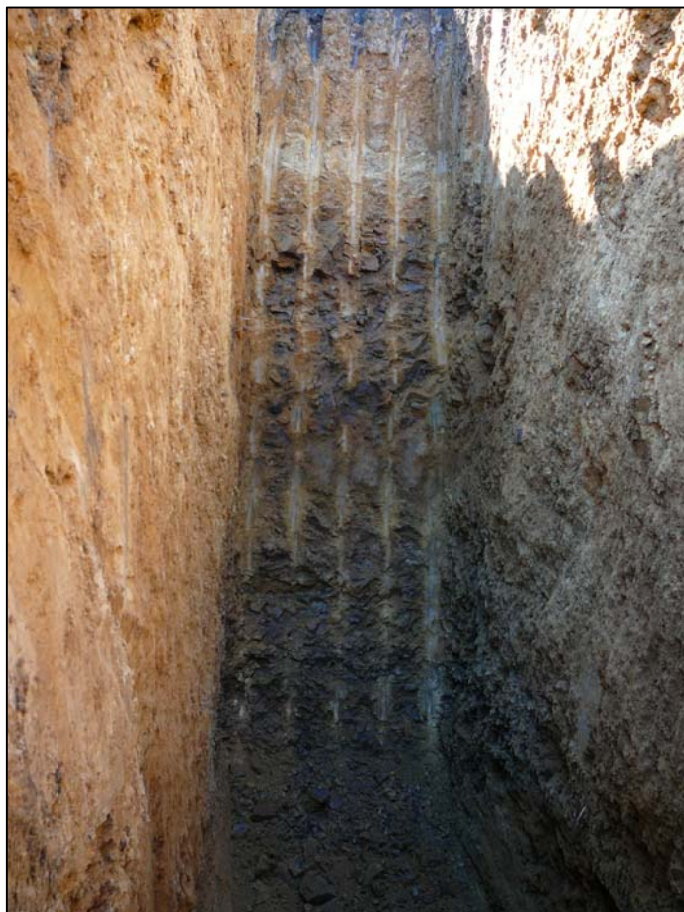
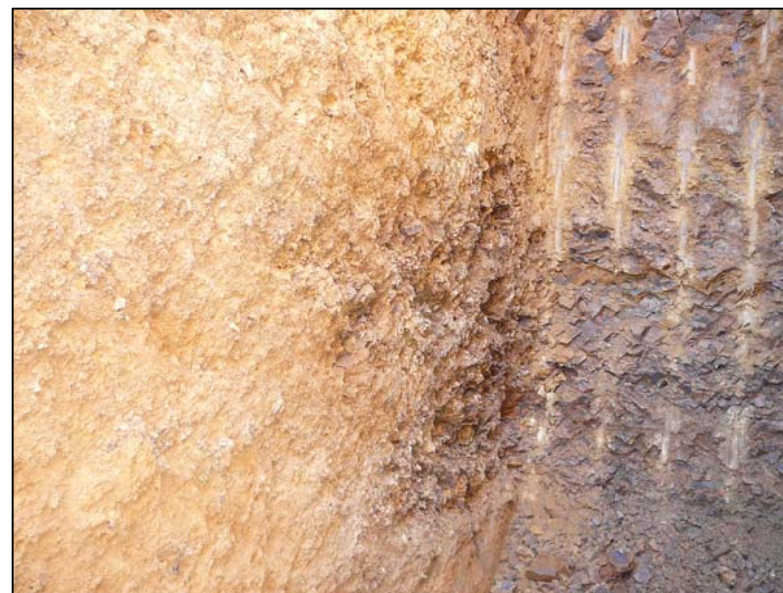
Figure 33

NSW Department of Commerce
Tillegra Dam
Storage Rim Landslide Assessment
NON DAYLIGHTING TOE
"SHOVE ZONE"
TP149
