TILLEGRA DAM DESIGN - CONSULTANCY 361802

Storage Rim Stability and Seepage Potential
Engineering Geotechnical Report

**STORAGE RIM LANDSLIDE
GEOTECHNICAL ASSESSMENT**

Report PSM1271.R1

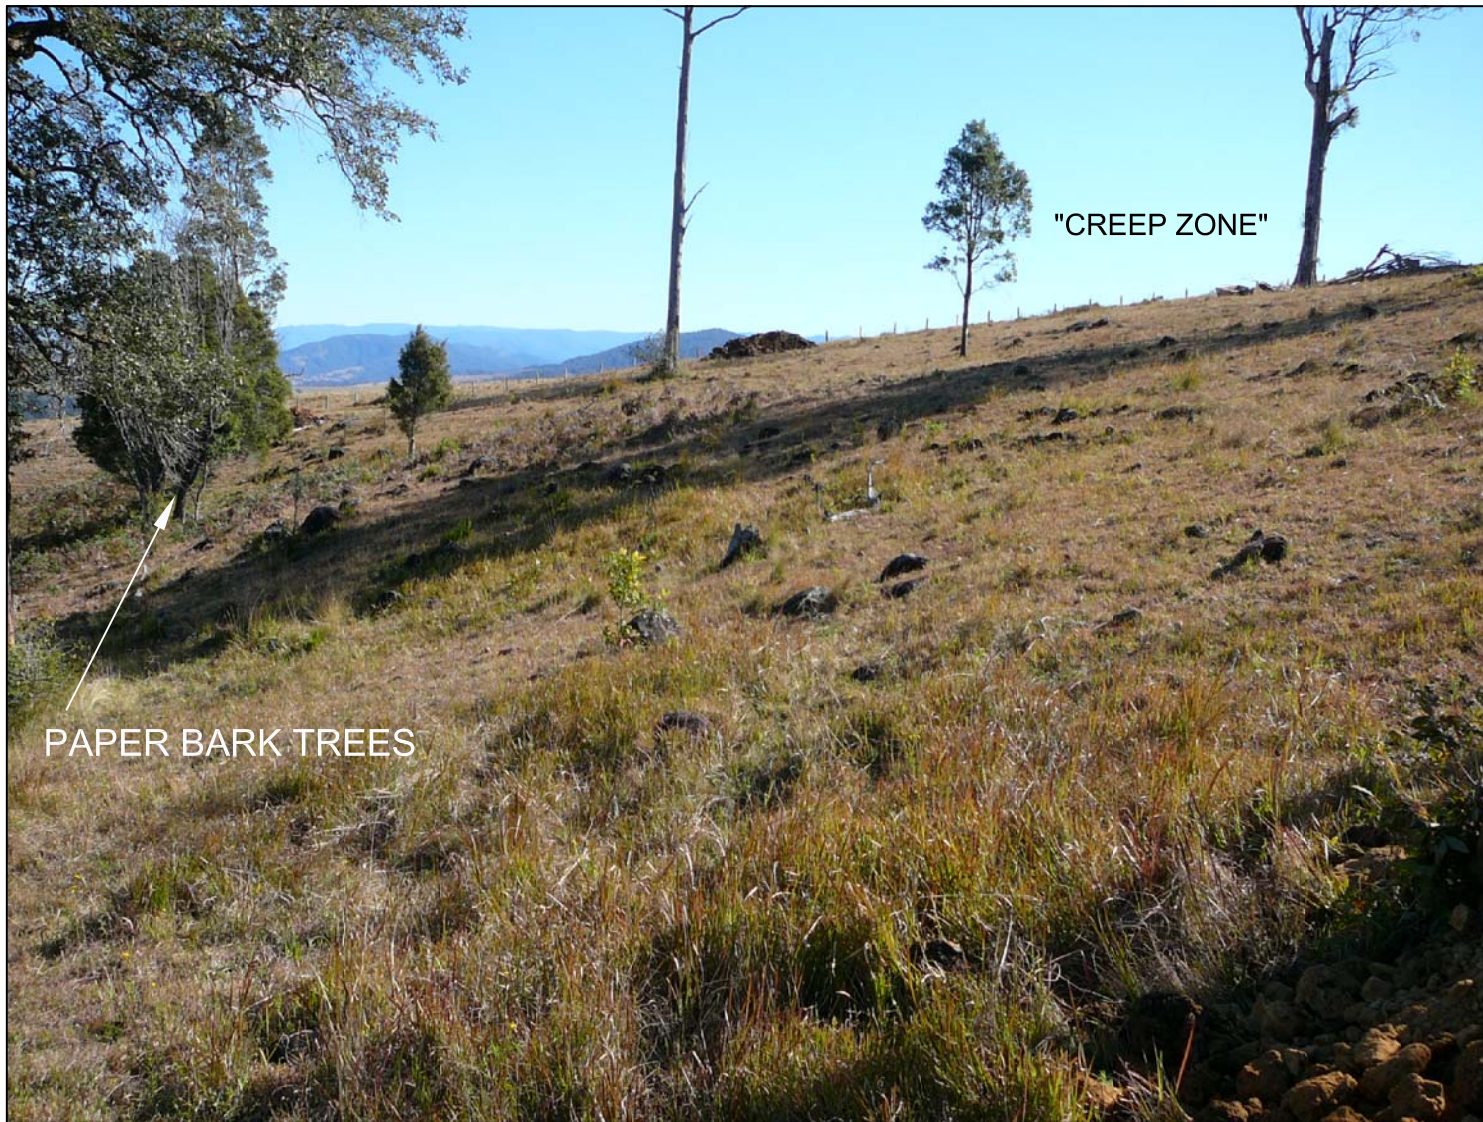
Figure 35

Surrounding the landslide in the north, northeast and east is a zone termed a creep zone. This zone has ground surface slopes in the range of about 6° to locally 12°. The ground surface is fairly smooth with some scattered boulders, Figure 35.

NSW Department of Commerce
Tillegra Dam
Storage Rim Landslide Assessment
CREEP ZONE ABOVE
LANDSLIDE 2A

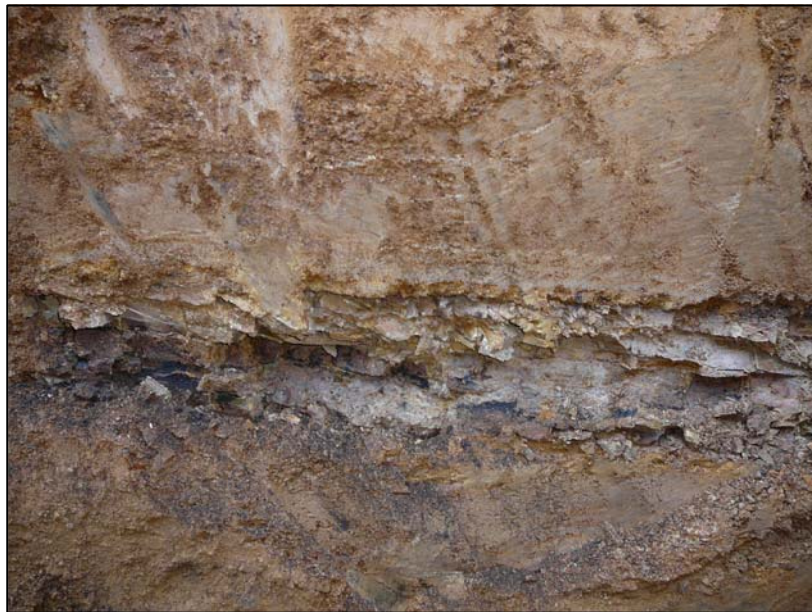
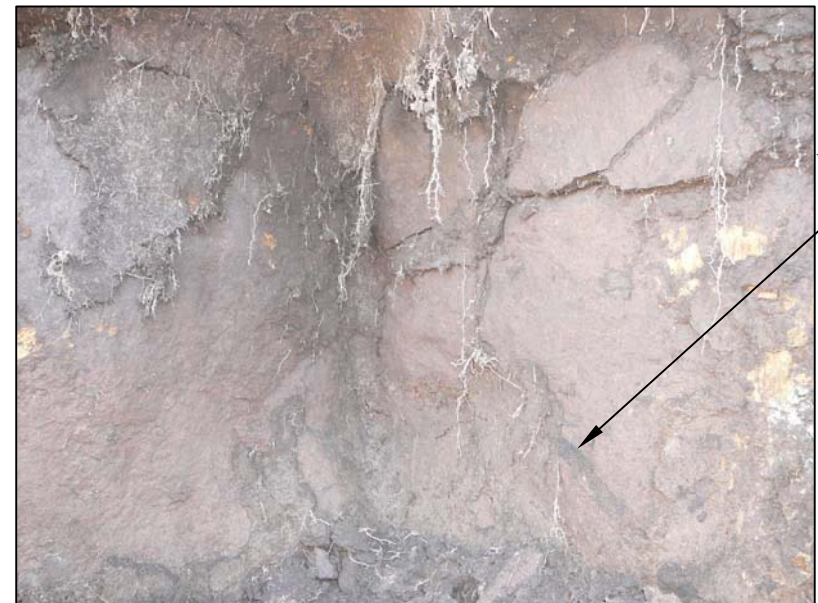
Figure 36

1. Evidence of small movement on the upper creep plane at the base of the meta-shale layer, Figure 36.
2. This movement was shallow, at a depth of 1.5 to 2.0m, TP147 and TP148.
3. The mass above the meta-shale layer was often high strength, blocky rock, with clay infill, and locally extremely to highly weathered sandstone, Figure 36.
4. Some test pits refused on rock at shallow depths and did not reach the creep plane.
5. Borehole DDH30 confirmed there was not a deeper slide plane present, Figure 9.
6. Borehole DDH30 also confirmed that regression of Slide 2A could not affect the storage rim, Figure 39.

CREEP
ZONE

META
SHALE

CLAY
INFILL

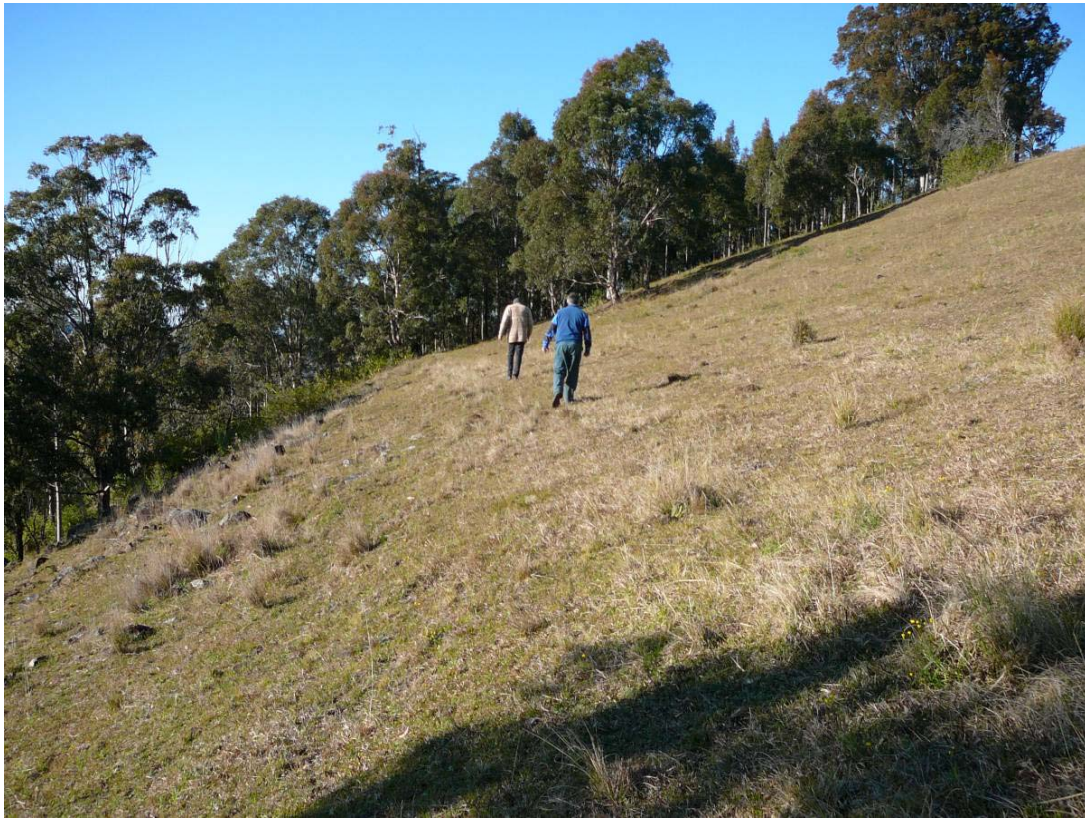
Photo 1: Trig Hill

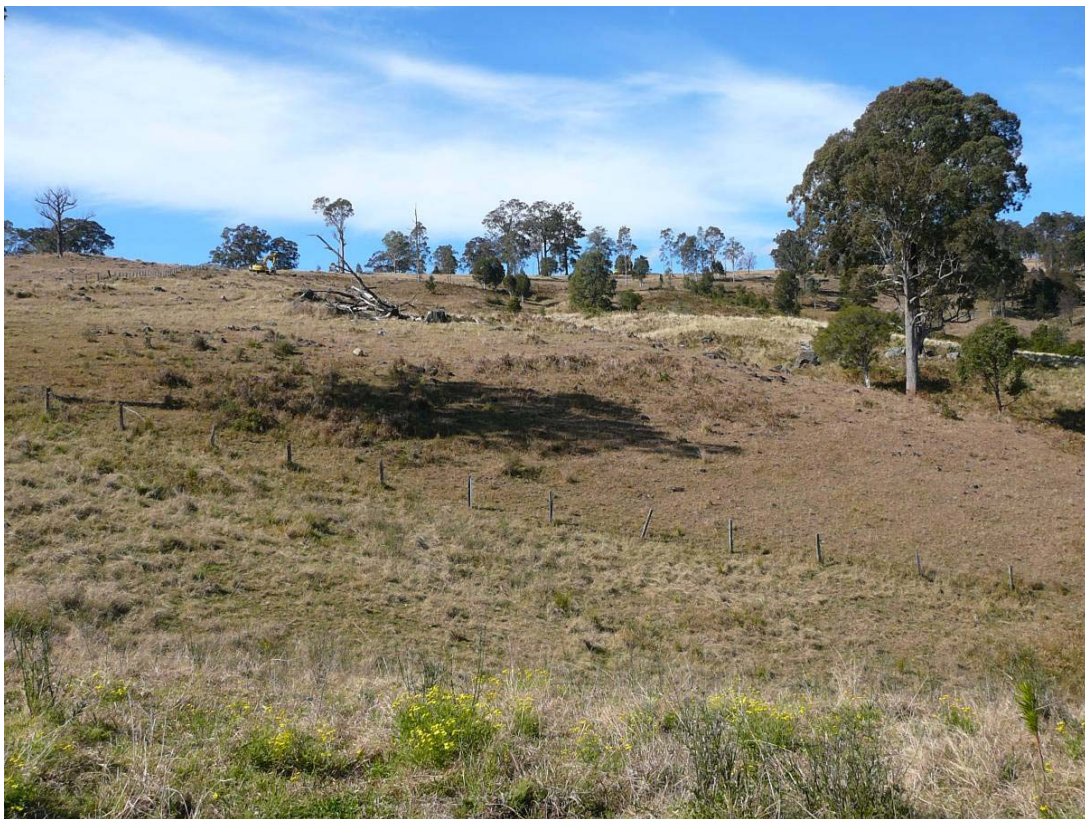
Photo 2: Views of the slide 2A

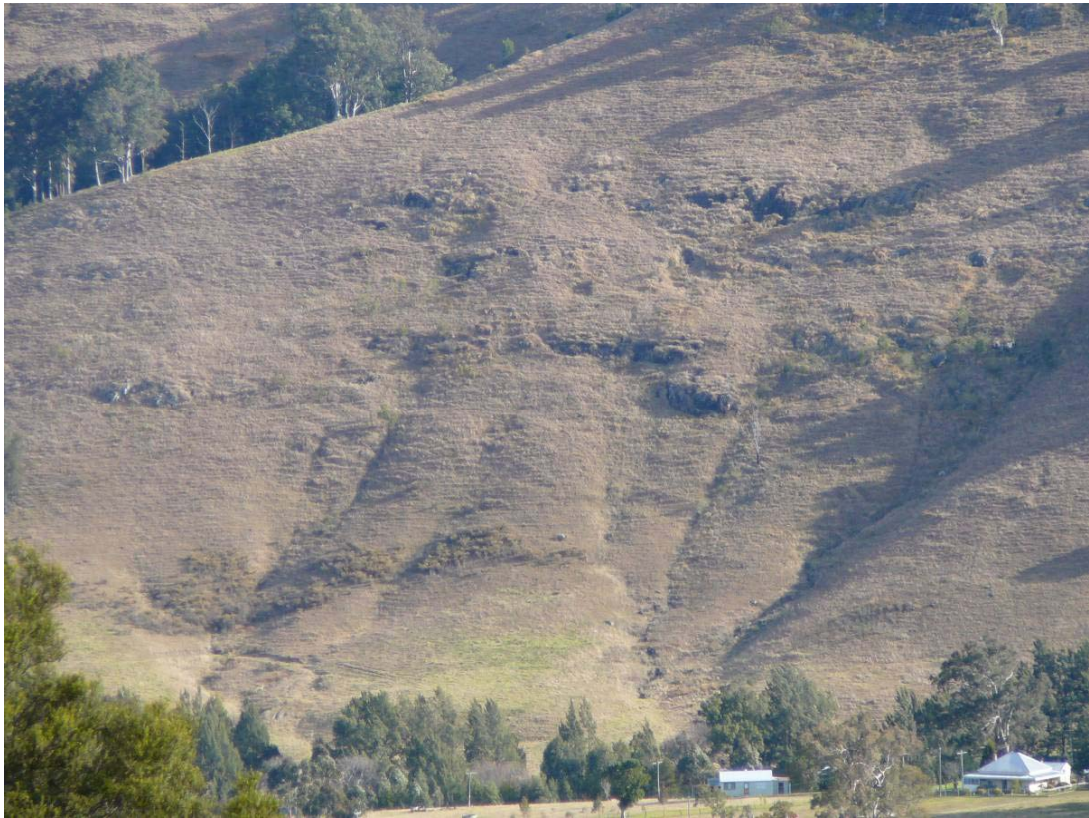
Photo 3: Possible Slide 8A

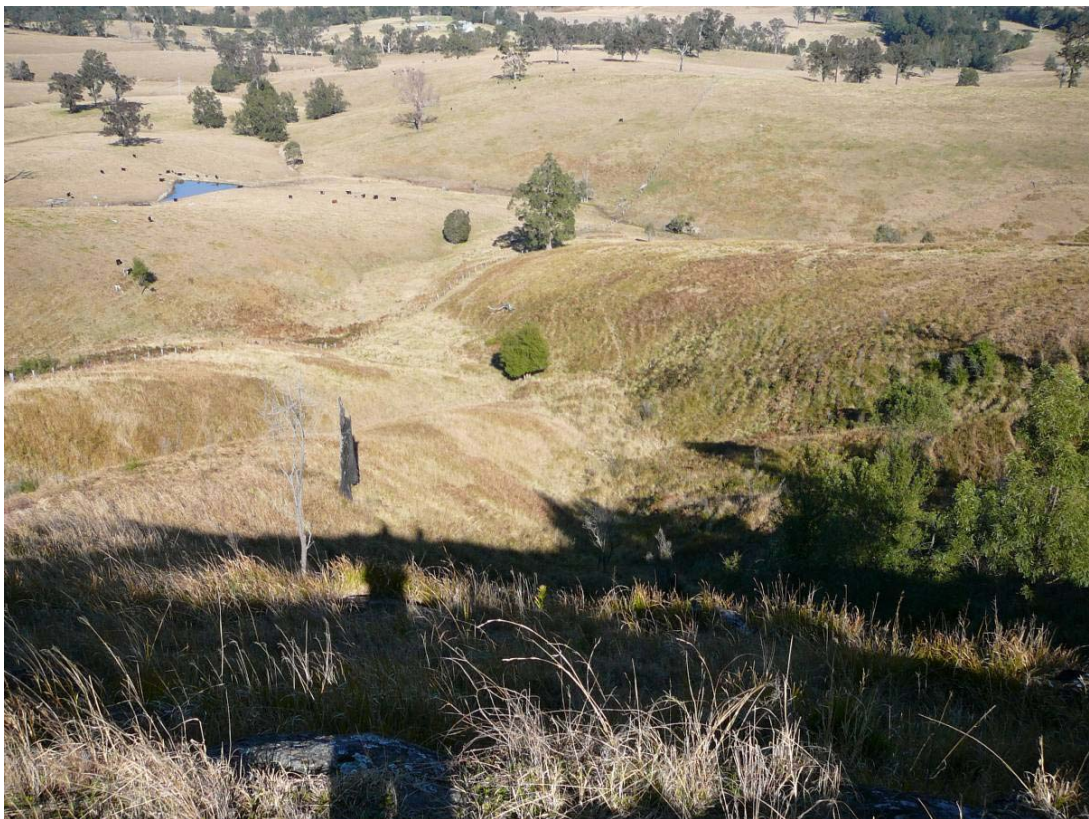
Photo 4: Outwash fan below Slide 1A note small boulders only

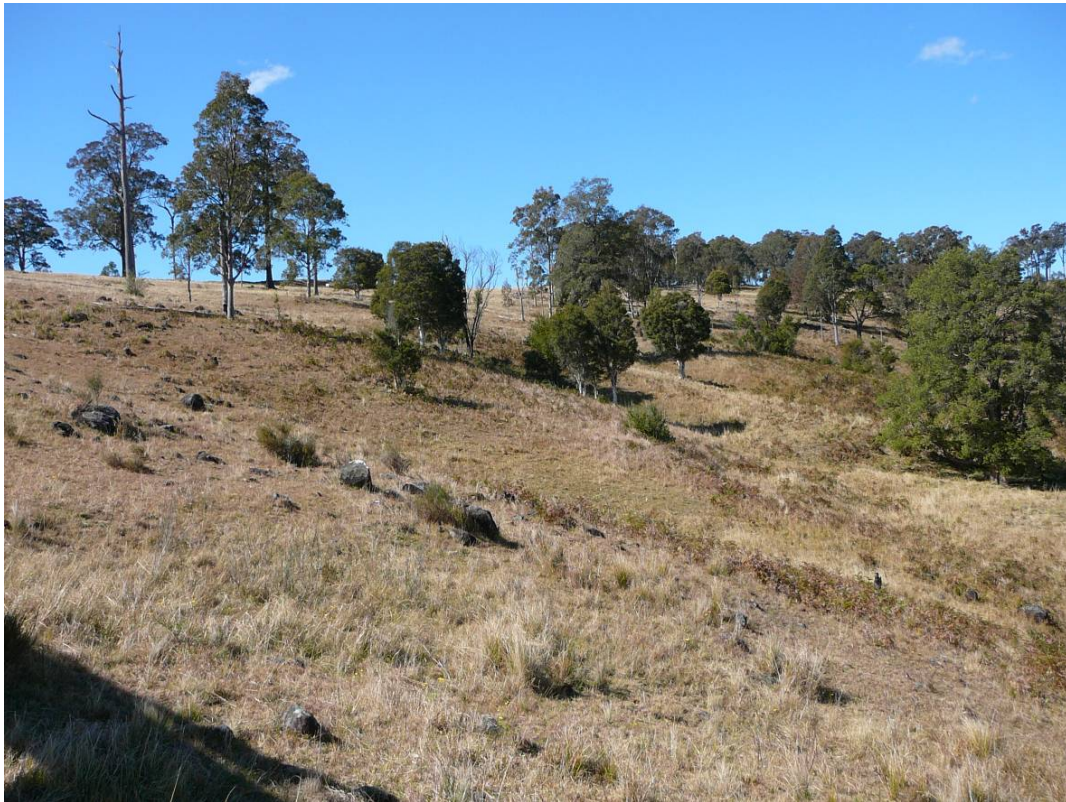
**Photo 5: View to South east in Domain 2 above Head scarp Slide 2A
Note Melaleucas "paper bark"**

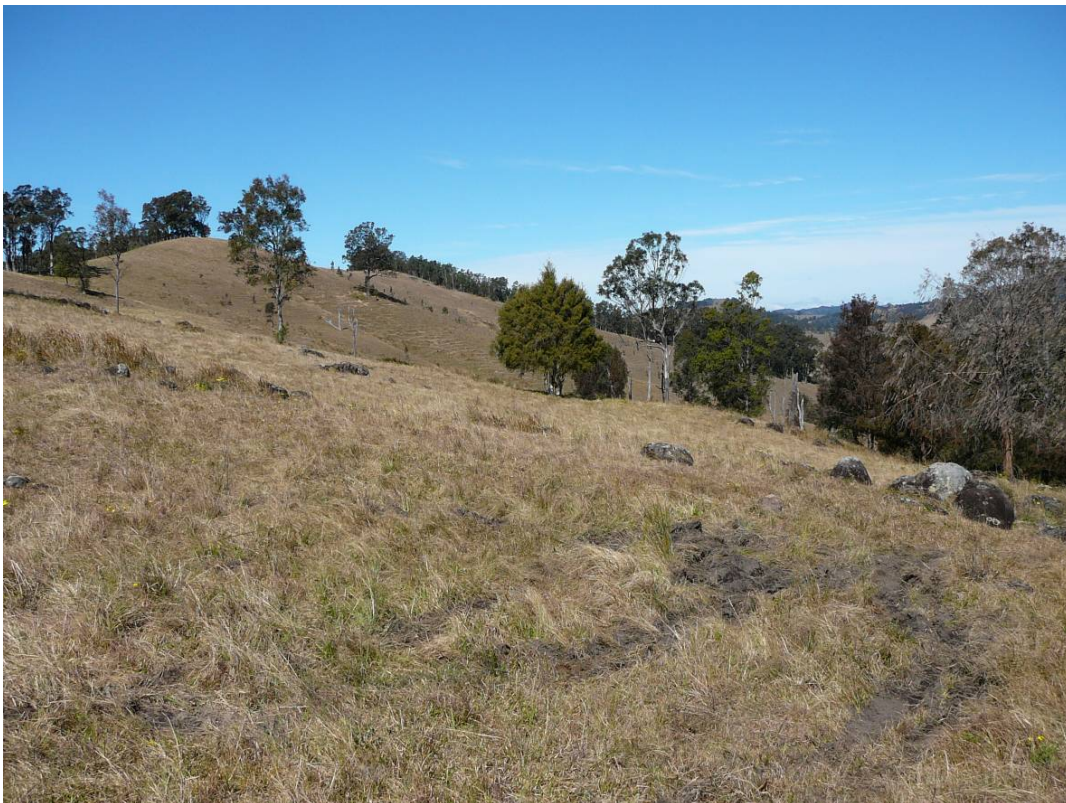
Photo 6: Slope above Slide 2A note melaleucas and change in slope

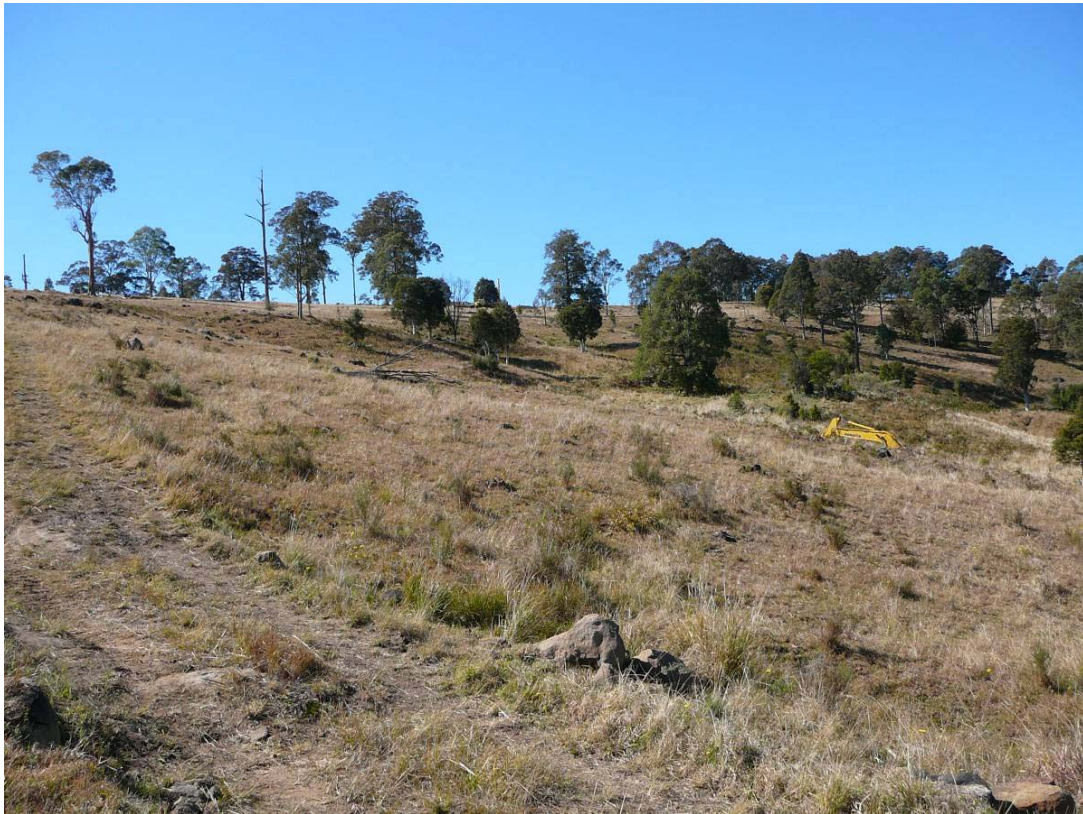
Photo 7: Slide 2A

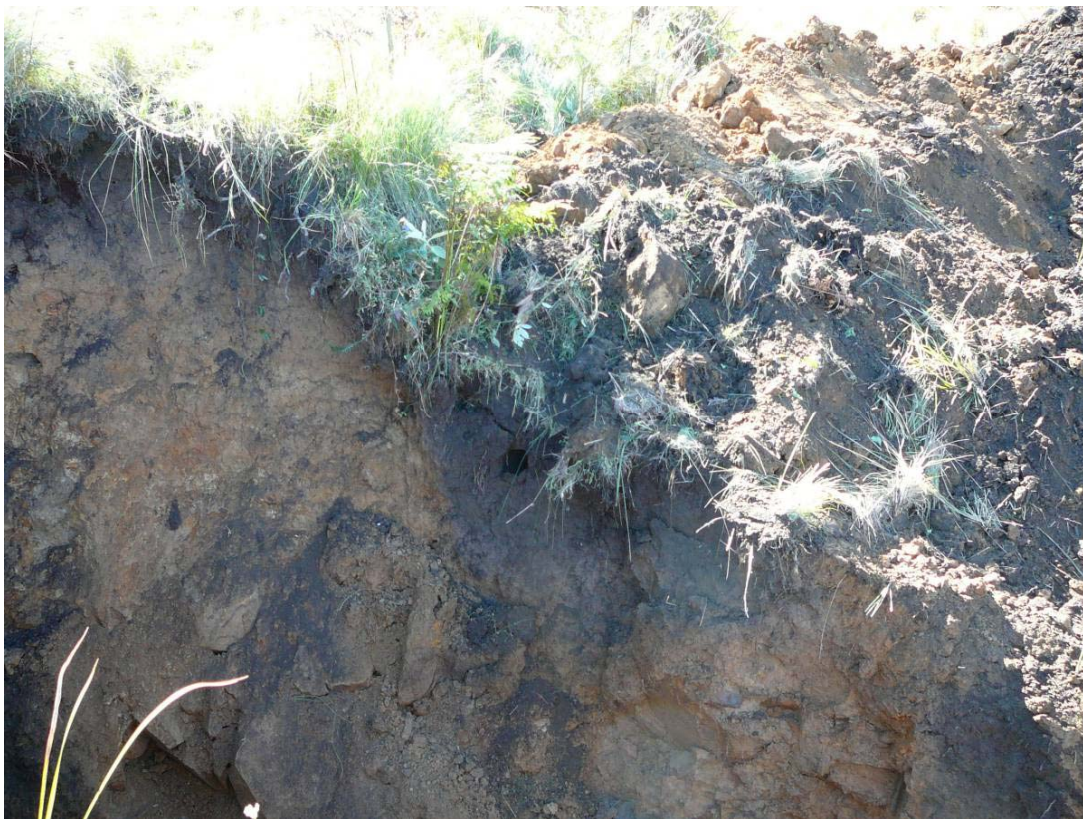
Photo 8: TP138 Scarp and topsoil “infill” tension zone

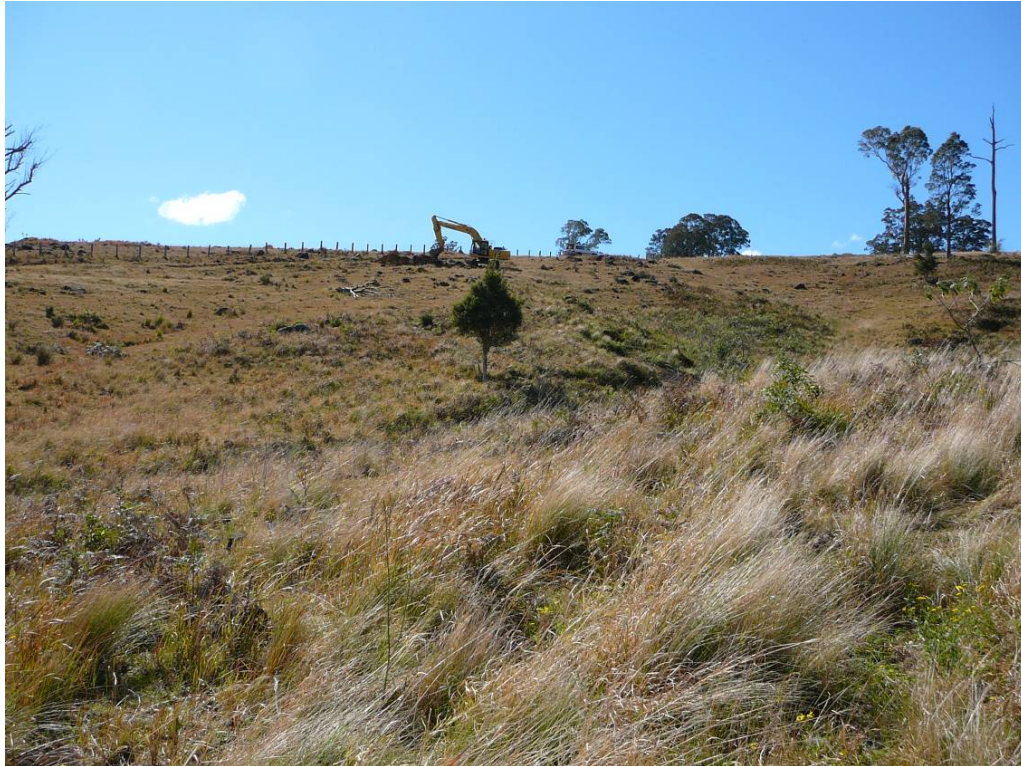
Photo 9: TP138 and TP139

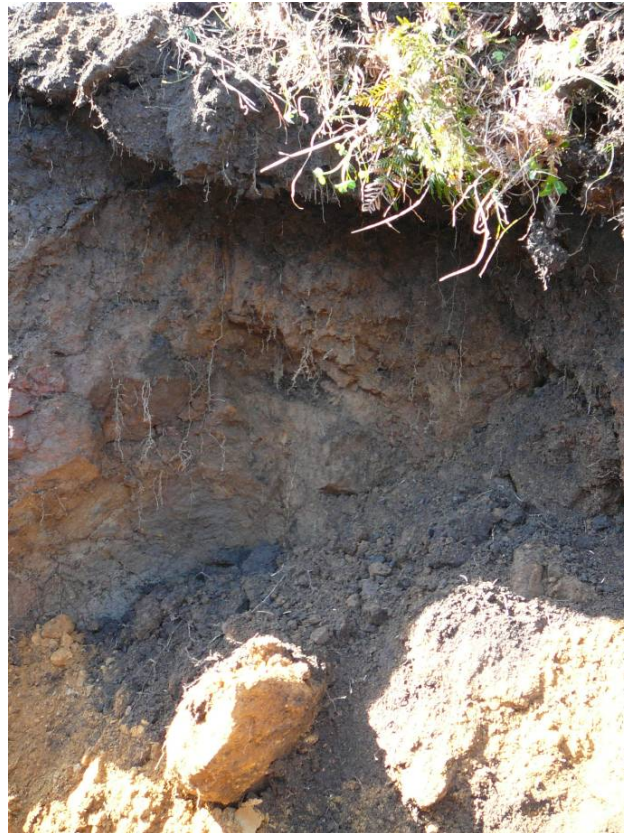
Photo 10: TP140 Note loosened rock mass in creep zone

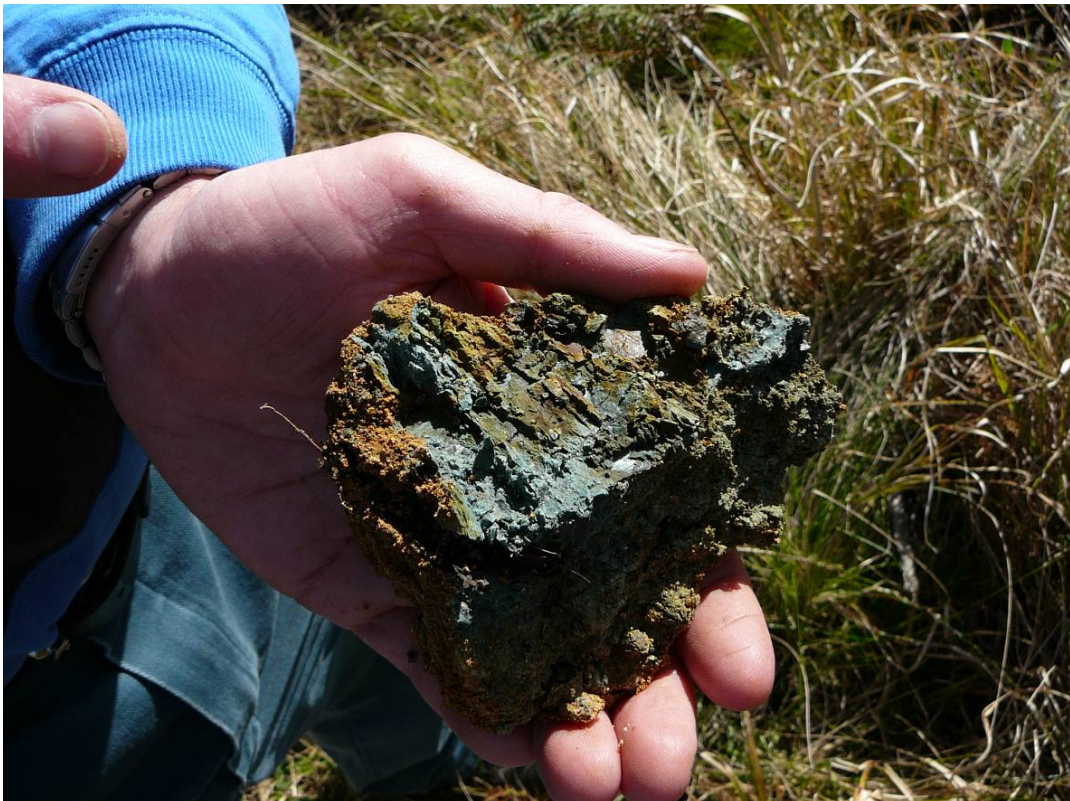
Photo 12: TP142 Lower slide plane, thin clay seam in extremely weathered rock

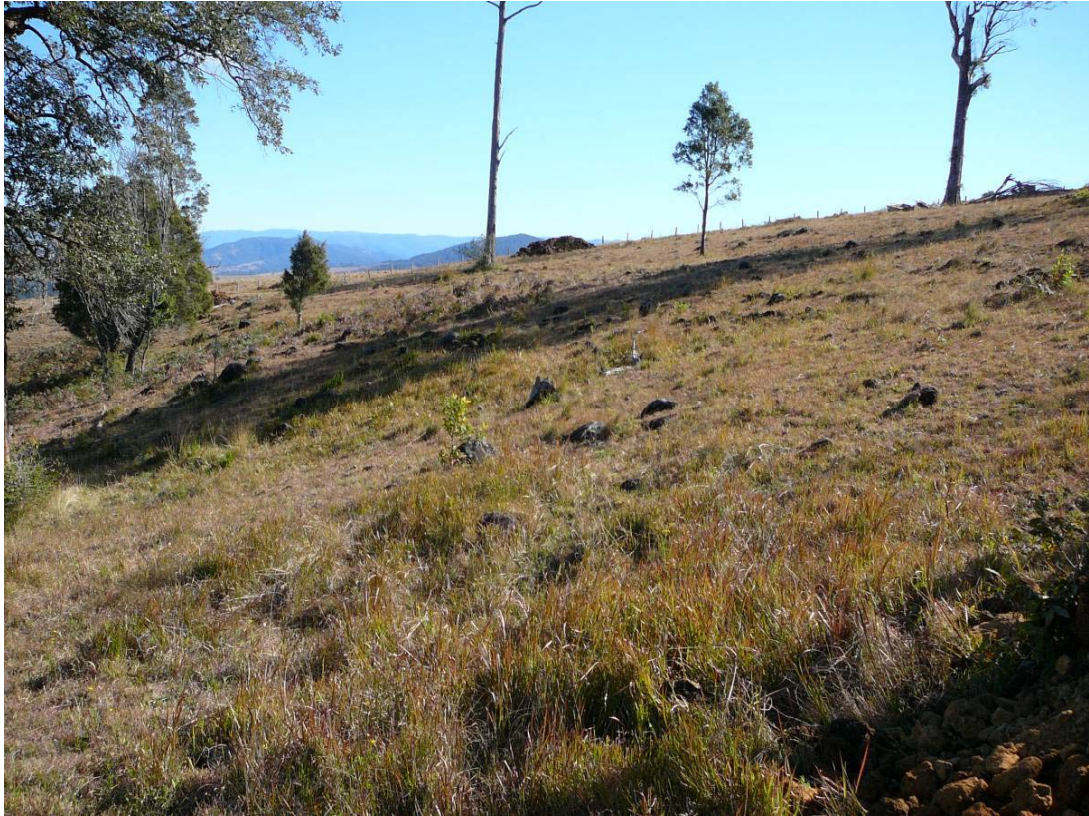
Photo 13: View of TP147 and TP148

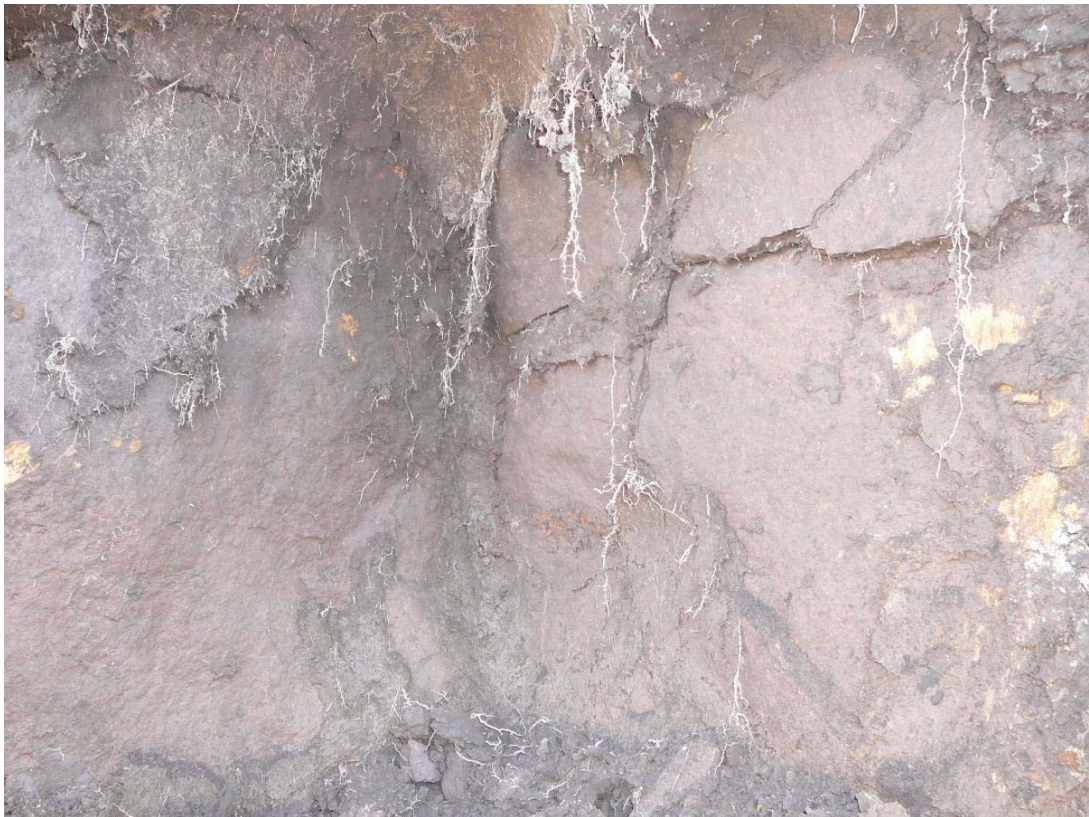
Photo 14: TP146, 147, 148

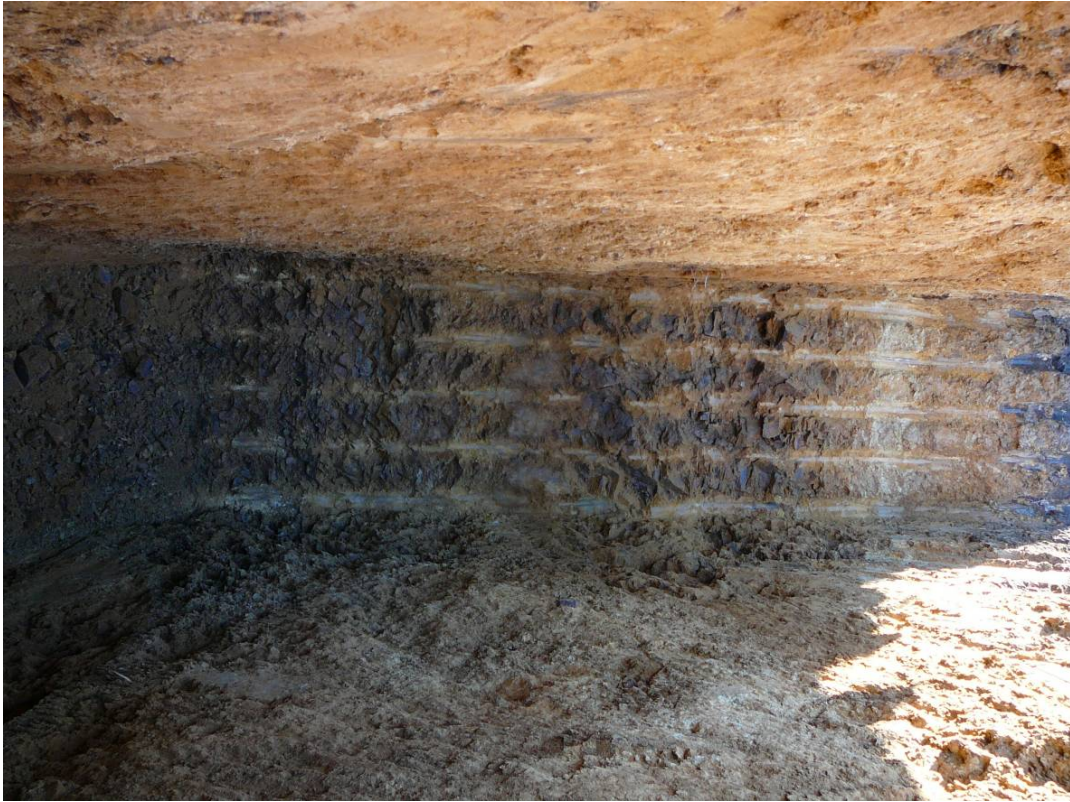
Photo 15: TP149 in toe of main slide

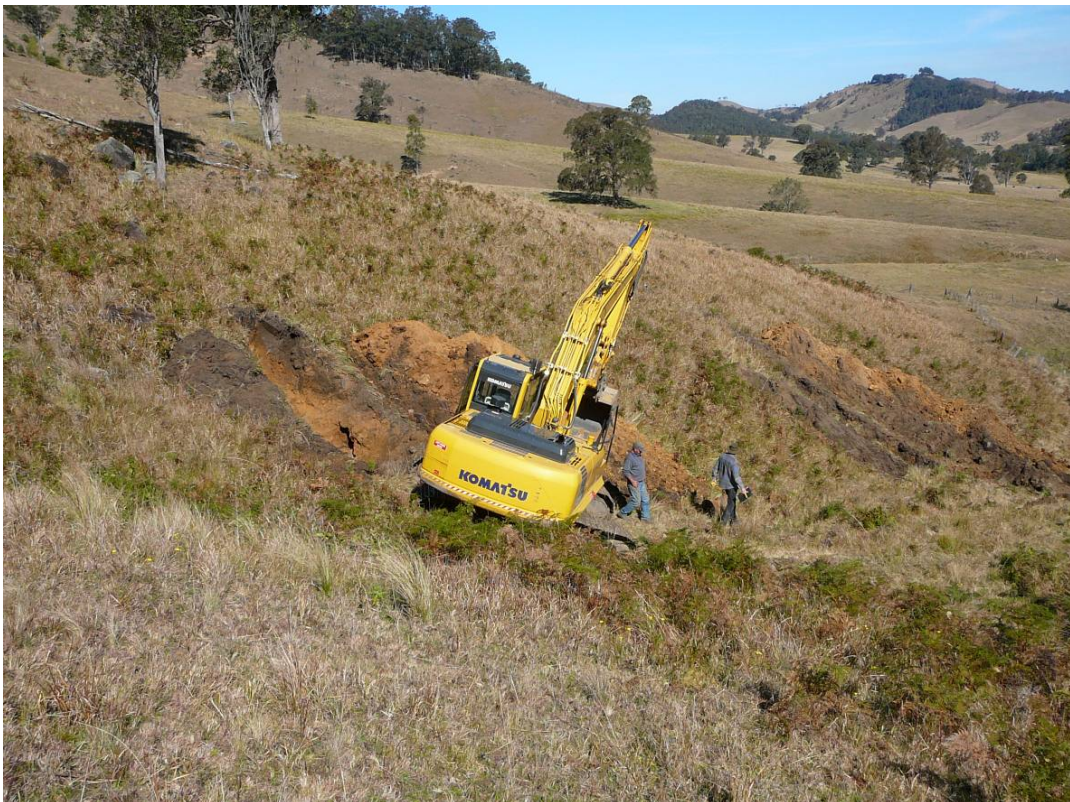
Photo 16: TP150, TP 151 setting and photos
